SUMMARY 1924 Peach Tree Lane , Bethlehem, Pa 18015 Creighton Faust October 17, 2024

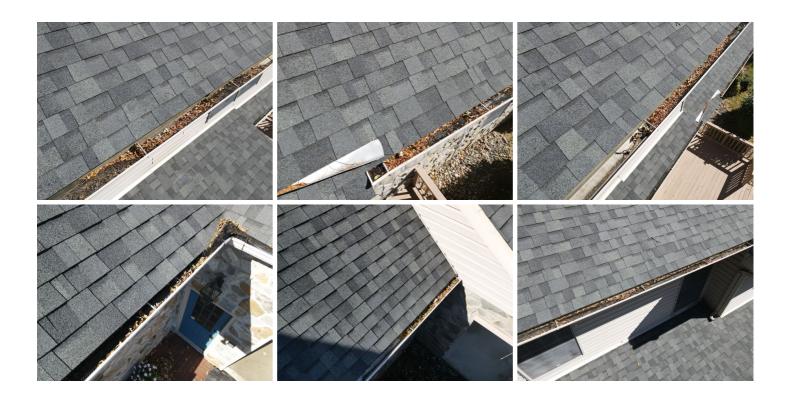
3.3.1 Roof Drainage Systems

### **DEBRIS**

Debris has accumulated in the gutters. The gutters should be maintained to correctly facilitate water flow.

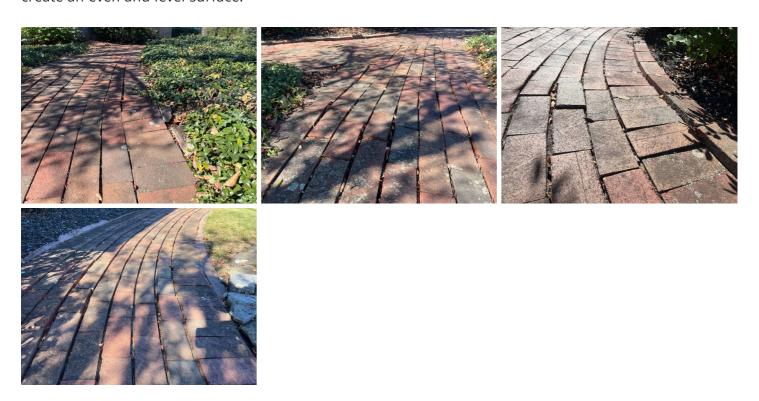
4.2.1 Walkways, Stoops, Steps, Patios & Driveways WALKS UNEVEN

The walks are uneven at a few small areas. This is a safety concern-trip hazard, suggest making repairs to create an even and level surface.

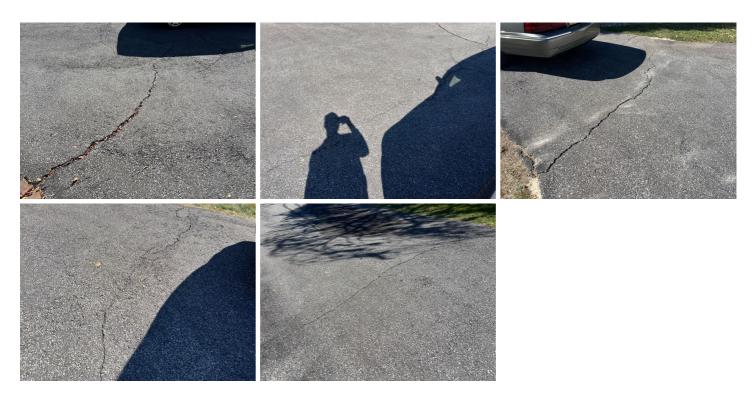
4.2.2 Walkways, Stoops, Steps, Patios & Driveways **DRIVEWAY CRACKING**

Cracking was observed. Recommend monitoring and/or have contractor patch/seal.

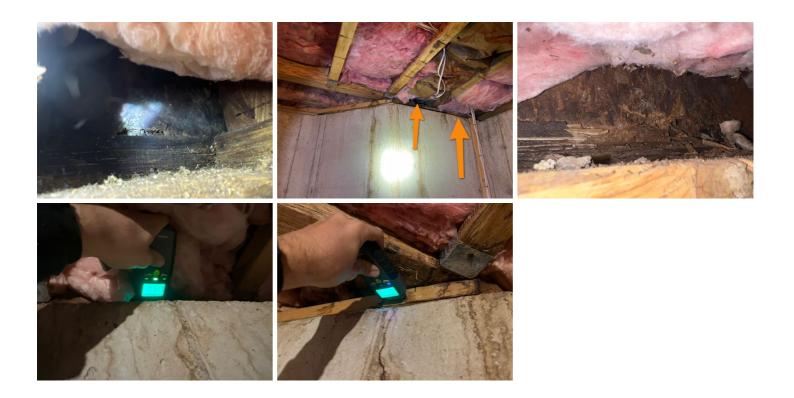
# 5.3.1 Floor Structure **ROT AT BAND JOIST**

FRONT BASEMENT, RIGHT OF FRONT DOOR

Rot was observed at the band joist. This area should be repaired by a qualified professional. The source of moisture must be addressed to prevent reoccurrence.

Recommendation

Contact a qualified professional.
