THE PENTAGON BUILDING PERFORMANCE REPORT

January 2003

American Society of Civil Engineers

SEI
Structural Engineering Institute
of the American Society of Civil Engineers

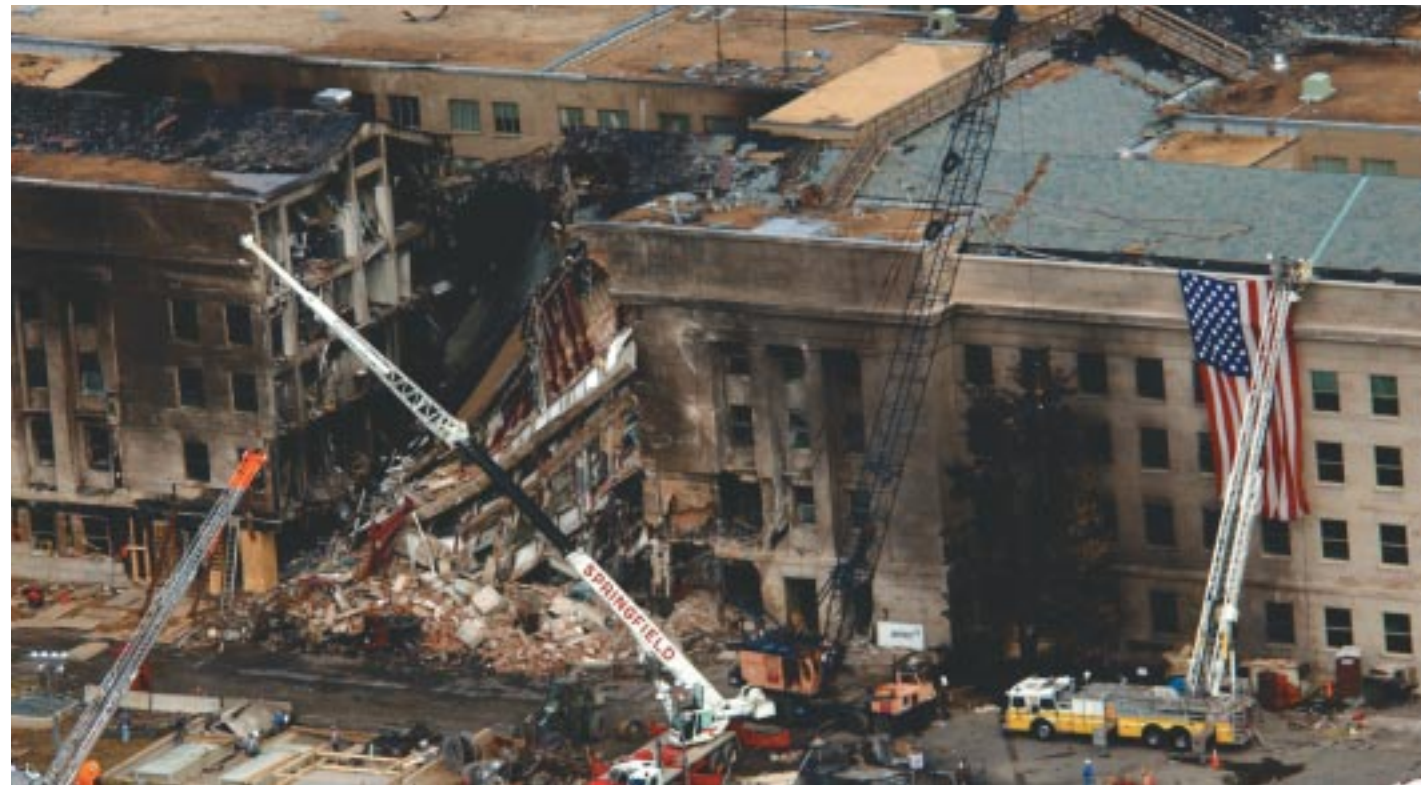
Figure 1.3 Crash damage

Figure 1.3 presents an exterior view of the extent of damage from the crash, including a collapsed portion of Ring E at the point of impact, beyond which the impact destruction from the decelerating aircraft continues; the subsequent devastation from the fire is also evident. The superior performance of the improved window system incorporated during the renovation is evident on the right.

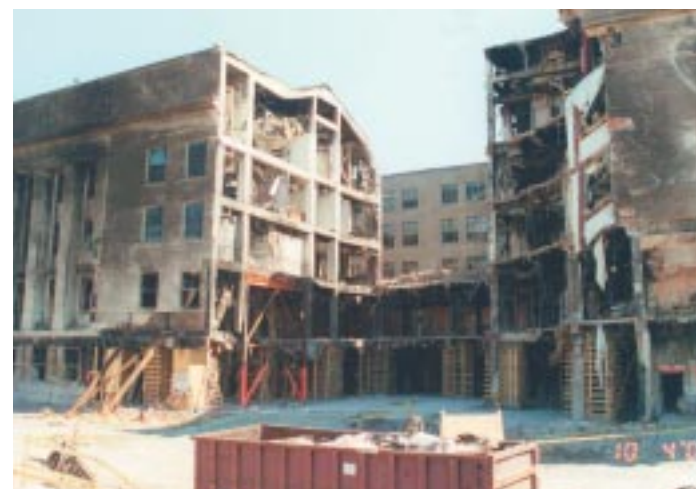
Figure 5.1 Impact area with debris removed

By the time the full Pentagon BPS team visited the site, all debris from the aircraft and structural collapse had been removed (figure 5.1) and shoring was in place wherever there was severe structural damage. The design team charged with reconstructing the Pentagon was assessing the building and preparations were being made to demolish the areas for reconstruction. Consequently, the Pentagon BPS team never had direct access to the structural debris as it existed immediately after the aircraft impact and subsequent fire.

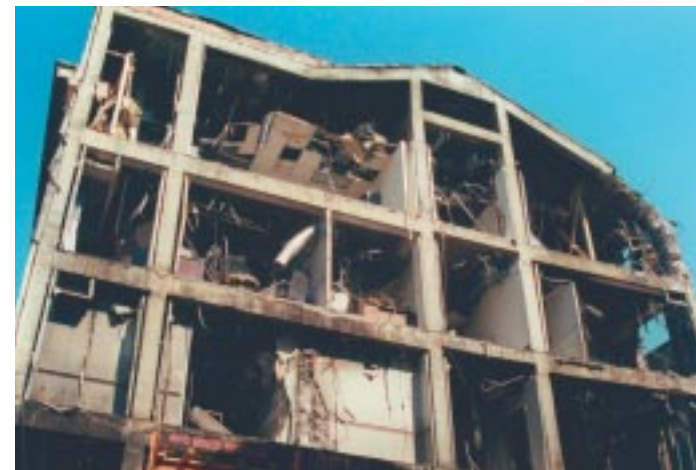
Figure 5.2 Beams and columns on north side of expansion joint

The collapsed portion of Ring E was immediately south of an expansion joint on column line 11 (figures 5.2 and 5.3). The collapsed area extended south from the expansion joint to approxi-

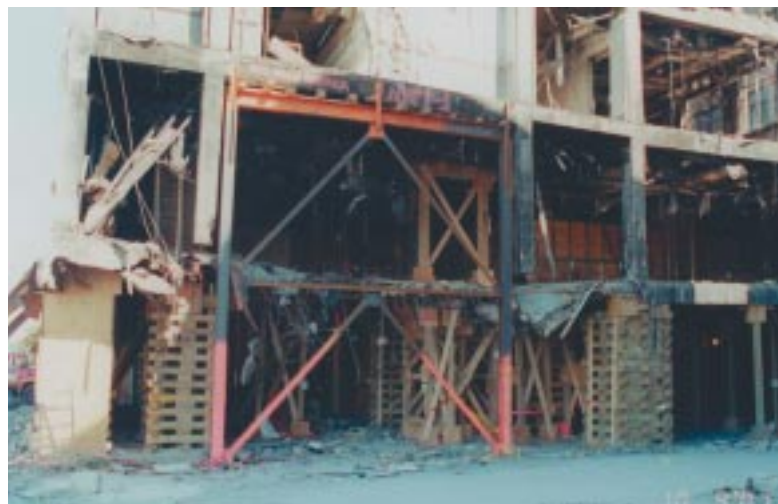
Figure 5.5 Missing first-floor columns 11A, 11B, and 11C

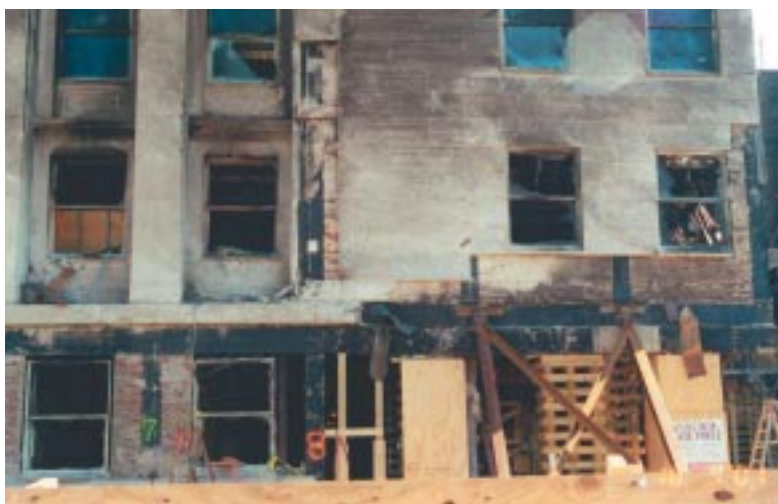
Figure 5.6 Facade damage to the north of the impact area

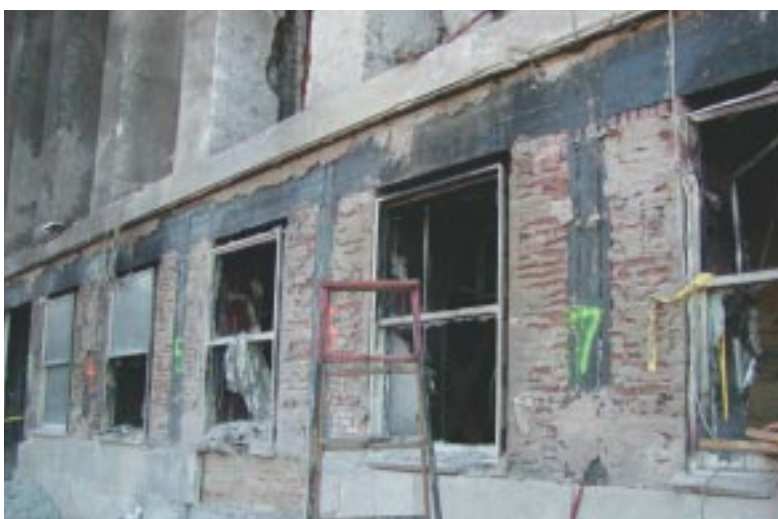
Figure 5.7 First-floor facade damage to the north of the impact area

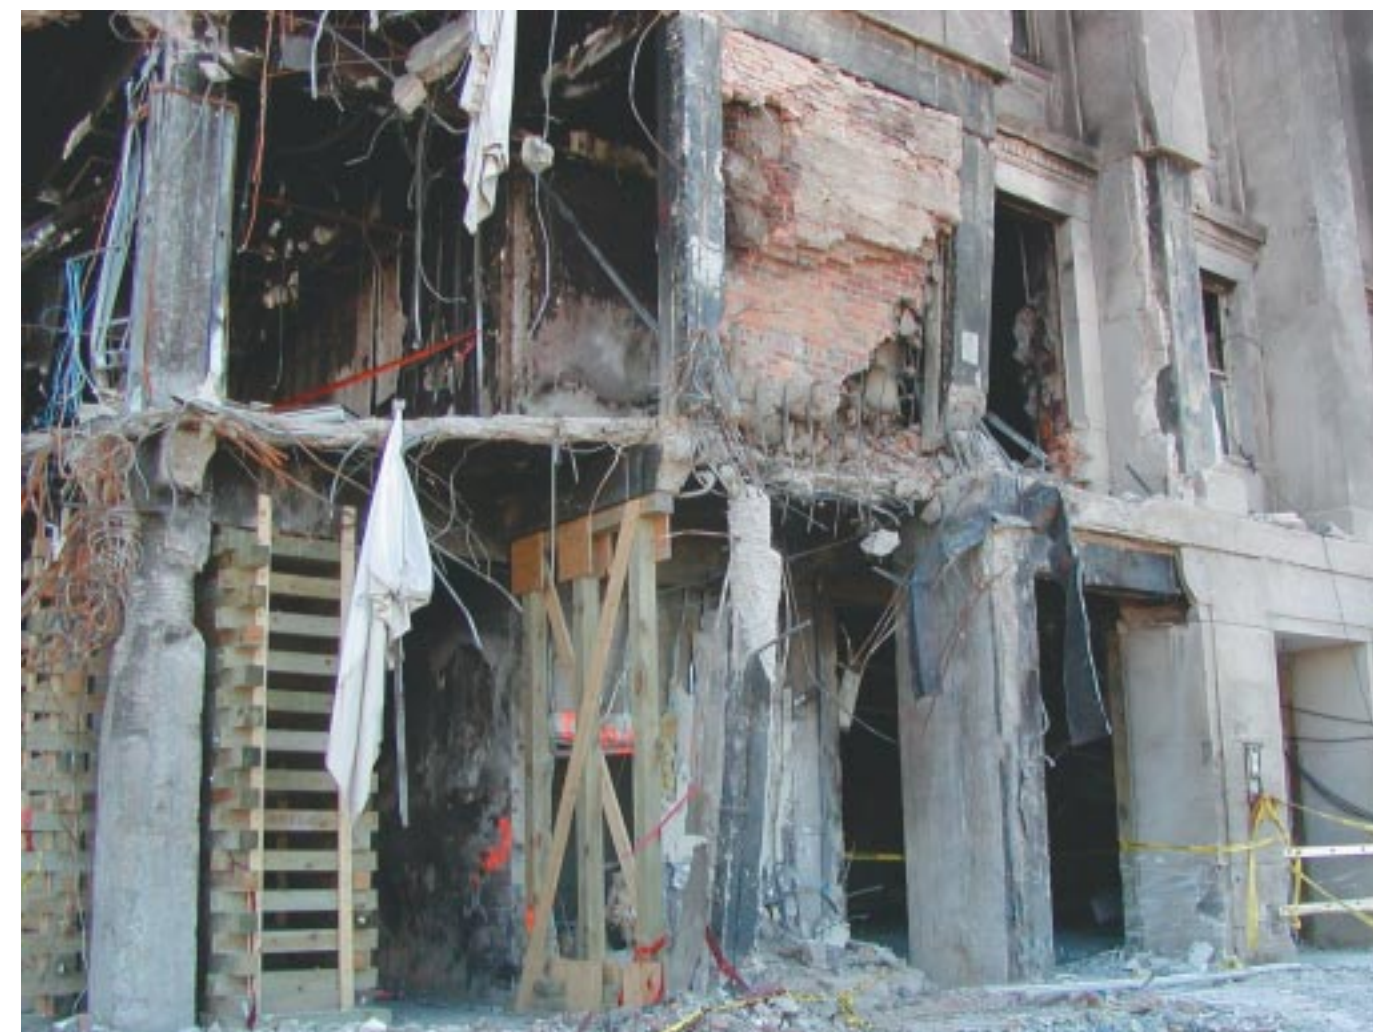
Figure 5.8 Facade damage to the south of the impact area

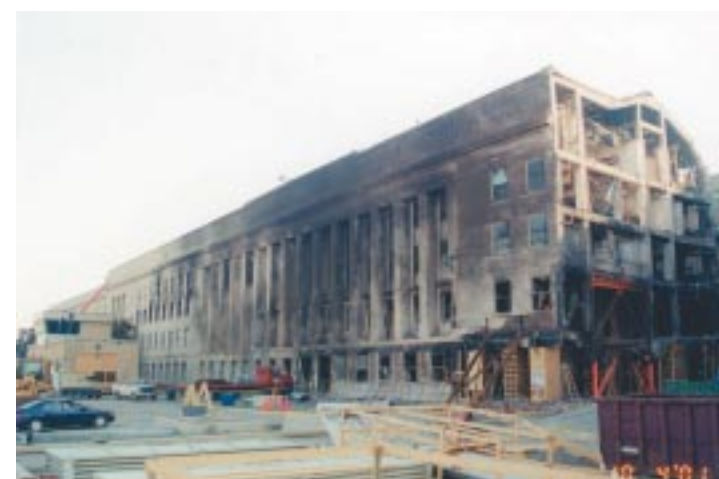
Figure 5.9 Exterior evidence of fire to the north of the impact area

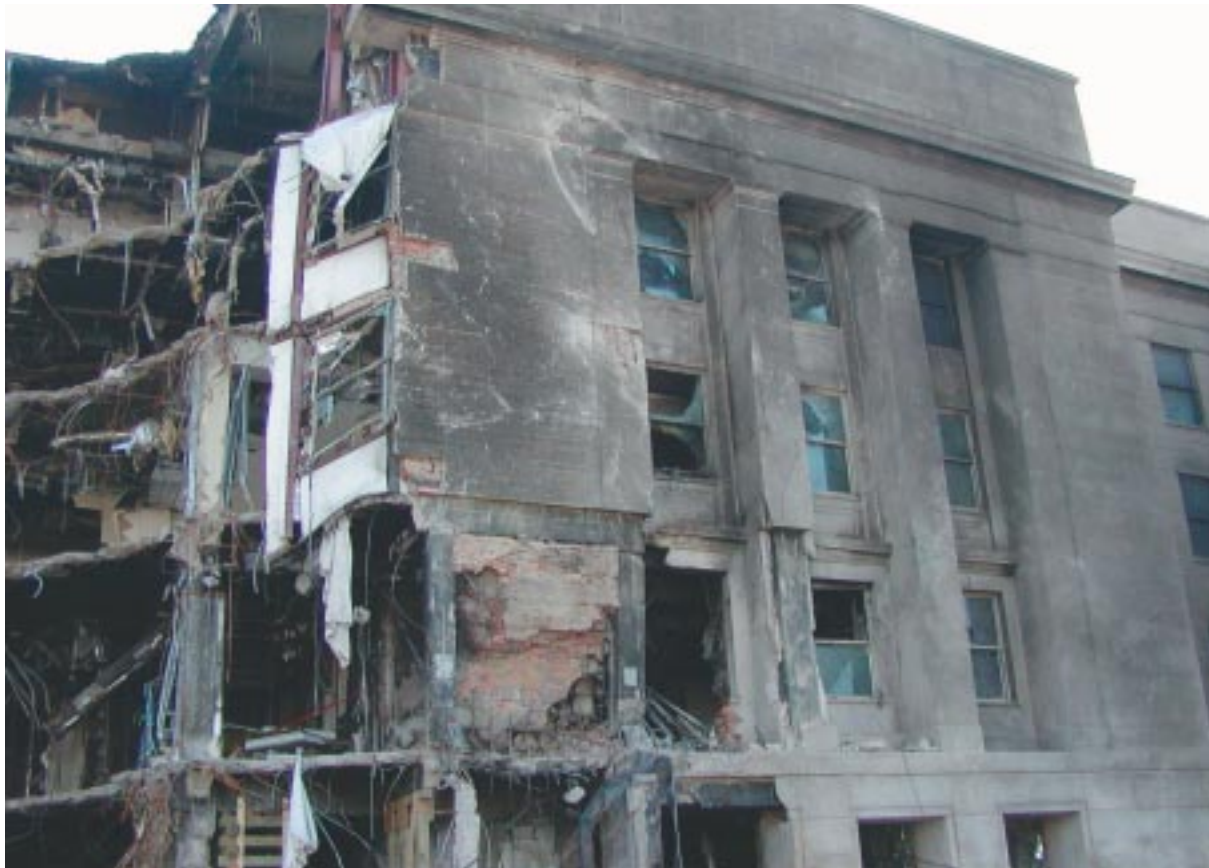
The west facade of the Pentagon was severely scarred by debris impact, particularly to the south of the collapse area (figure 5.11). Just above the second-floor slab, the exterior columns on column lines 18 and 19

Figure 5.11 Debris scars at upper levels south of impact area

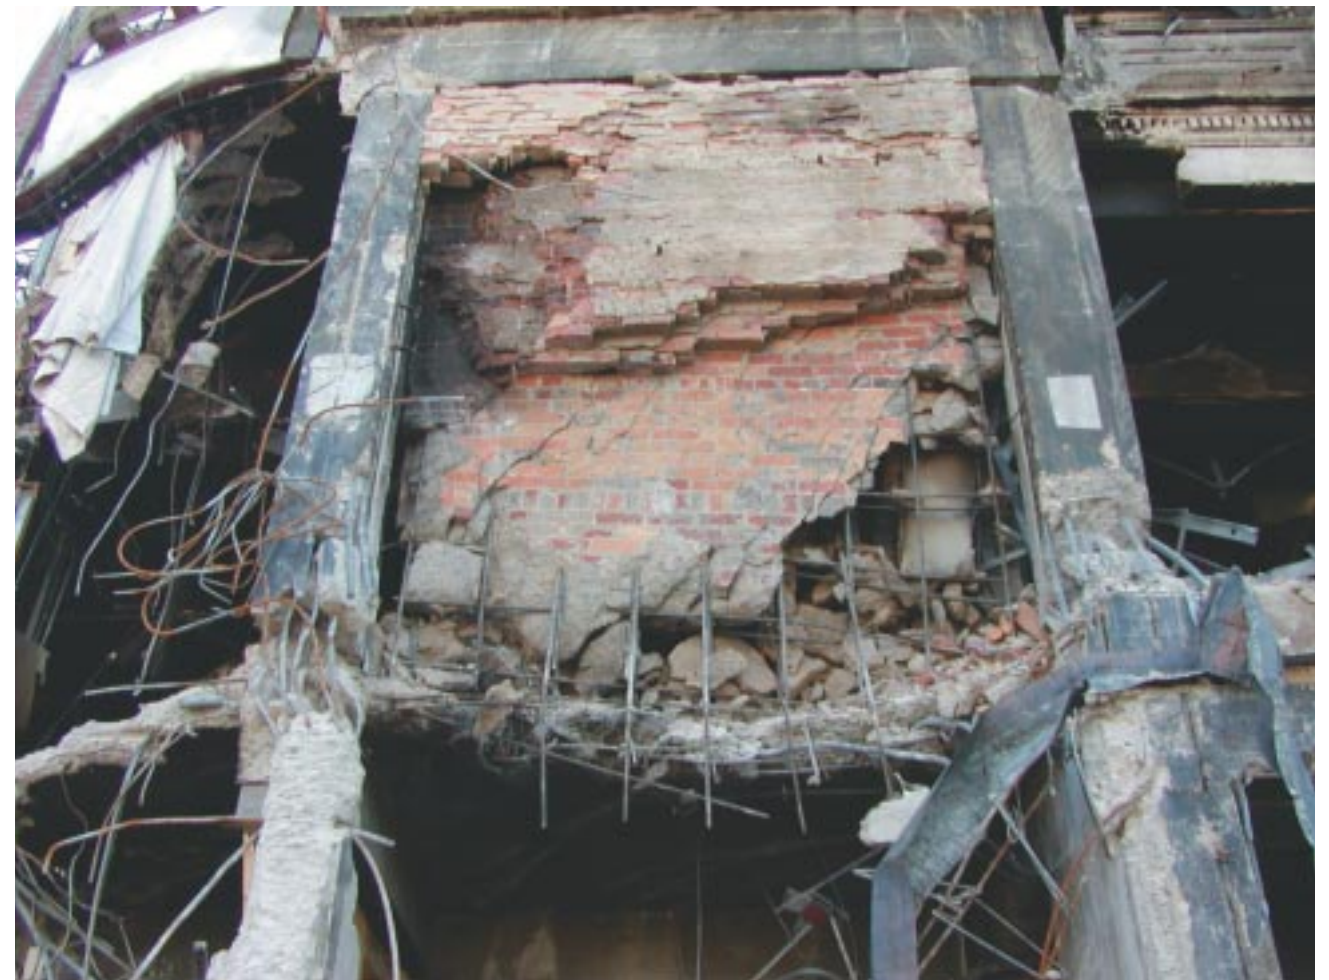
Figure 5.12 Gashes from impact of right wing

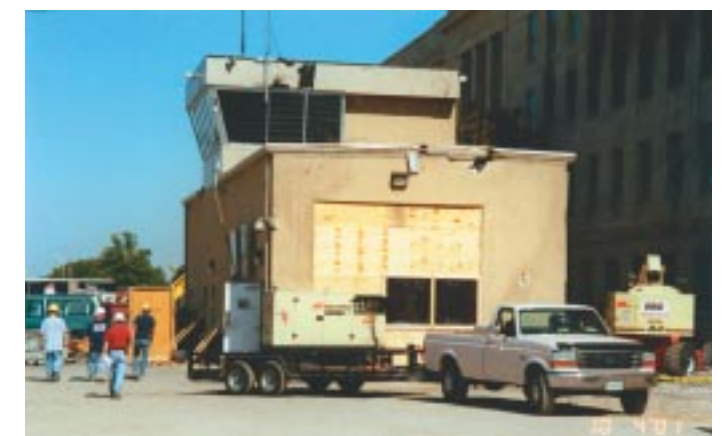
Figure 5.13 Damage to fire station

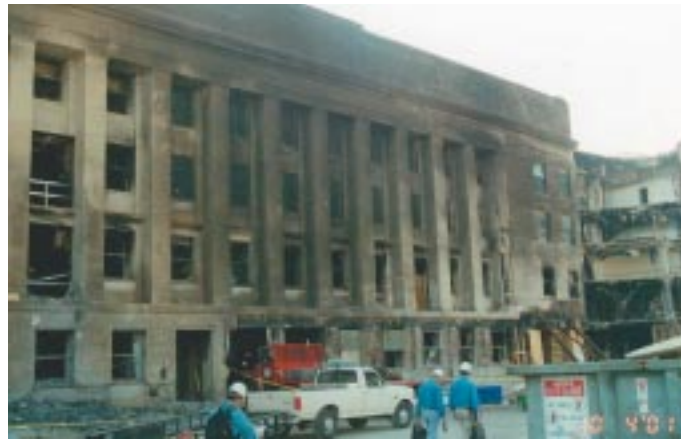
Figure 5.14 Upgraded windows in place

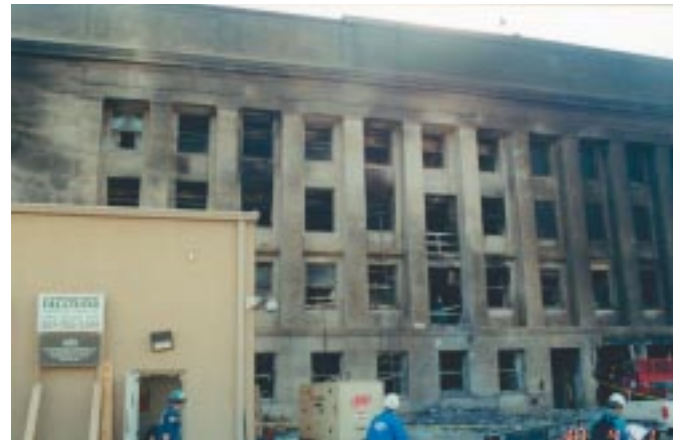
Figure 5.15 Broken conventional windows

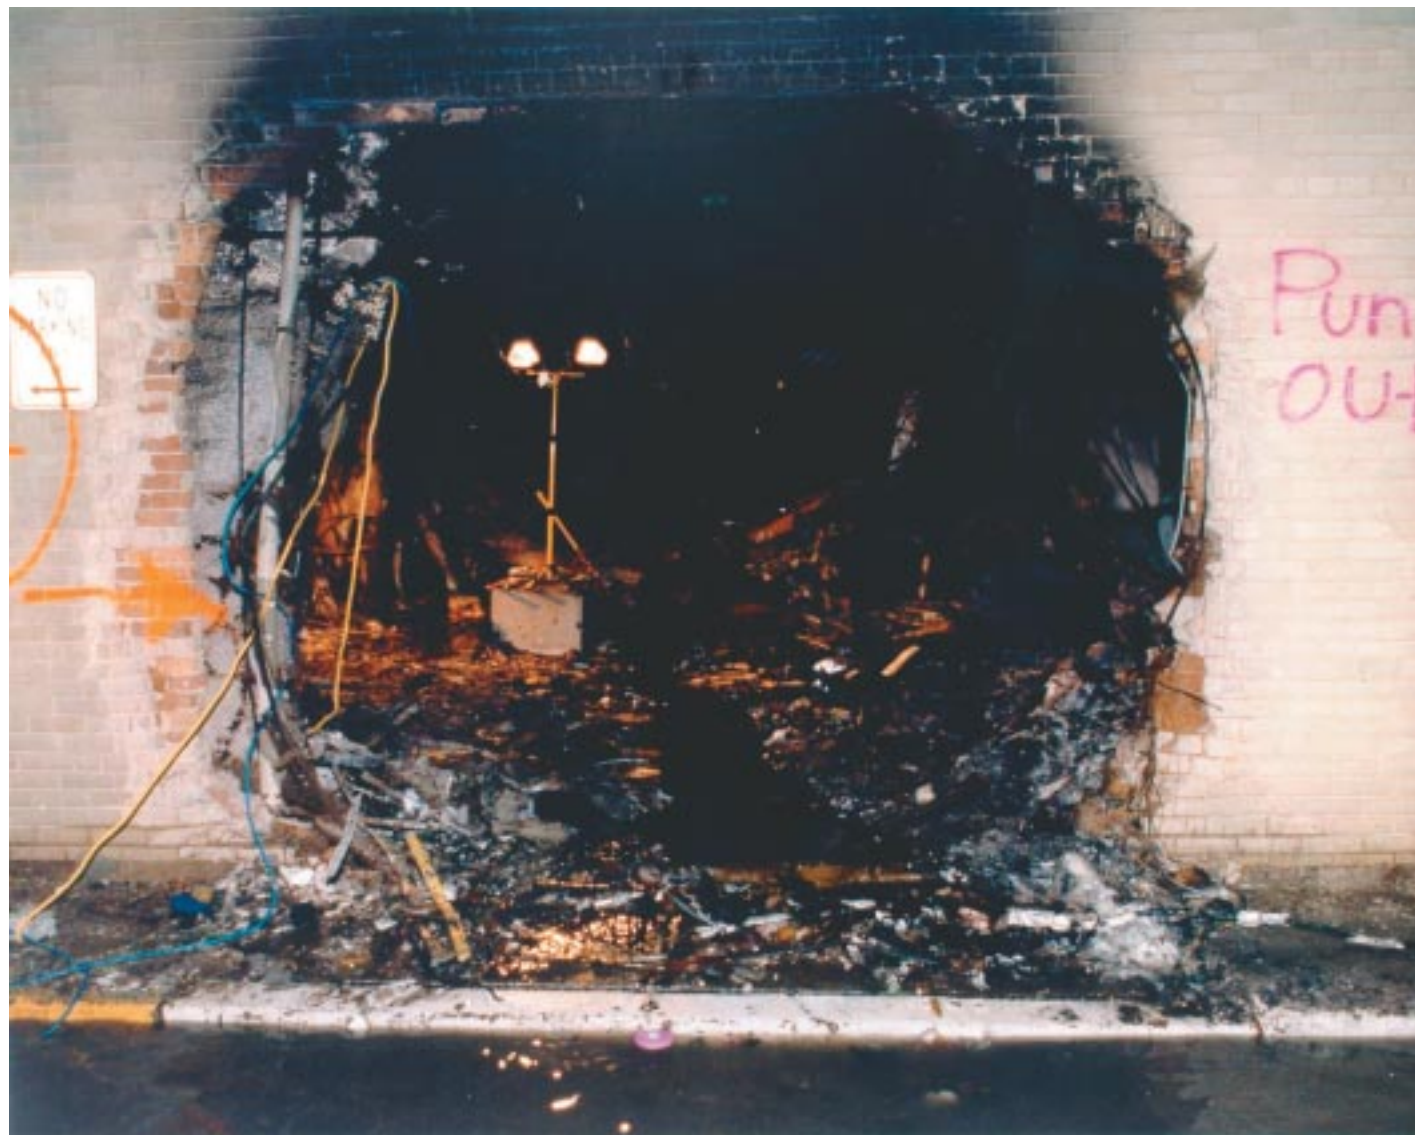
Figure 5.16 Hole to AE Drive

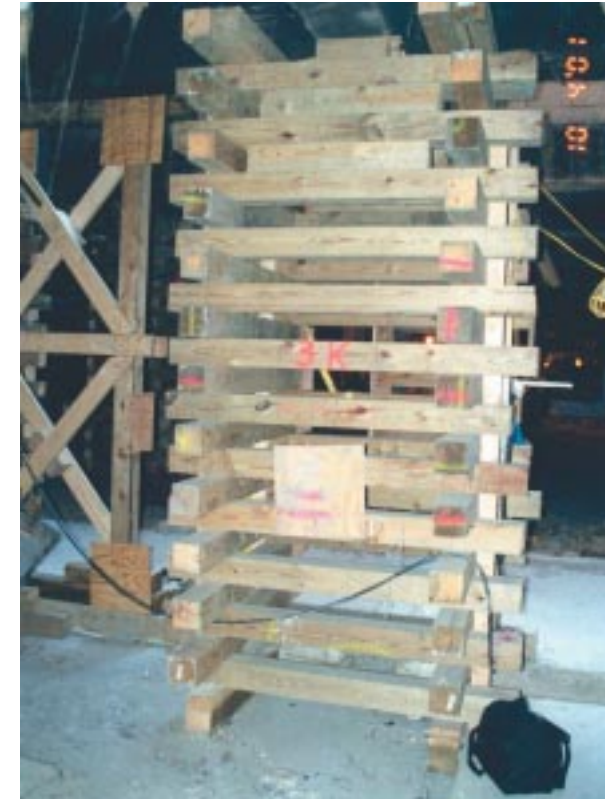
Figure 5.17 Column missing at location 3K

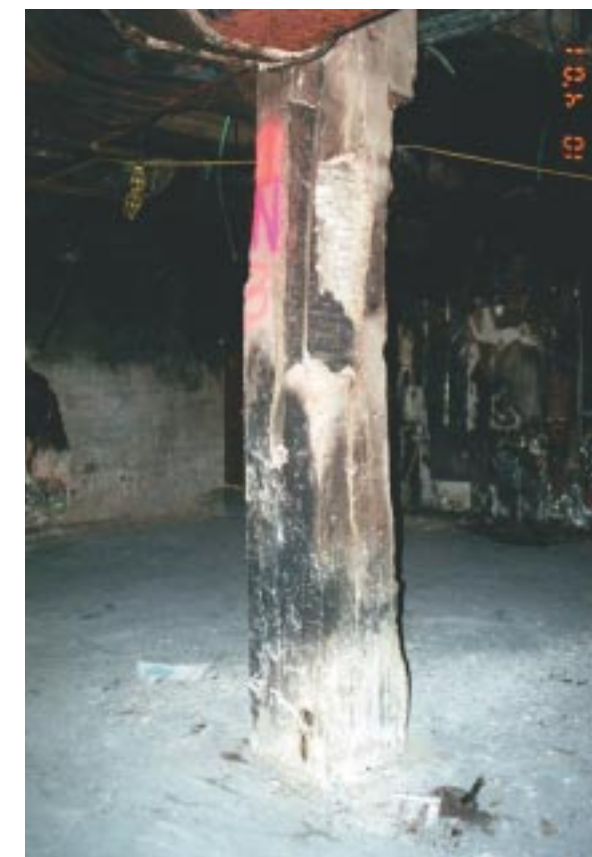
Figure 5.19 Column 3N damaged by impact and fire

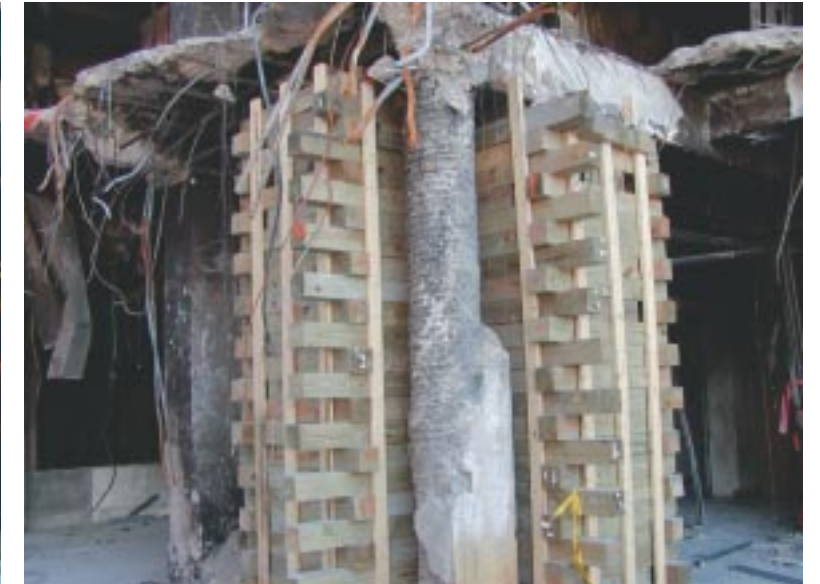
Figure 5.18 Column 15B with concrete cover removed by impact

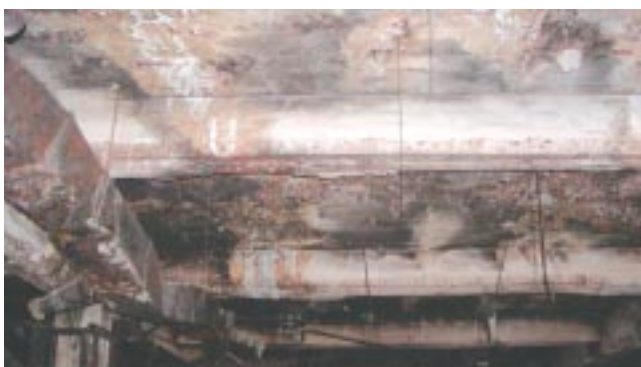
Figure 5.25 Impact and fire damage near column line C

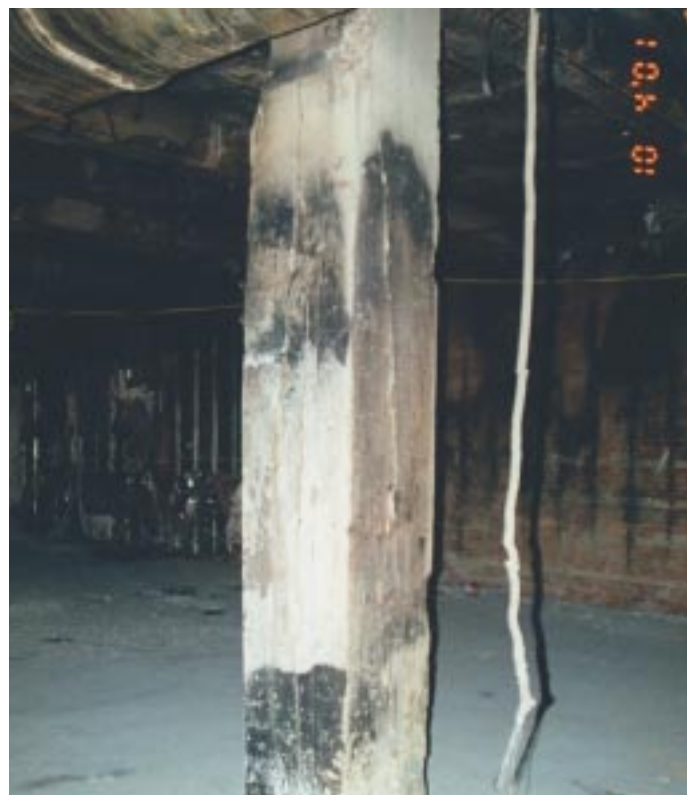
Figure 5.24 Cracked column 5N

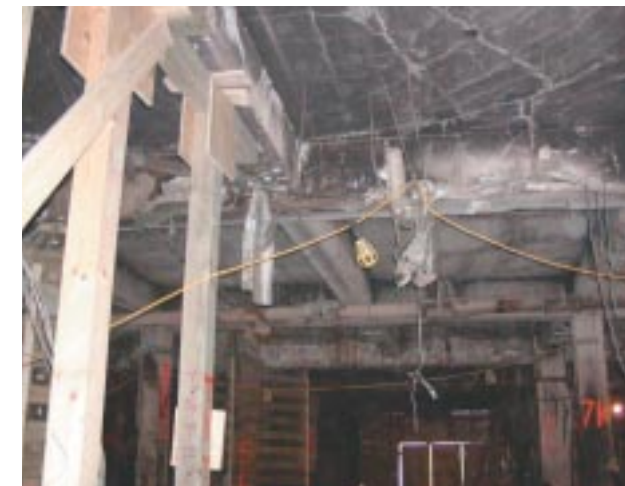
Figure 5.26 Impact damage near column 6K

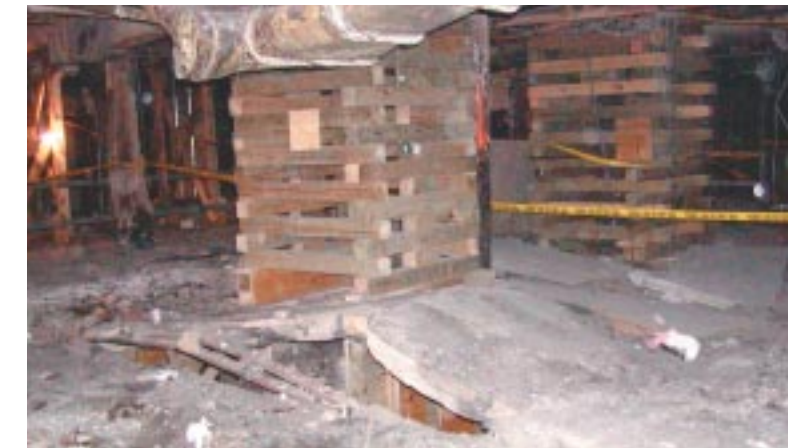
Figure 5.27 Breached second-floor slab

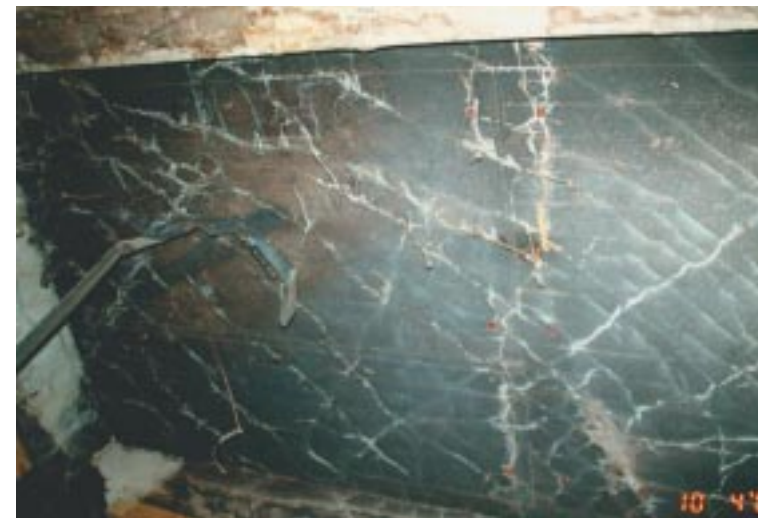
Figure 5.28 Crack patterns in second-floor slab

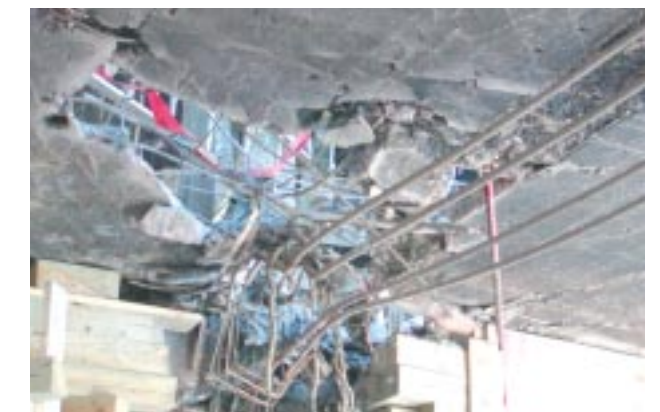
Figure 5.29 Concrete stripped from floor beam

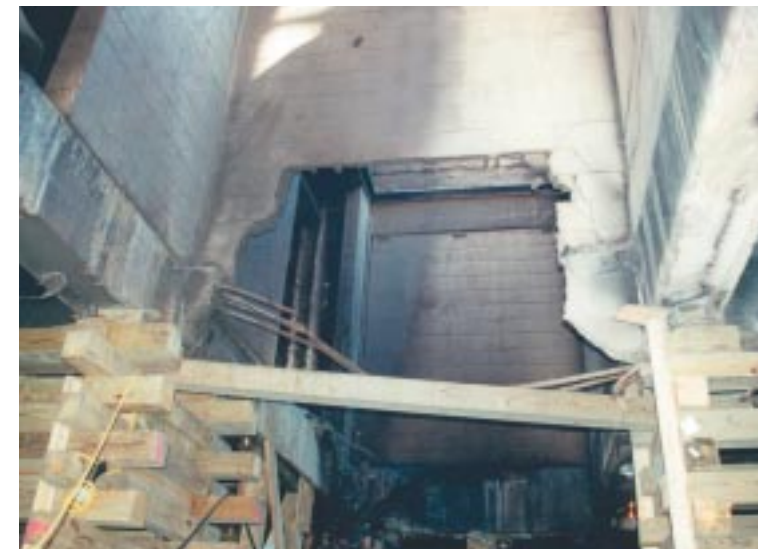
Figure 5.30 Missing beam in air shaft

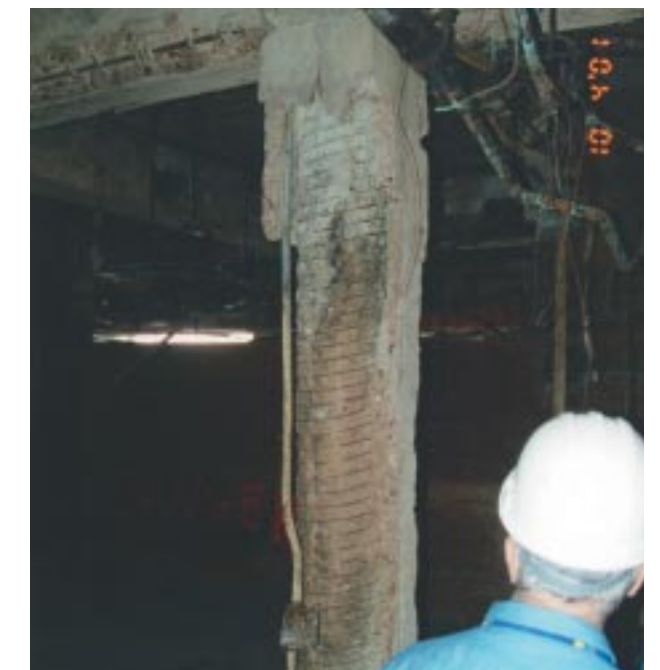
Figure 5.31 Fire damage to column in second story

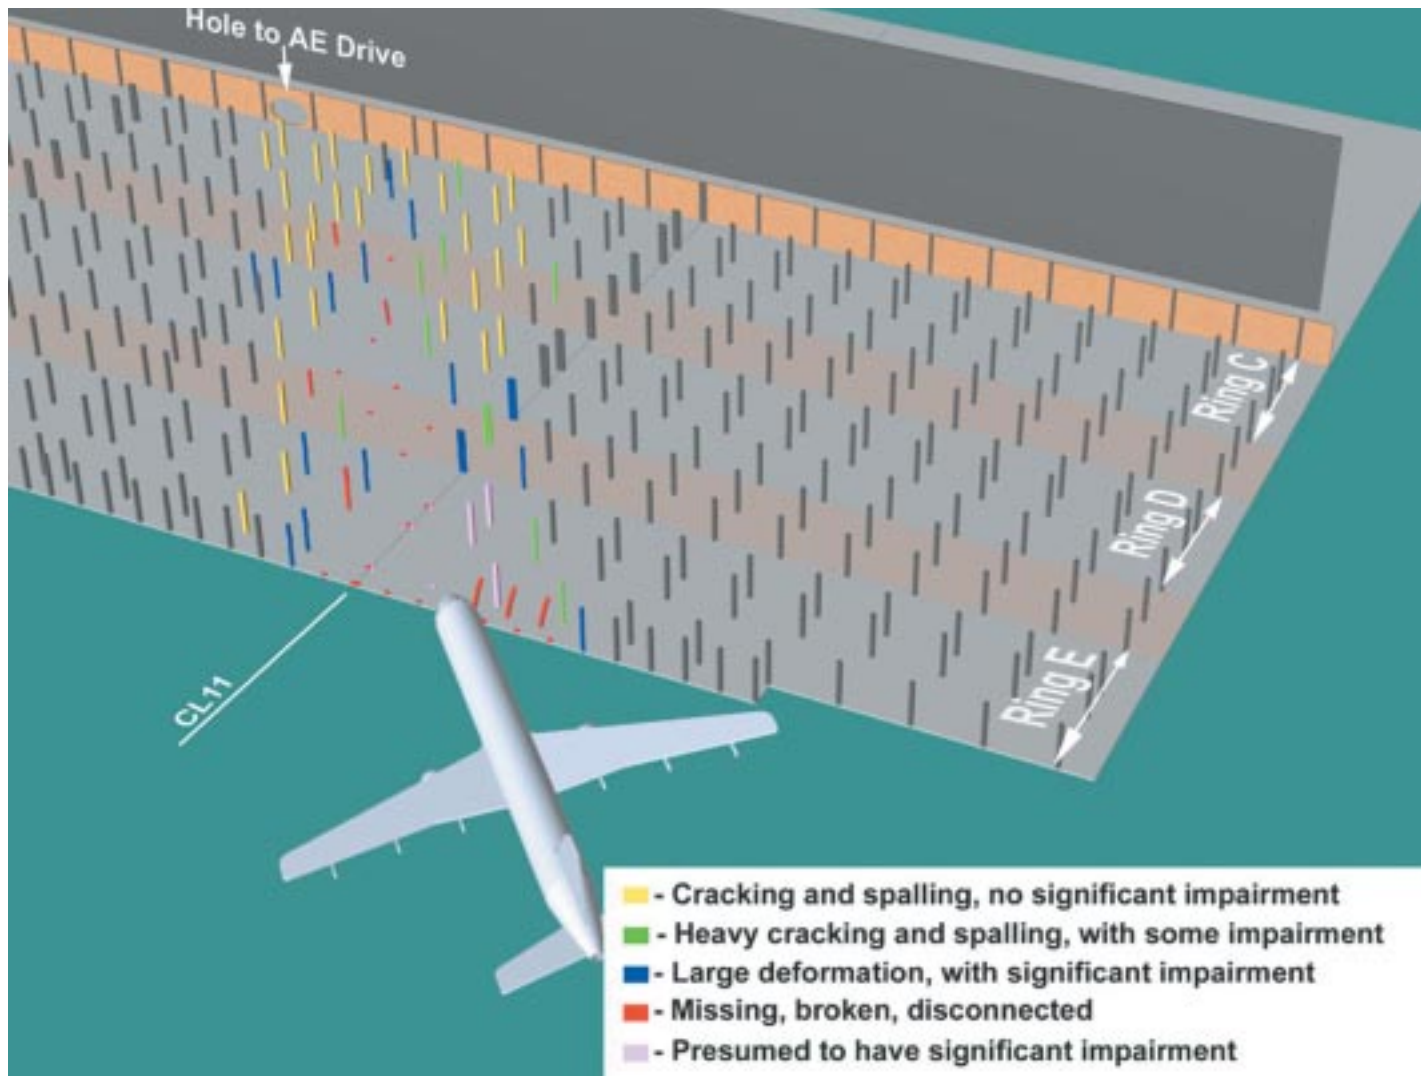
Damage to the first-floor columns is summarized in figures 6.2 and 6.3. In formulating opinions about columns in the collapse area, the BPS team interpreted photographs taken after impact and before collapse.

Figure 6.2 Damage to columns in first story viewed along path of aircraft

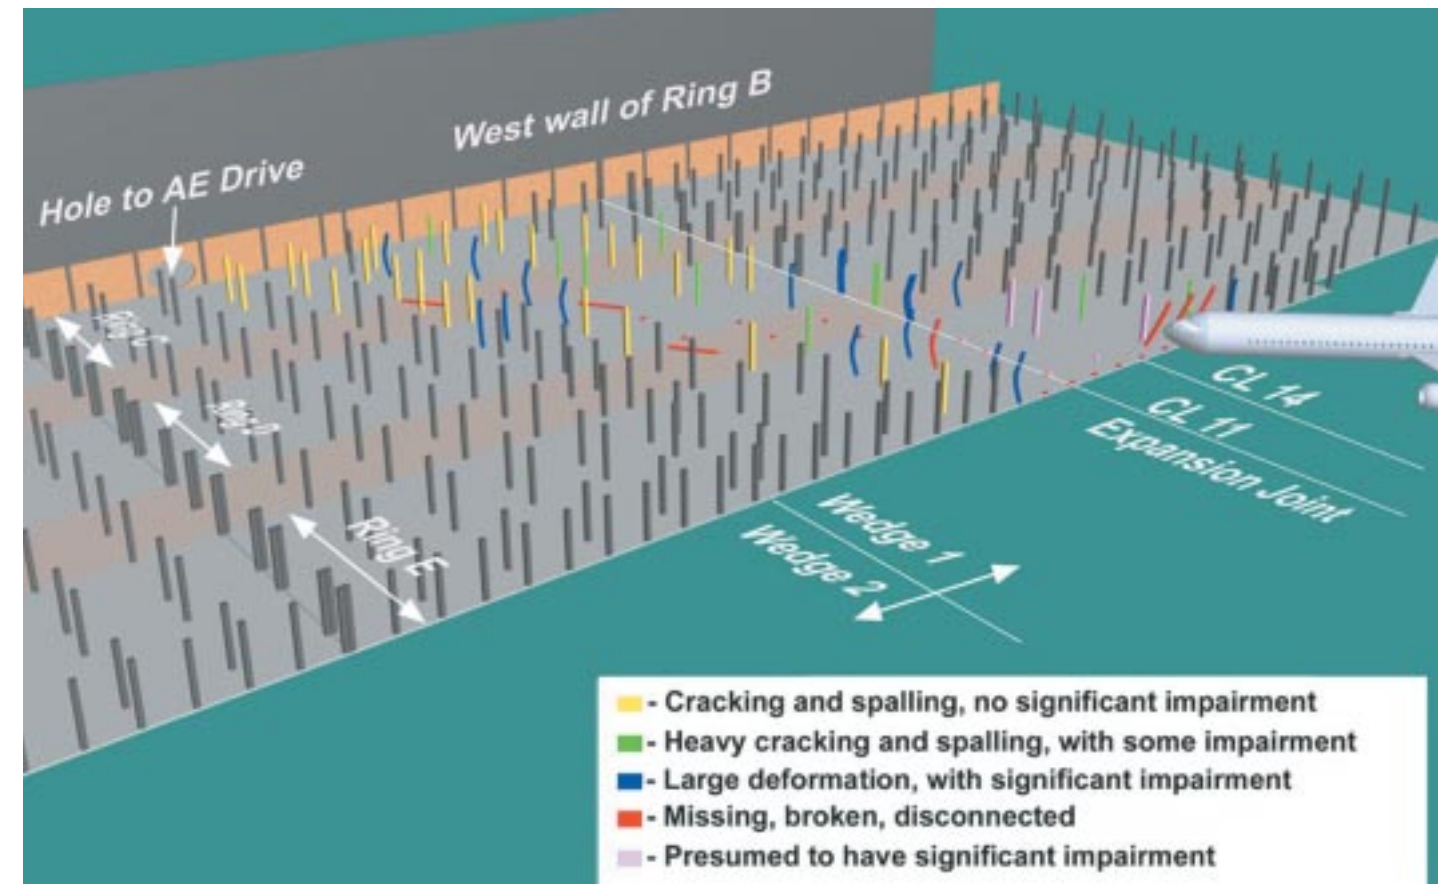
Figure 6.3 Damage to columns in first story viewed across path of aircraft

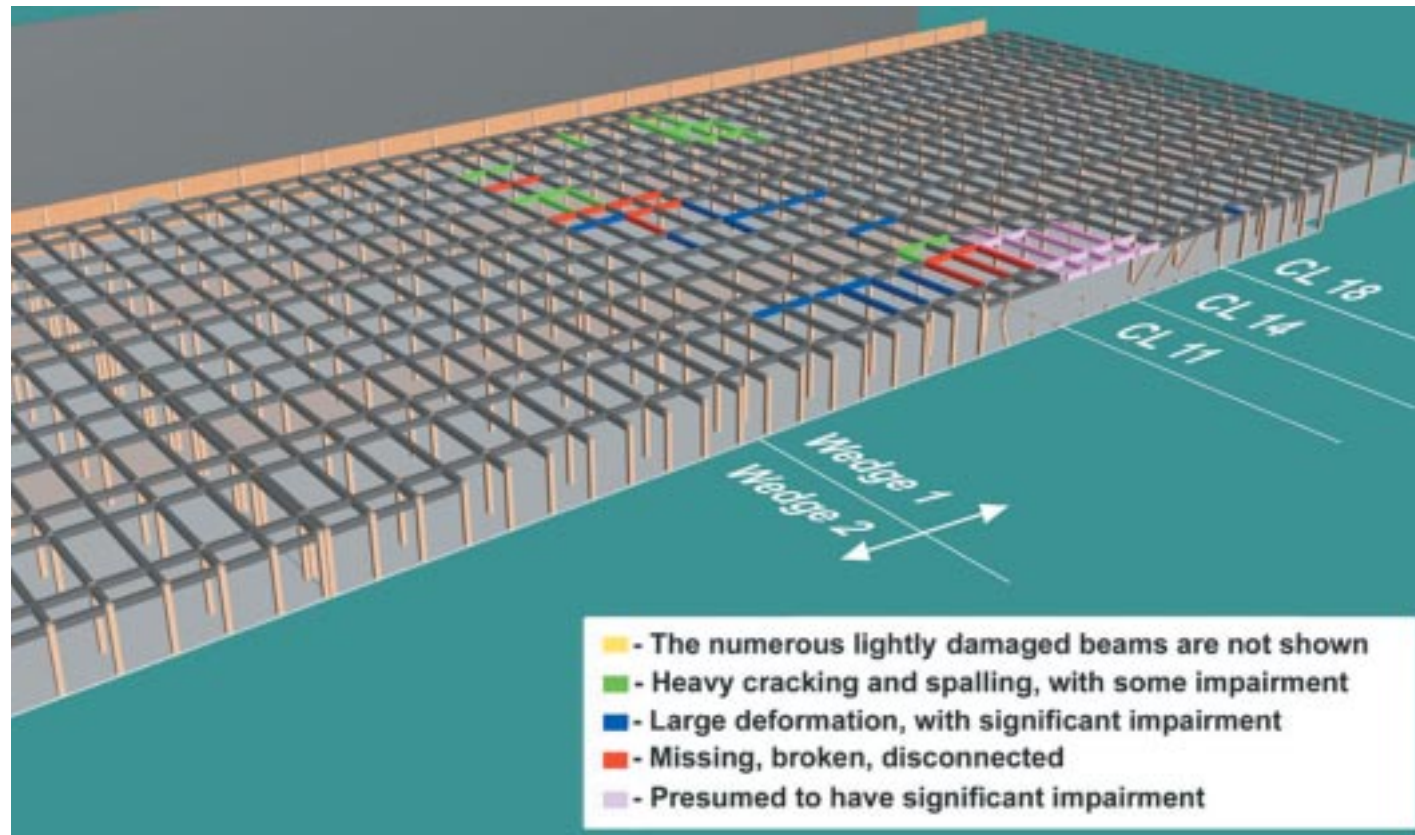
Figure 6.4 Damage to second-story beams

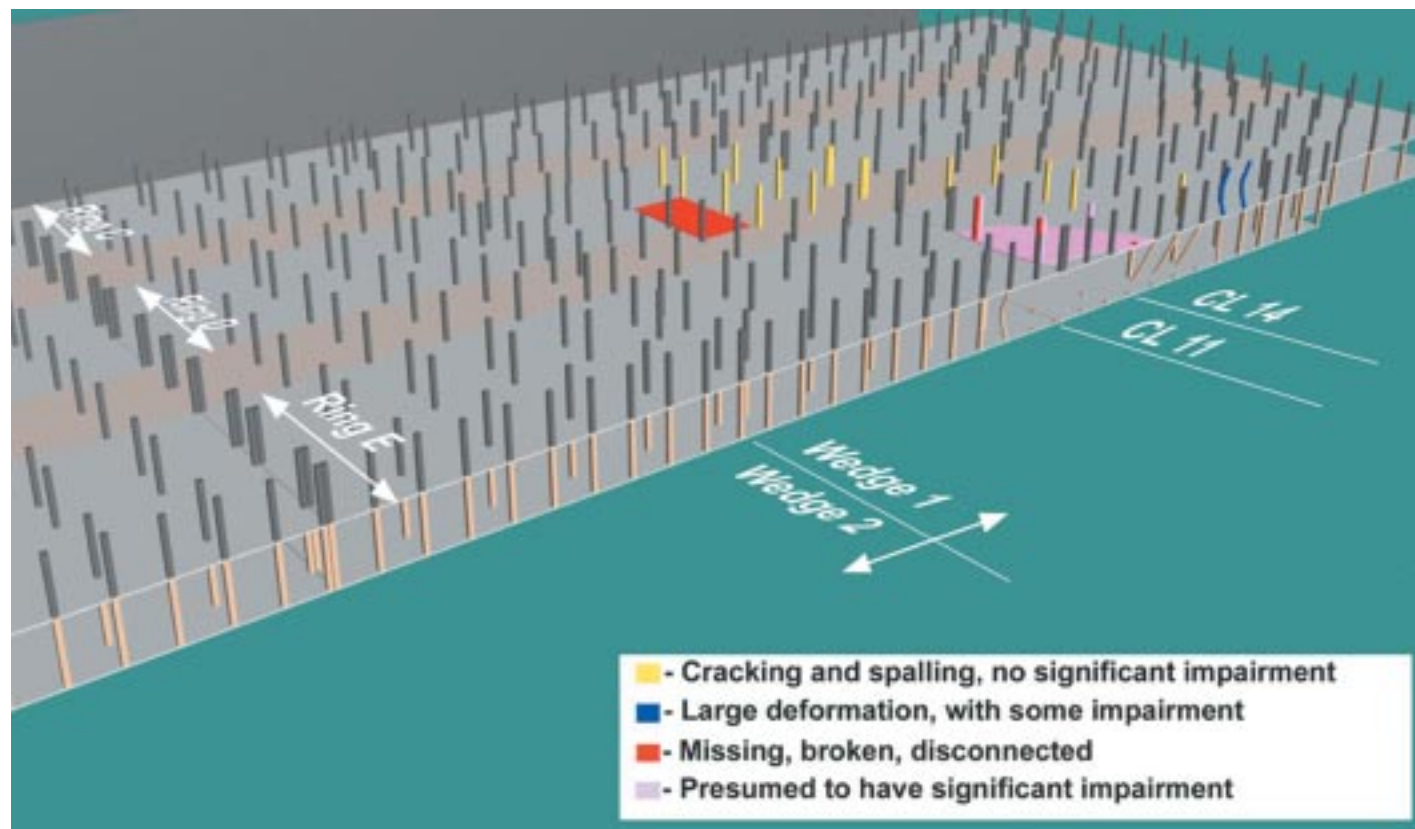
Figure 6.5 Damage to columns and slab in second story

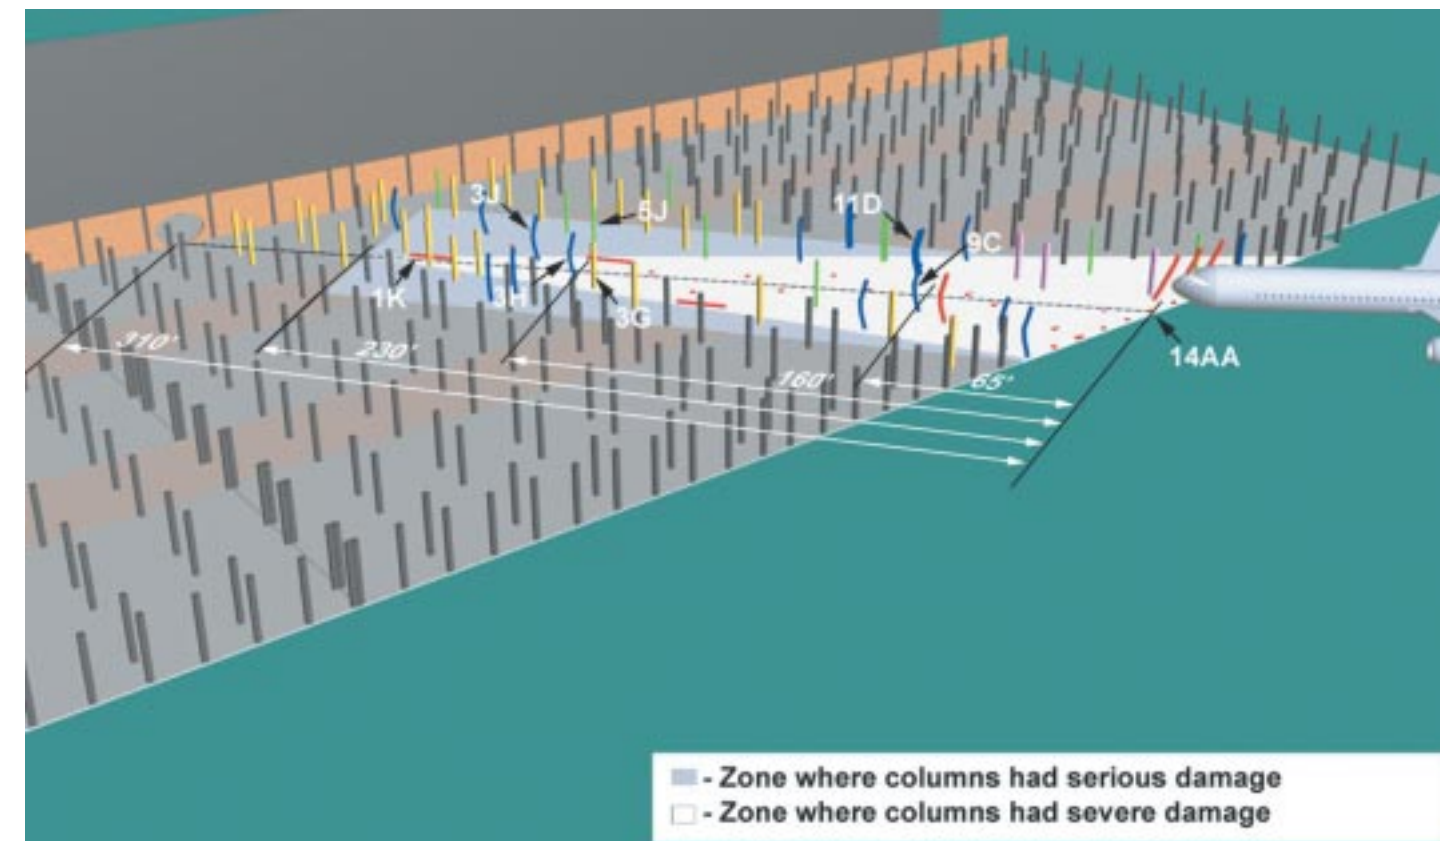
Figure 6.6 Damage regions in first story

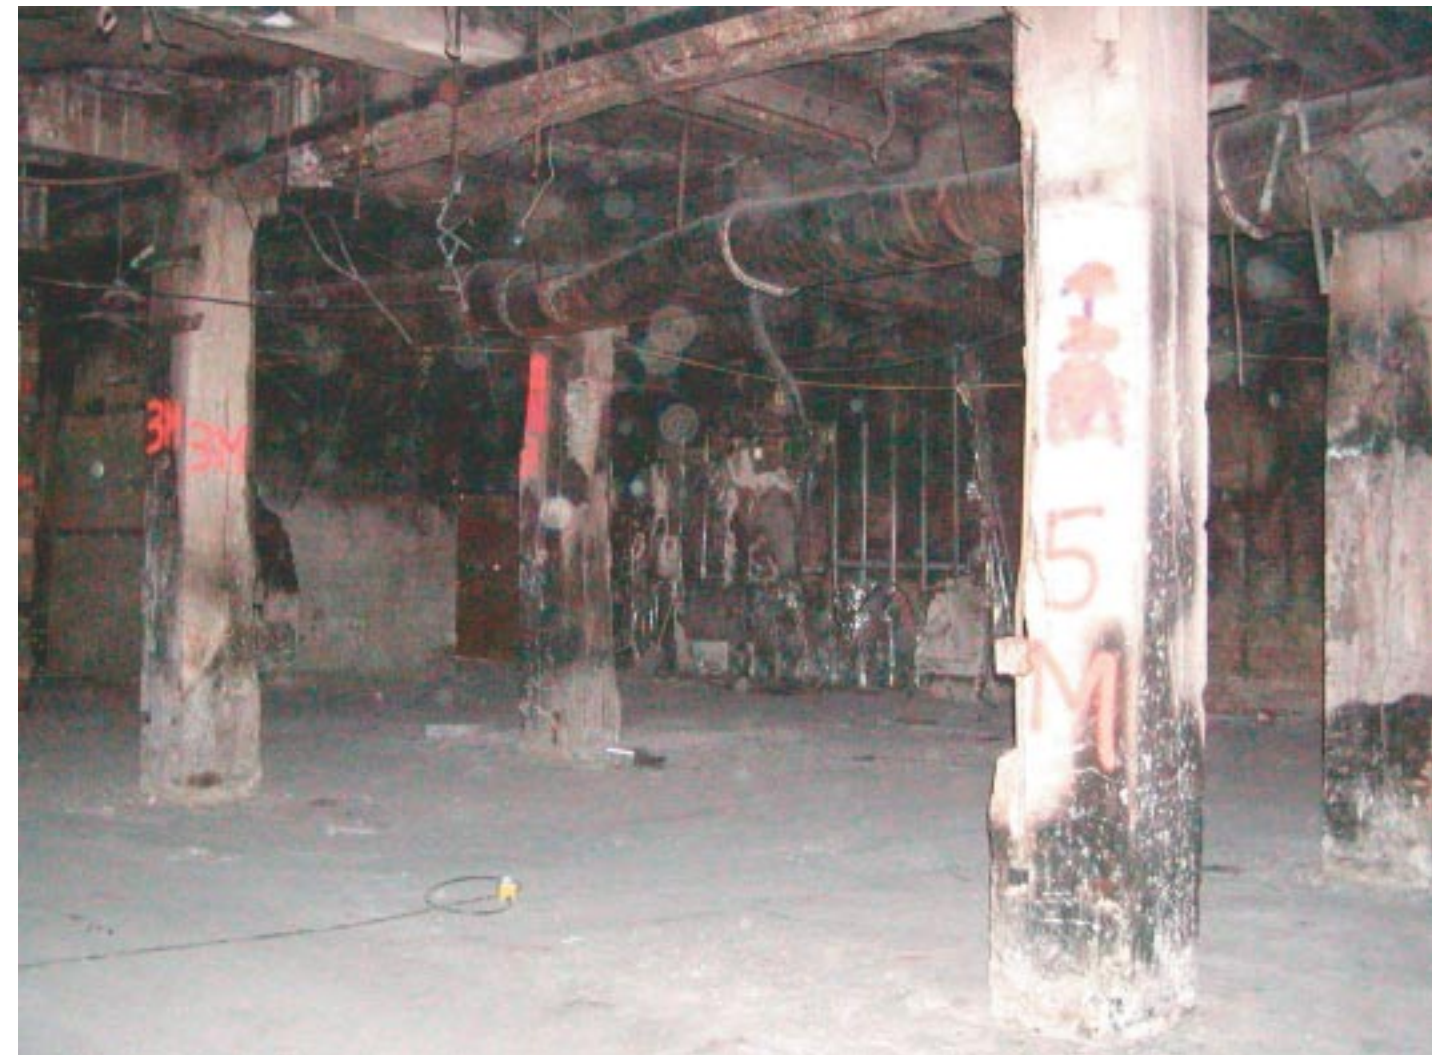
Figure 6.8 First-story columns 5N and 5M

Figures 6.8 and 6.9 show first-floor columns 5M, 5N, 3M, and 3N at the time of the BPS team visit. These columns are located in Ring C, toward the end of the damage path. All four sustained
