THE PENTAGON BUILDING PERFORMANCE REPORT

January 2003

American Society of Civil Engineers

SEI
Structural Engineering Institute
of the American Society of Civil Engineers

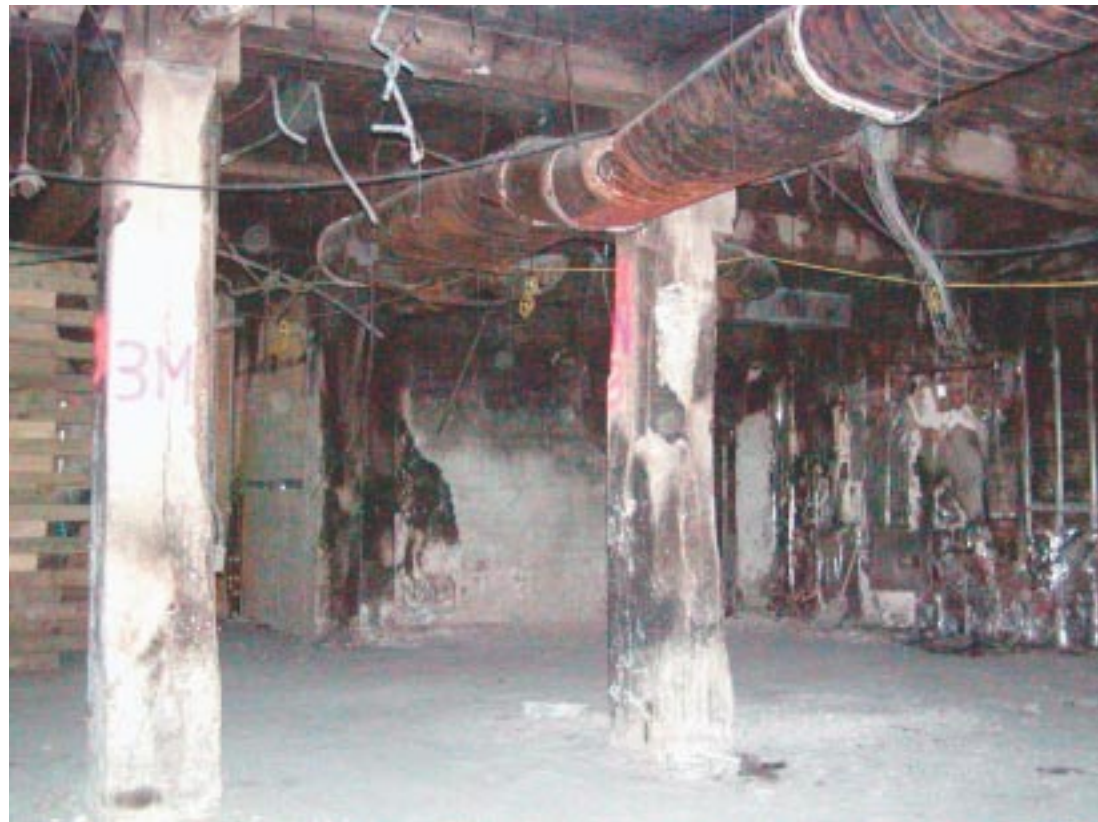
Figure 6.9 First-story columns 3M and 3N

Figures 6.8 and 6.9 show first-floor columns 5M, 5N, 3M, and 3N at the time of the BPS team visit. These columns are located in Ring C, toward the end of the damage path. All four sustained

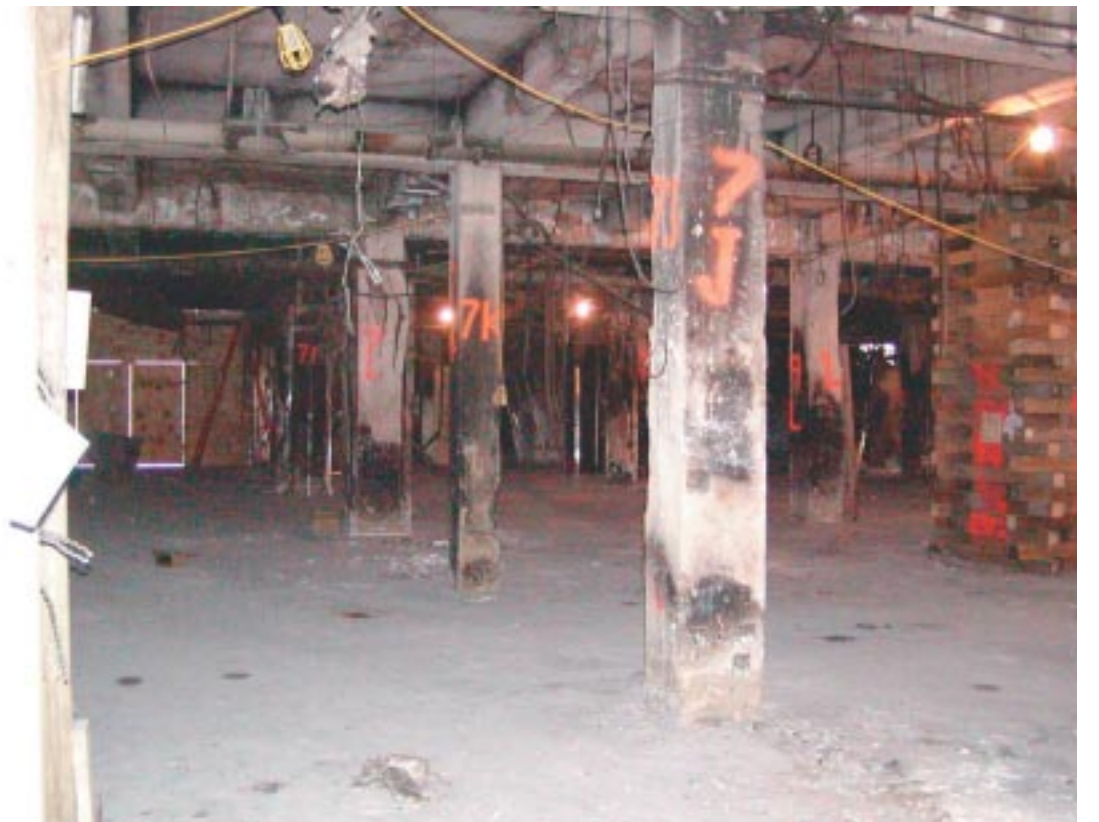
Figure 6.10 First-story columns 7J, 7K, and 7L

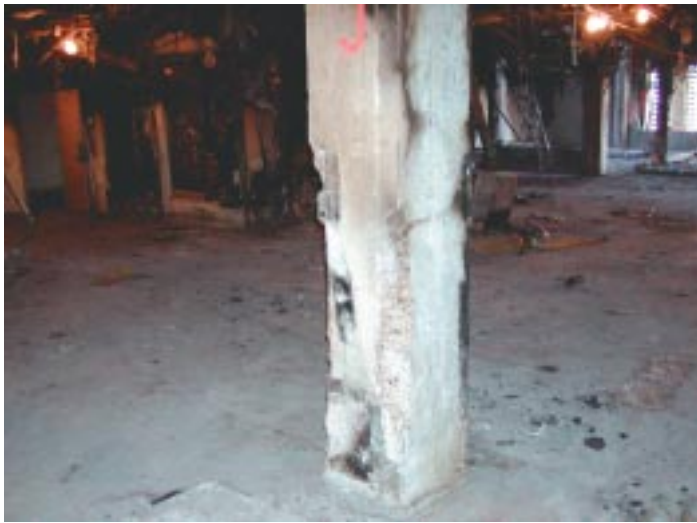
Figure 6.11 First-story column 7J

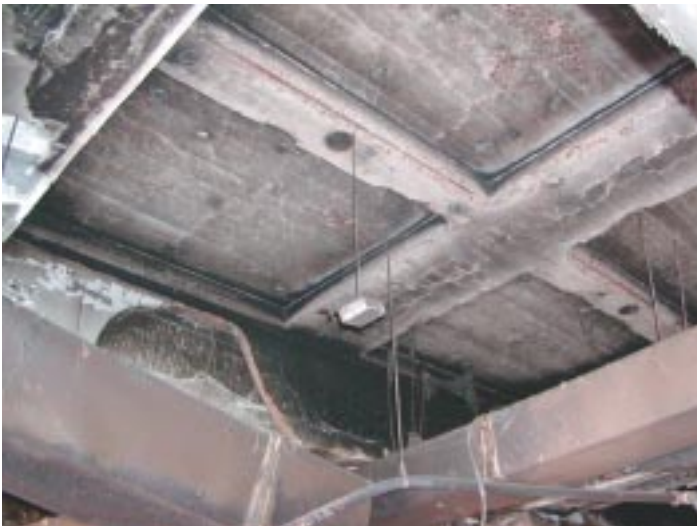
Figure 6.12 Fire damage to third-floor (light well) beams

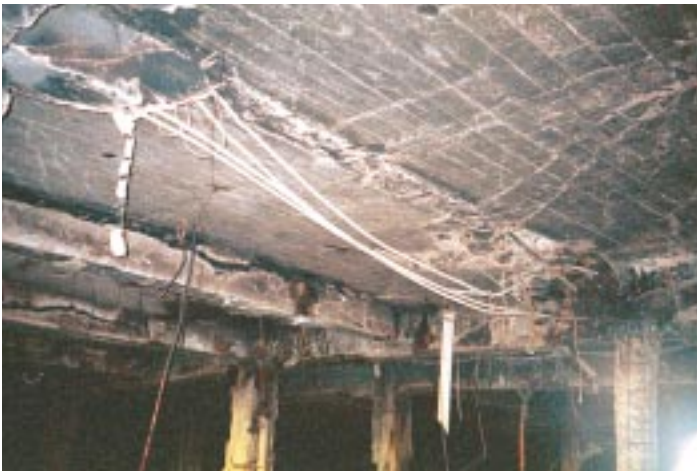
Figure 6.13 Concrete stripped from second-floor beam at grid 9 between grids A and B; extensive cracking in slab

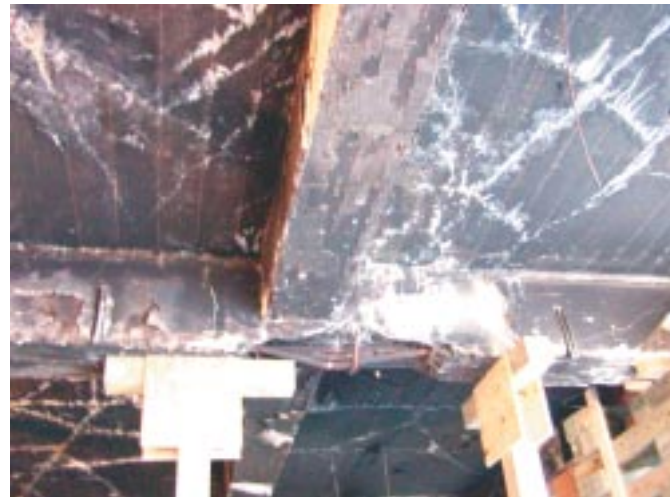
Figure 6.14 Fire-damaged second-floor beams

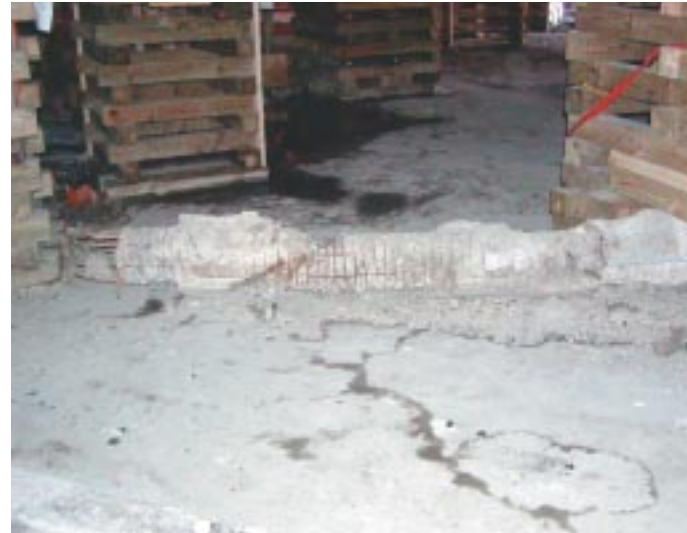
Figure 7.5a Column impacted and torn off at supports

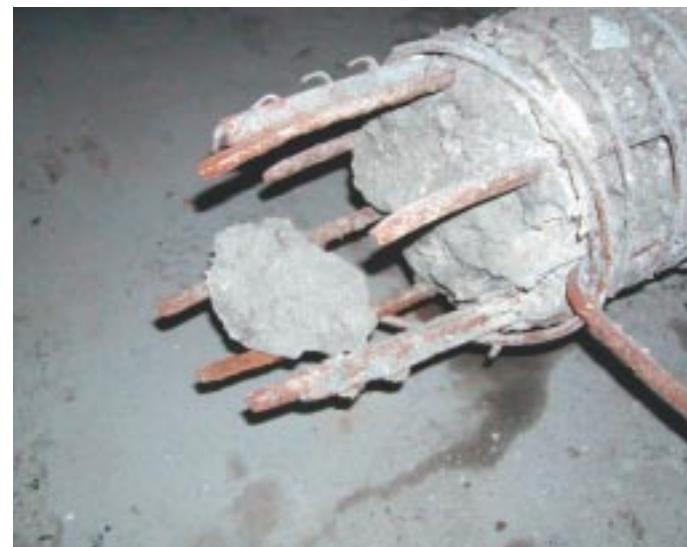
Figure 7.5b Ends of fractured reinforcing bars showing necking

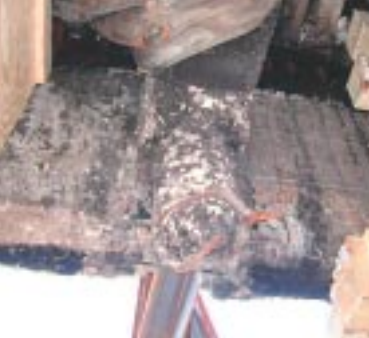
10AA	<ul style="list-style-type: none"> • Missing • Remaining upper section connected to is stripped to spiral reinforcement • Shored

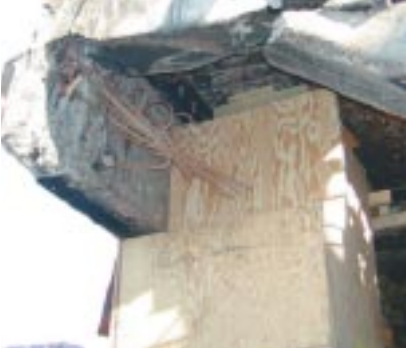
11AA	<ul style="list-style-type: none"> • Missing • Remnants of 8 #8 deformed bars visible at ceiling • Shored

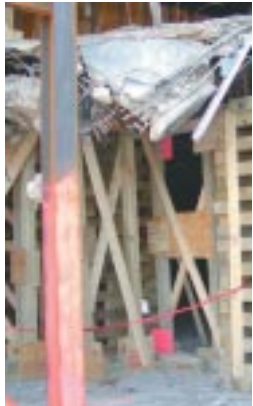
11A	<ul style="list-style-type: none"> • Missing • Shored

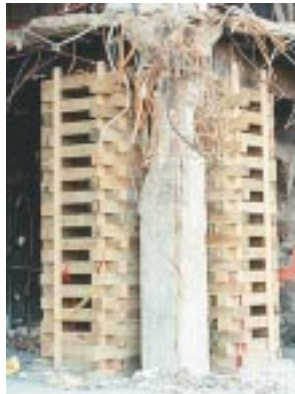
17A	<ul style="list-style-type: none"> • Stripped to spiral reinforcement at top of column • Shored

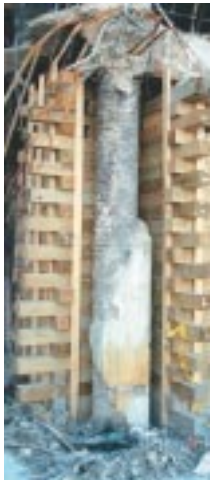
11B,13B	<ul style="list-style-type: none"> • Missing 	N/A
15B	<ul style="list-style-type: none"> • Spalled to spiral reinforcement from midheight to top • Shored

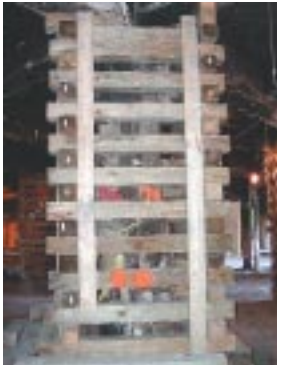
COLUMN LABEL	DESCRIPTION OF DAMAGE	PHOTO (IF AVAILABLE)
7D	<ul style="list-style-type: none"> • Split by vertical crack that looks typically like thermal cracking • Shored

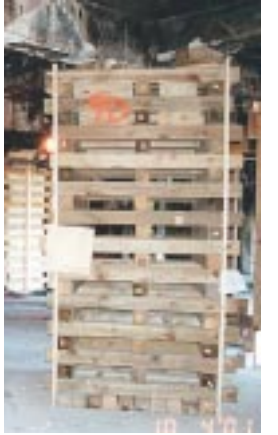
9D	<ul style="list-style-type: none"> • Missing • Shored

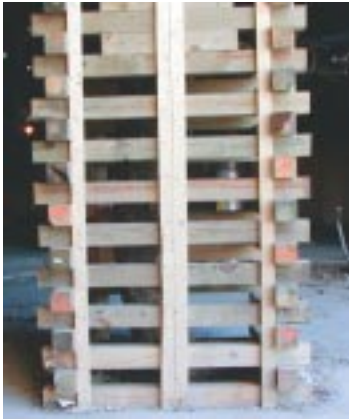
13D	<ul style="list-style-type: none"> • Stripped to spiral reinforcement • Bowed to Northeast • Shored

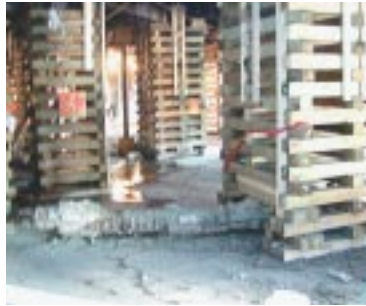
COLUMN LABEL	DESCRIPTION OF DAMAGE	PHOTO (IF AVAILABLE)
5E	<ul style="list-style-type: none"> • Downed • Stripped to spiral reinforcement • Shored

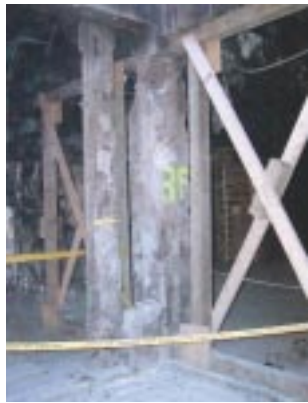
3F	<ul style="list-style-type: none"> • Spalled to spiral reinforcement at top

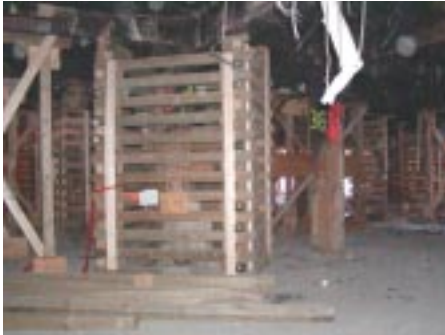
3G	<ul style="list-style-type: none"> • Slightly blackened

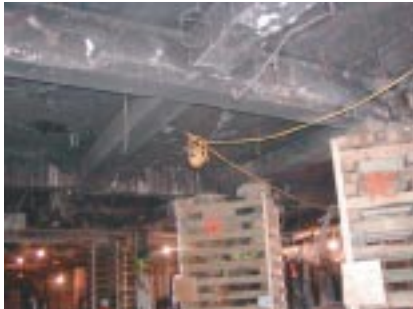
7G	<ul style="list-style-type: none"> • Severe spalling • Steel visible mid-height to top • Shored 	N/A
9G	<ul style="list-style-type: none"> • Moderate spalling • Steel visible on northwest side at midsection

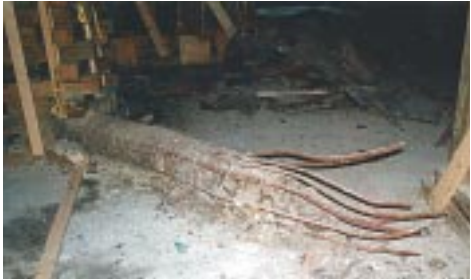
5H	<ul style="list-style-type: none"> • Downed • Stripped to spiral reinforcement • Shored

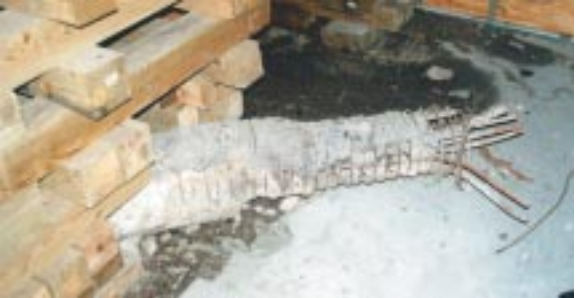
1K-South	<ul style="list-style-type: none"> • Downed • Stripped to spiral reinforcement • Shored
