CDA INSPECTION SERVICES

RESIDENTIAL REPORT

5880 Saucon Ridge Rd
Coopersburg, PA 18036

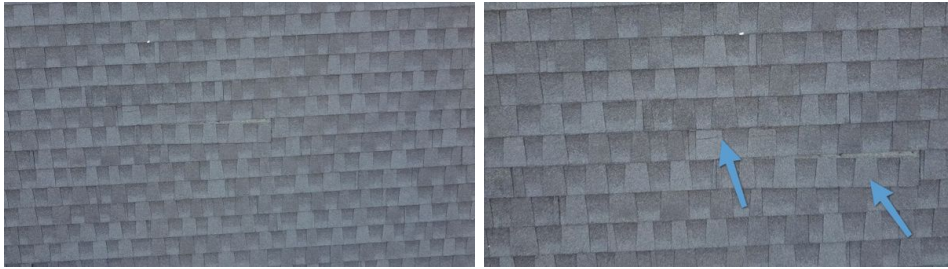
3.2.1 Pitched Roof Asphalt Shingles

LOOSE SHINGLE(S)

One or more shingles are loose. This is a very easy repair by a qualified roofing professional.

Contact a qualified professional.

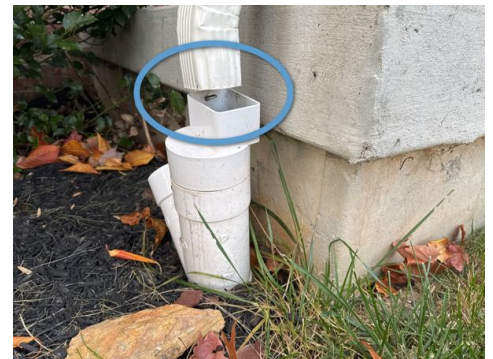
3.3.1 Roof Drainage Systems

DOWNSPOUTS DO NOT FULLY EMPTY INTO BELOW GRADE DRAINAGE

Contact a qualified professional.

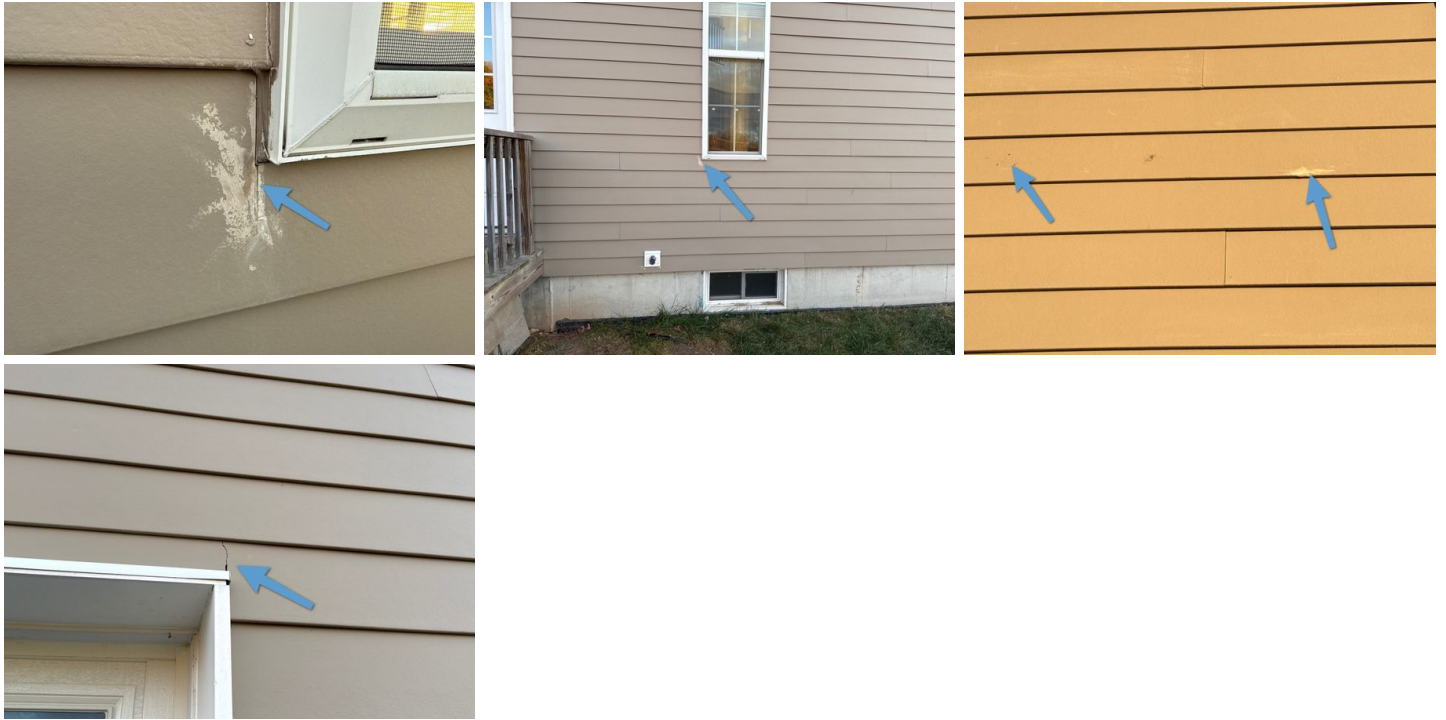
DAMAGED/HOLES SIDING

The siding is damaged or has holes at a few small areas. This could allow moisture to penetrate causing further damage to the building materials. The siding material should be repaired or replaced.

Contact a qualified professional.

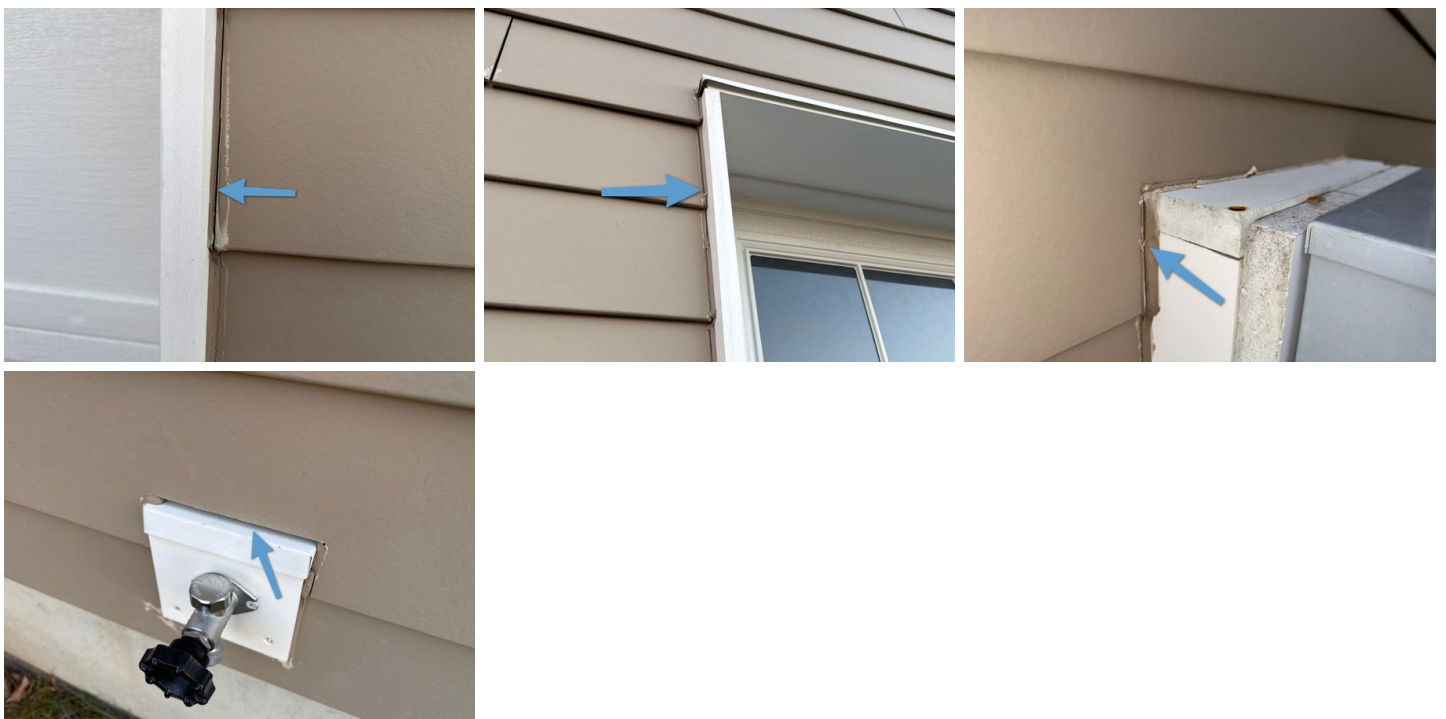
4.4.2 Siding

CAULKING MISSING OR DETERIORATING

The caulking is missing or deteriorated at siding intersection areas. Caulking is an important part of the weather resistant envelope. You should have these areas cleaned and re-caulked with the appropriate material.

Contact a qualified professional.

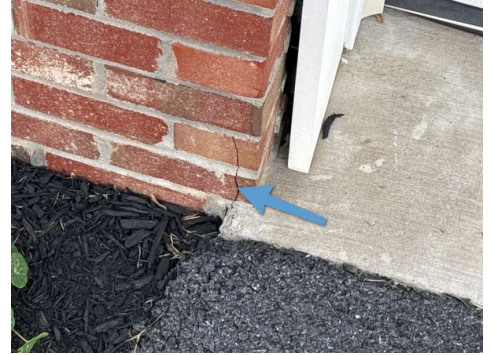
4.4.3 Siding

DAMAGED SIDING AND/OR BRICK

There are areas of the siding and/or brick which is damaged. It is unknown as to why this is present. Recommend to have a qualified contractor further evaluate and follow their recommendations.

Contact a qualified professional.

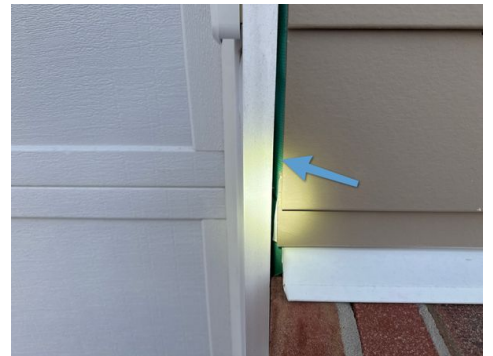
4.4.4 Siding

There is a gap between the siding and trim. The building wrap is visible, indicating that there is a proper moisture barrier in place. However, the gap is too large to seal with caulk.

Contact a qualified professional.

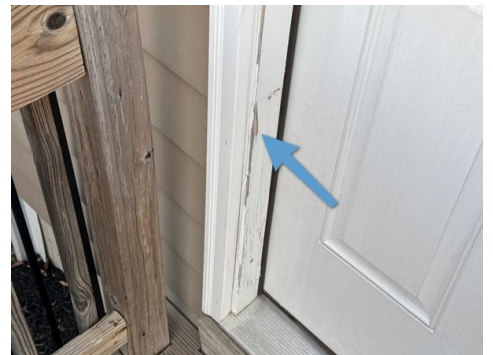
4.5.1 Trim

DETERIORATED PAINT

The paint is deteriorated at various areas of trim. The trim should be re-painted to protect the wood from the exterior extremities.

Contact a qualified professional.

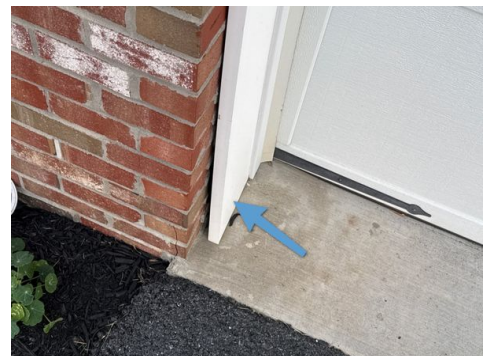
4.5.2 Trim

LOOSE TRIM

The trim is loose. This should be repaired or replaced.

Contact a qualified professional.

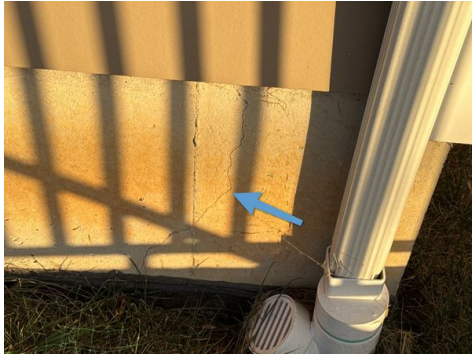
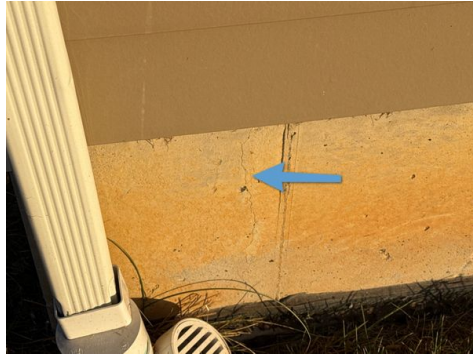
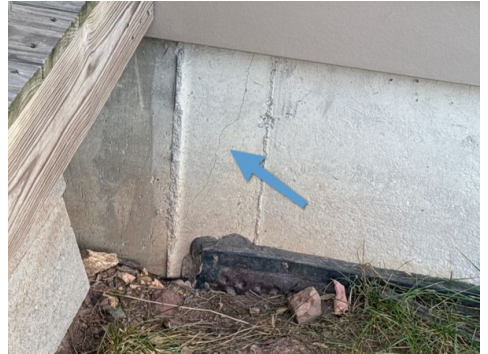
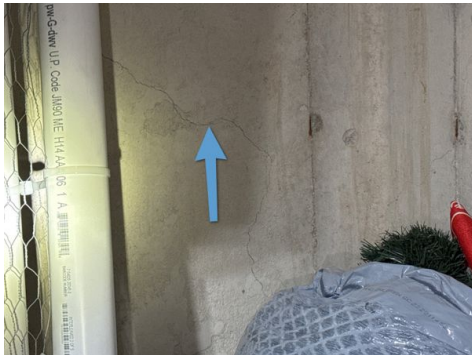
5.2.1 Foundation

FOUNDATION CRACKS

There are typical crack(s) present at some areas of the foundation wall. This is common as concrete ages and shrinks where surface cracks are normal at approximately 1/16". You should monitor for any additional change or moisture at these areas. If leakage should occur these can be sealed by a qualified contractor.

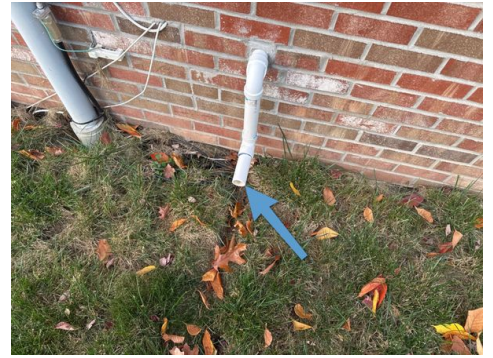
SUMP PUMP DISCHARGE TOO CLOSE TO FOUNDATION

The sump pump empties too close to the foundation. This may allow water to re-enter the pit or basement areas. The line should be extended to keep water away from the foundation.

Contact a qualified professional.

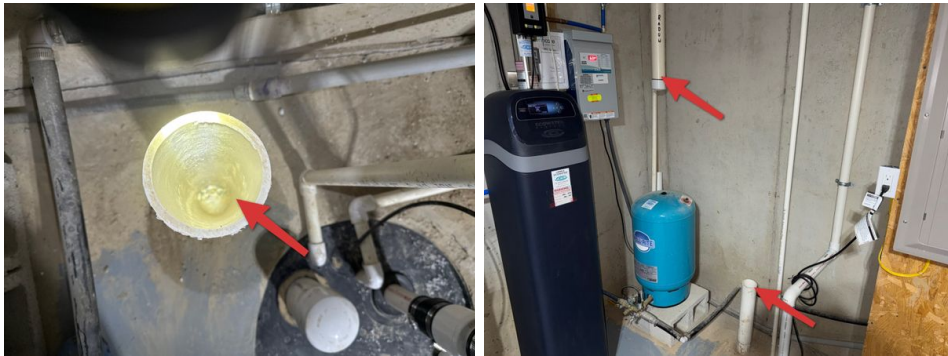
6.8.1 Radon

Safety Defects

Contact a qualified professional.

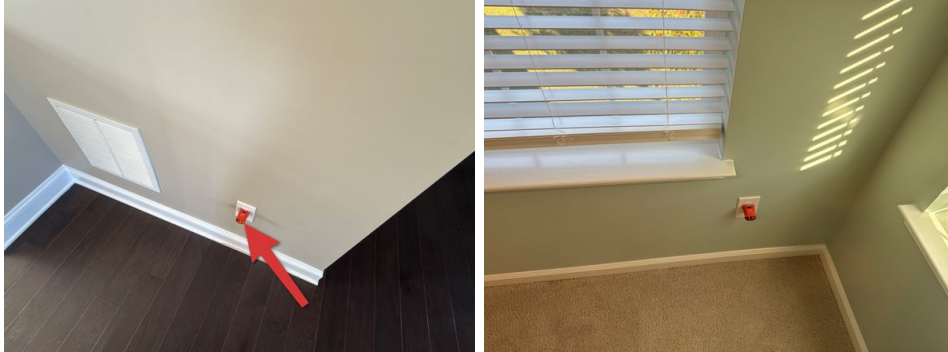
**LOOSE RECEPTACLES AND OR JUNCTION BOX**

There are loose outlets and or junction boxes present. This could cause a short circuit. These outlets should be repaired or replaced.

Contact a qualified professional.

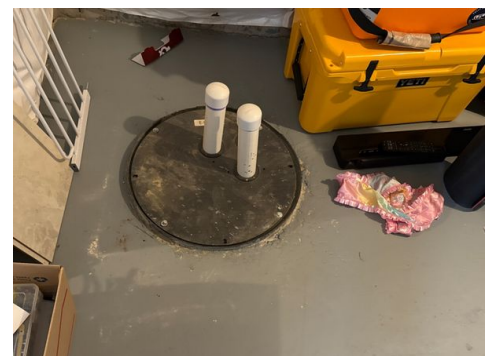
LIFT PUMP PRESENT/DISCONNECTED

There is a lift pump present however it is disconnected. The lift pump could not be tested due to these circumstances.

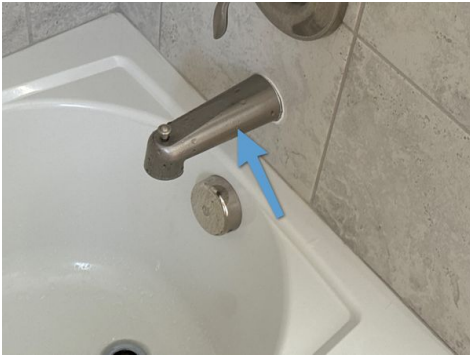
8.5.1 Sinks/Tubs/showers/Toilets

LOOSE FAUCET

The faucet is loose and may begin to leak. This should be repaired by a qualified plumber.

Contact a qualified professional.

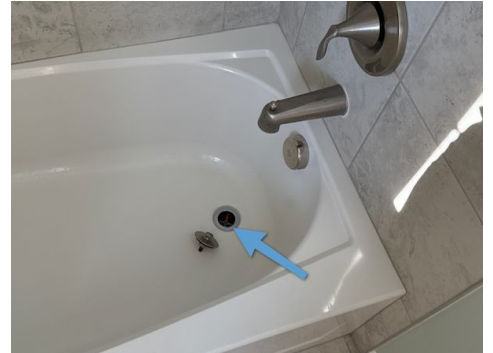
8.5.2 Sinks/Tubs/showers/Toilets

POPUP TUB DRAIN NOT WORKING/MISSING

The tub drain popup is not working or is missing. This should be repaired or replaced.

Maintenance / Service

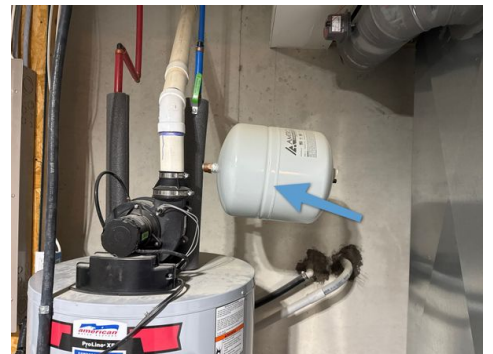
8.6.1 Hot Water Systems

MISSING EXPANSION TANK STRAPS

The support straps are missing at the tank. Support straps should be considered as they support the water weight of the tank. The tanks can weigh 15 to 30 pounds depending on the size.

Maintenance / Service

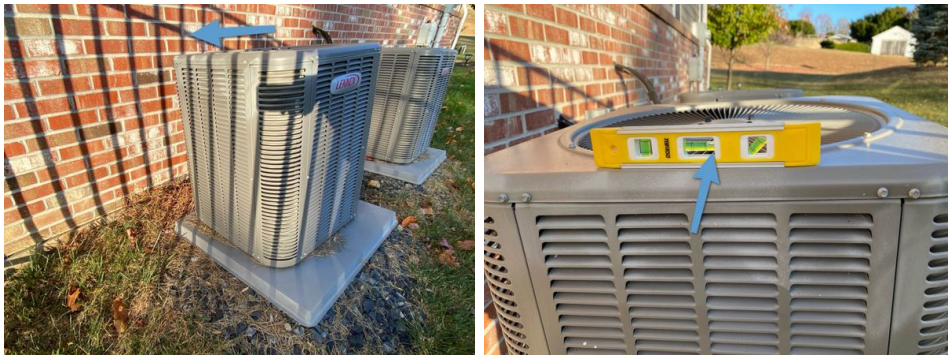
The exterior unit is not level. This can damage the compressor. The unit should be leveled by a qualified HVAC contractor.

Contact a qualified professional.

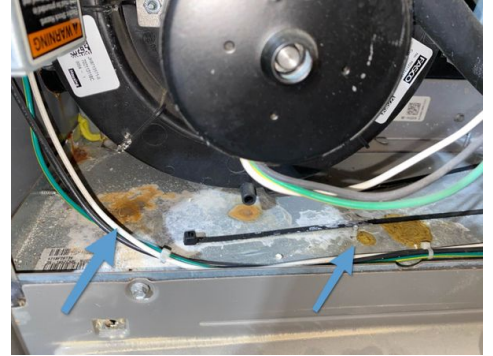
CORROSION/RUST

Furnace was corroded or rusted in one or more areas. This could be the result of standing water, leakage from air conditioning condensate, humidifiers, overhead plumbing leaks or improper venting/condensation of exhaust products. This should be further evaluated.
