## RESIDENTIAL REPORT

743 Yorkshire Rd  
Allentown, PA 18103

Creighton Faust  
MAY 6, 2024

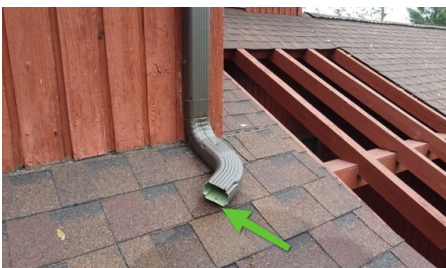
### Roof Drainage Systems: Upper Roof Discharges onto Lower Roof

The upper downspouts are discharging onto the lower roof. This may cause premature wear to the roofing material. You may consider extending the downspouts to the lower gutter.

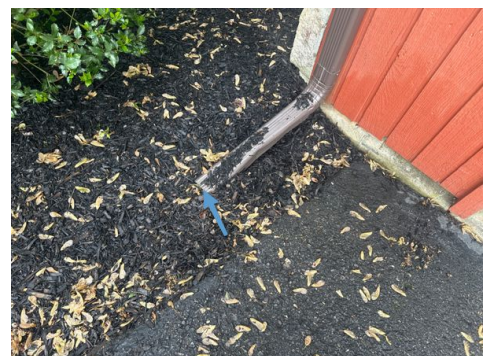
### DOWNSPOUTS DRAIN NEAR HOUSE

One or more downspouts drain too close to the home's foundation. This can result in excessive moisture in the soil at the foundation, which can lead to foundation/structural movement. You should install downspout extensions to drain at least 6 feet from the foundation.

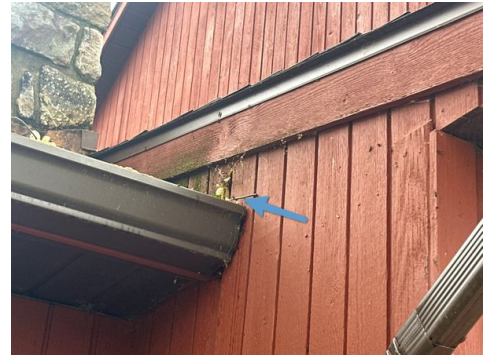
3.4.1 Flashings

### KICK OUT FLASHING(S) MISSING

A kick out flashing(s) is missing where the gutter intersects with the siding. This type of flashing is designed to divert roof water run off into the gutter and not overflowing to the lower foundation area. You should consider having this installed.

Recommendation

Contact a qualified professional.

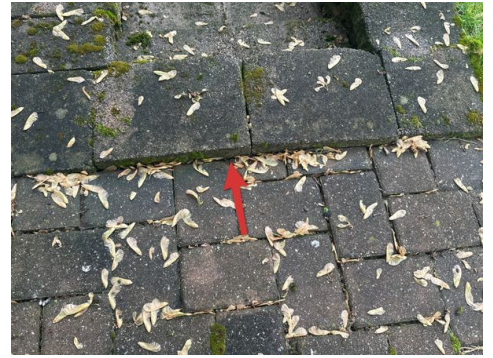
Safety Defects
**WALKS UNEVEN**

The walks are uneven at a few small areas. This is a safety concern-trip hazard, suggest making repairs to create an even and level surface.

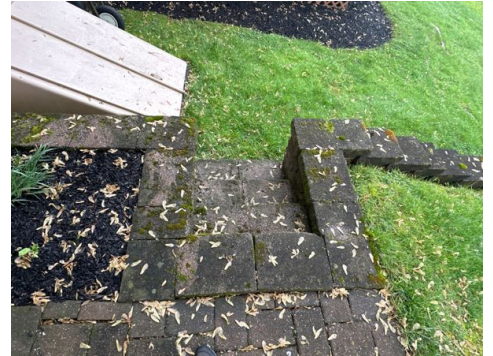
## 4.2.2 Walkways, Stoops, Steps, Patios &amp; Driveways

Safety Defects
**MISSING HANDRAIL**

The handrail is missing. Handrail should be installed to prevent injury.

Recommendation

Contact a qualified professional.

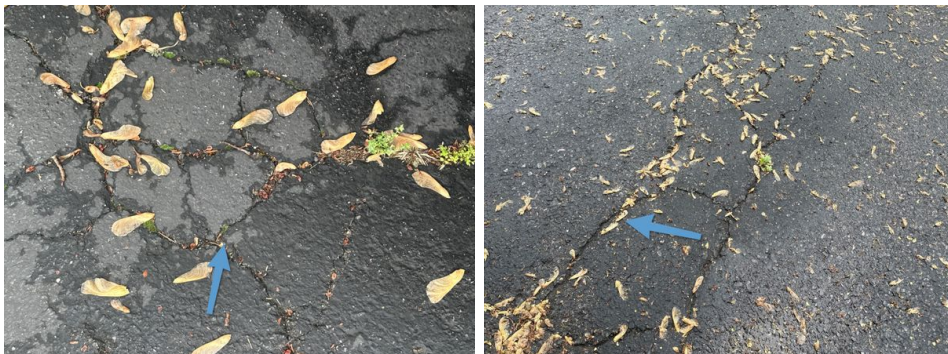
## 4.2.3 Walkways, Stoops, Steps, Patios &amp; Driveways

Maintenance / Service
**DRIVEWAY CRACKING**

Cracking was observed. Recommend monitoring and/or have contractor patch/seal.

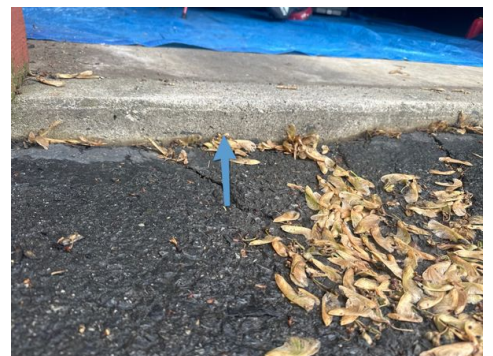
## 4.2.4 Walkways, Stoops, Steps, Patios &amp; Driveways

The driveway appears to have settled at the garage. This may allow water to accumulate next to the foundation. You should have the open areas sealed.

Recommendation

Contact a qualified professional.

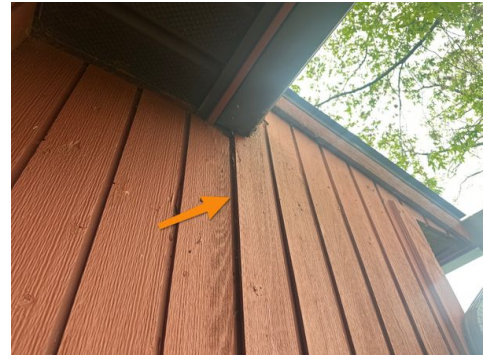
4.4.1 Siding

Major Items

**LOOSE SIDING**

The siding is loose at various areas. Loose siding can allow moisture or insects to enter. The siding provides important weather protection. The siding should be repaired or replaced.

Recommendation

Contact a qualified professional.

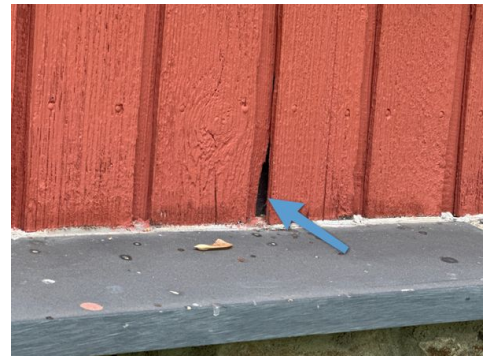
**DAMAGED/HOLES SIDING**

The siding is damaged or has holes at a few small areas. This could allow moisture to penetrate causing further damage to the building materials. The siding material should be repaired or replaced.

Recommendation

Contact a qualified professional.

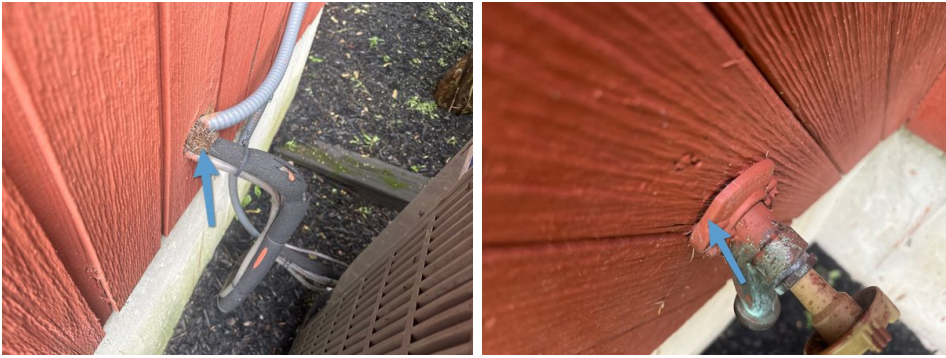
4.4.4 Siding

Caulking is missing where the utility lines or piping enter through the exterior wall. Moisture, pests or insects intrusion is possible. These areas should be caulked with appropriate caulking material.

Recommendation

Contact a qualified professional.

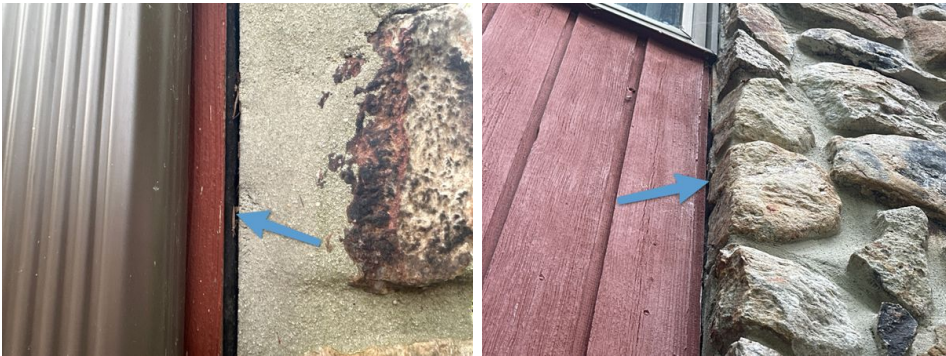
## 4.4.5 Siding

**CAULKING/GROUT AT MASONRY INTERSECTION**

The caulking or grout is missing at the intersection of the masonry and siding. These areas should be sealed to prevent moisture entry.

## Recommendation

Contact a qualified professional.

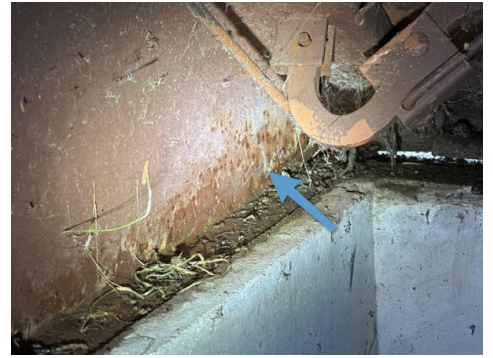
## 4.6.2 Exterior Doors

**RUSTY BILCO DOOR SYSTEM**

The bilco door is rusting. You should sand and paint the door system with an appropriate quality exterior paint.

Recommendation

Contact a qualified professional.

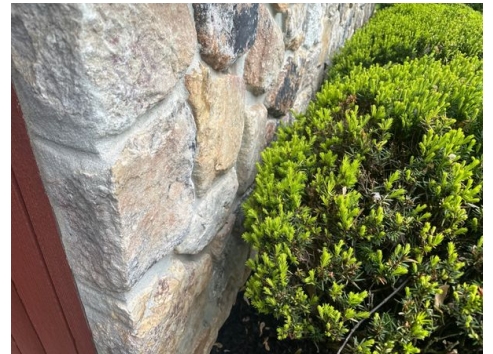
## 4.9.1 Vegetation, Grading &amp; Drainage

The trees or bushes are close or touching the dwelling. This can retain moisture at the siding areas which may allow for mold/mildew. You should trim these areas back to allow for proper air flow.

Recommendation

Contact a qualified professional.

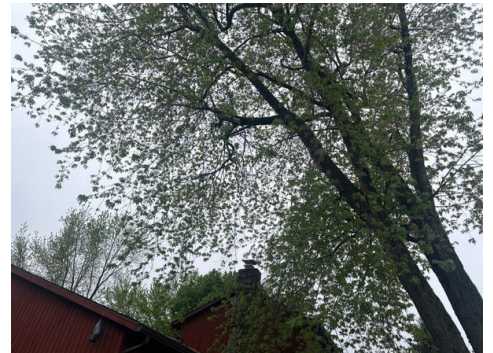
## 4.9.2 Vegetation, Grading &amp; Drainage

**TREE OVERHANG**

Tree's were observed overhanging the roof. This can cause damage to the roof and prevent proper drainage. The overhang should be trimmed back to allow for proper drainage and deter possible damage.

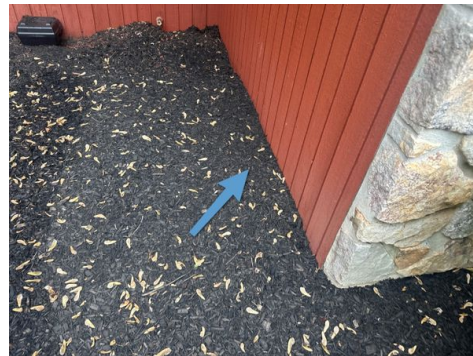
## 4.9.3 Vegetation, Grading &amp; Drainage

The grading is high at areas. This can allow moisture or insect penetration. The ground should be at least 2 to 3 inches below the siding or top of the foundation.

Recommendation

Contact a qualified professional.

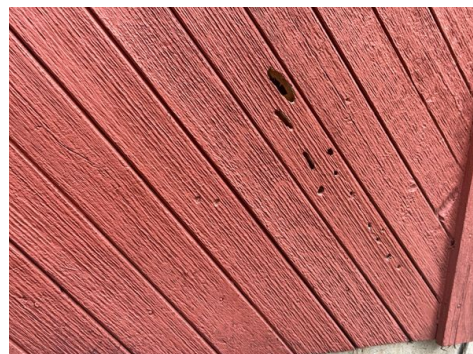
4.10.2 Pest Indications

**WOODPECKER DAMAGE**

There are signs of damage from woodpeckers.

Recommendation

Contact a qualified professional.

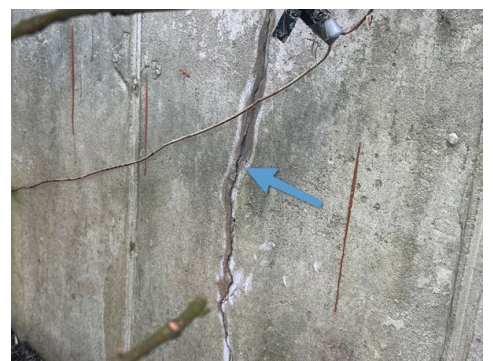
## 5.2.1 Foundation

**FOUNDATION CRACKS**

There are typical crack(s) present at some areas of the foundation wall. This is common as concrete ages and shrinks where surface cracks are normal at approximately 1/16". You should monitor for any additional change or moisture at these areas. If leakage should occur these can be sealed by a qualified contractor.

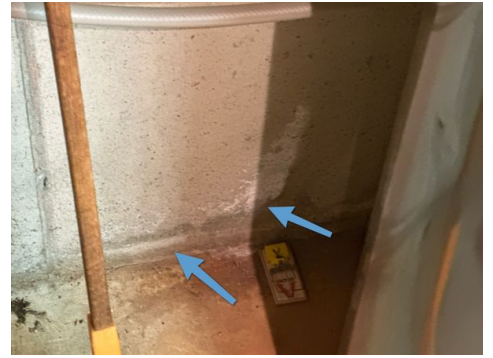
Efflorescence noted on the wall surface. This is a white, powdery deposit that is consistent with moisture intrusion. This can compromise the soil's ability to support the home structure and/or lead to mold growth. Recommend a qualified contractor identify source of moisture and correct.

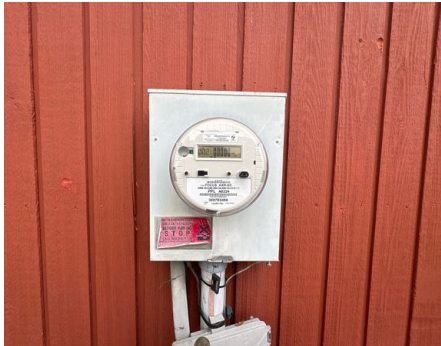
**Service Entrance Conductors:**  
**Service Entrance**  
 Underground

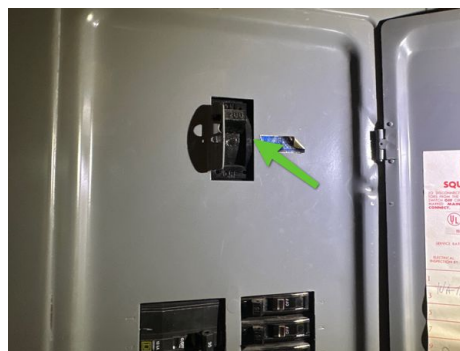
**Grounding & Bonding: Bonding**  
 Water meter bonded

**Service Entrance Conductors:**  
**Electrical Service Conductors**  
 Aluminum

**Main & Subpanels & Main**  
**Overcurrent Device: Main**  
**Disconnect Location**  
 Inside the Main Panel

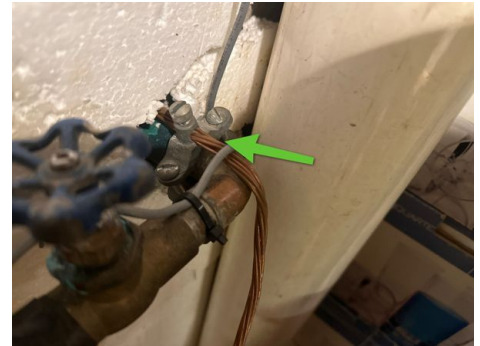
**Main & Subpanels & Main**  
**Overcurrent Device: Panel**  
**Capacity**  
 200 AMP

**Branch Wiring Circuits: Wiring**  
**Method**  
 Non Metallic

**Grounding & Bonding: Service**  
**Grounding Location**  
 Plumbing supply line

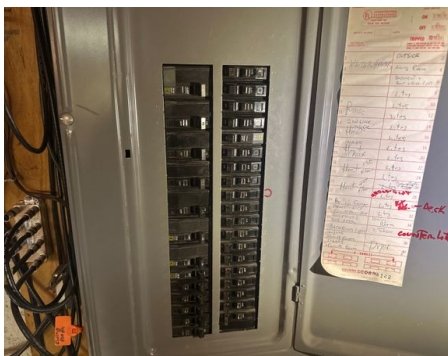
**Main & Subpanels & Main Overcurrent Device: No additional room for expansion**

There is no room for additional breakers inside the panel. If you need additional breakers you will need an additional subpanel or a larger panel box.

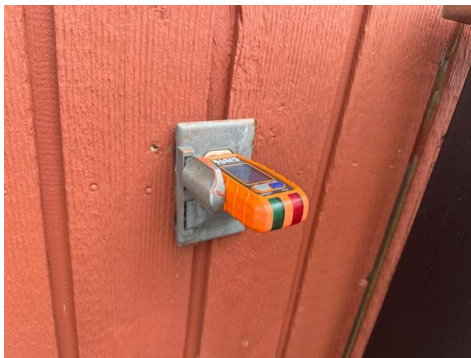
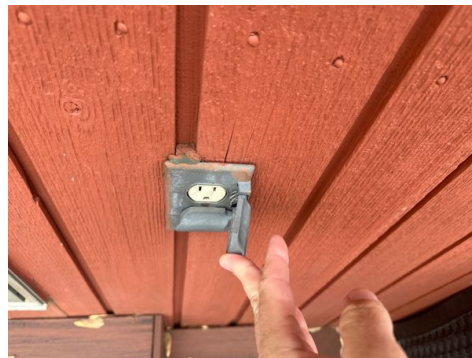
#### 7.7.1 GFCI/AFCI

### **GFCI OUTLET(S) MISSING**

Safety Defects

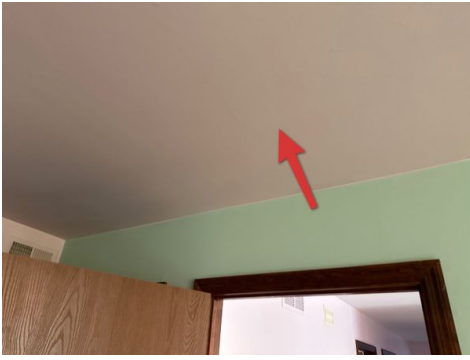
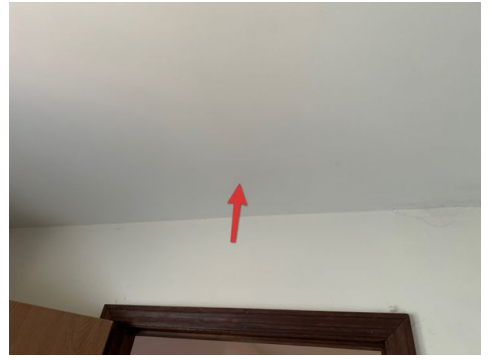
#### 7.8.1 Smoke Detectors

### **MISSING SMOKE DETECTORS**

Safety Defects

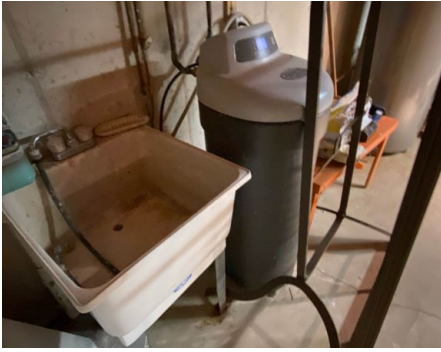
**General: Filters**  
Water Softner

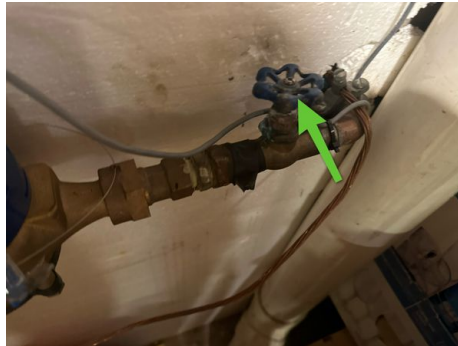
**Main Water Shut-off Device:**  
**Location**  
Basement

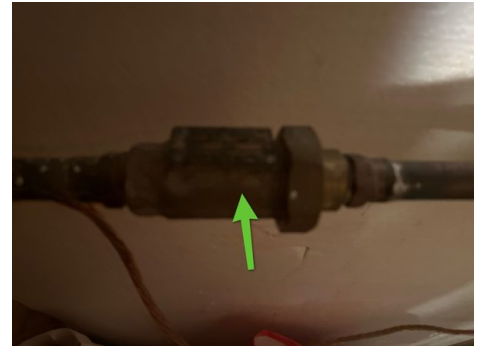
**Main Water Shut-off Device:**  
**Check Valve/ Pressure Regulator**  
Backflow Preventer

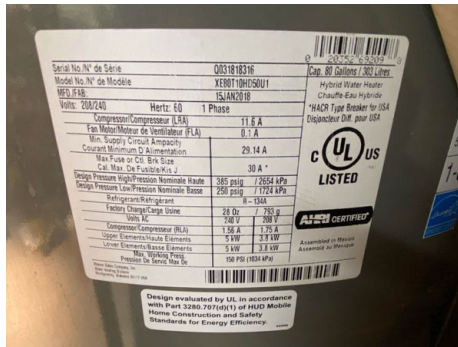
**Hot Water Systems: Age**  
6

**Hot Water Systems: Power Source/Type**  
Electric, Heat Pump

**Hot Water Systems: Capacity**  
80 gallons

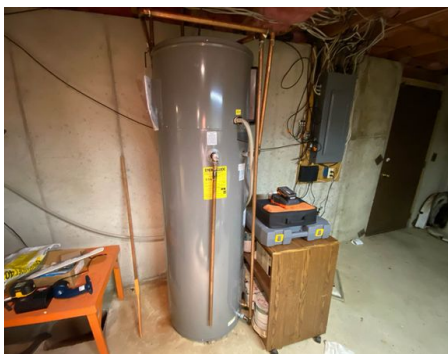
Rheem

We recommend flushing & servicing your water heater tank annually for optimal performance. Water temperature should be set to at least 125 degrees F to kill microbes and no higher than 130 degrees F to prevent scalding.

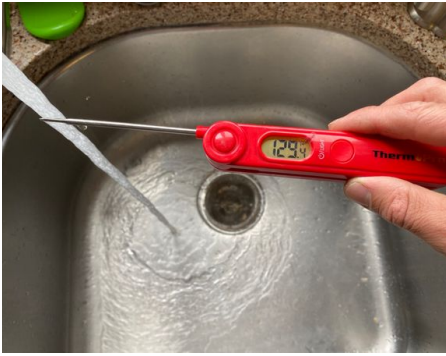
## Hot Water Systems: Functional

The water heating system was tested at various areas. The hot water heating system was functional at the time of this inspection.

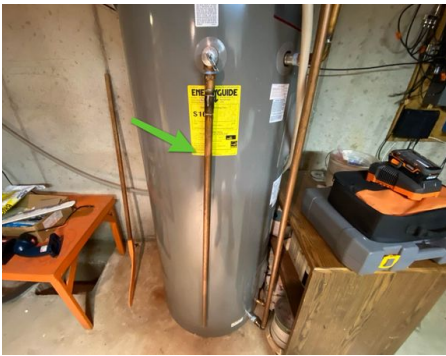
## Hot Water Systems: TPR Drain Valve

Present

TPR Valves and Discharge Piping. Temperature/pressure-relief or TPR valves are safety devices installed on water heating appliances, such as boilers and domestic water supply heaters. ... The valve should be connected to a discharge pipe (also called a drain line) that runs down the length of the water heater tank.

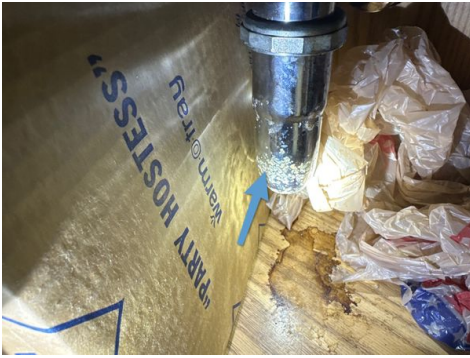
### 8.4.1 Drain, Waste, & Vent Systems

#### **CORRODED DRAIN LINES**

Some of the drain lines show signs of corrosion. Consider replacement in the future to prevent the potential for leaks.

Maintenance / Service

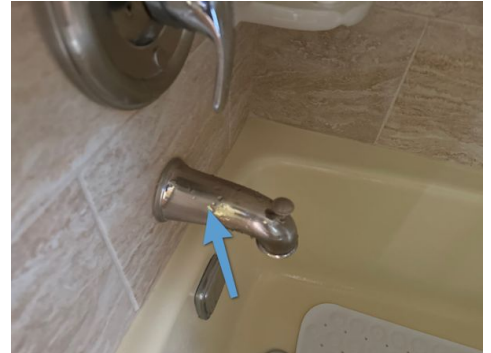
## 8.5.1 Sinks/Tubs/showers/Toilets

**LOOSE FAUCET**

The faucet is loose and may begin to leak. This should be repaired by a qualified plumber.

Contact a qualified professional.

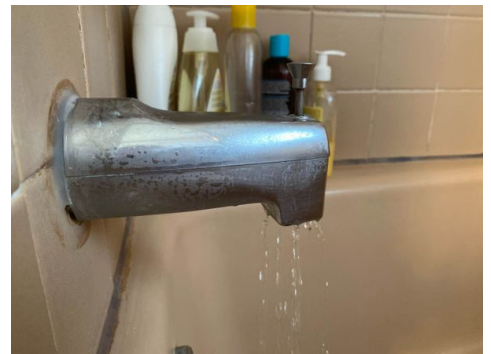
## 8.5.2 Sinks/Tubs/showers/Toilets

**TUB DIVERter LEAKS**

The diverter at the tub is allowing water to flow through the spout instead of directing it to the shower head. The diverter should be repaired or replaced for proper or designated flow location.

Contact a qualified professional.

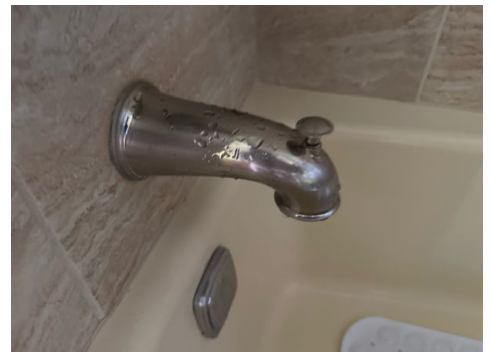
## 8.5.3 Sinks/Tubs/showers/Toilets

The tub diverter sticks. This is a simple repair.

Contact a qualified professional.

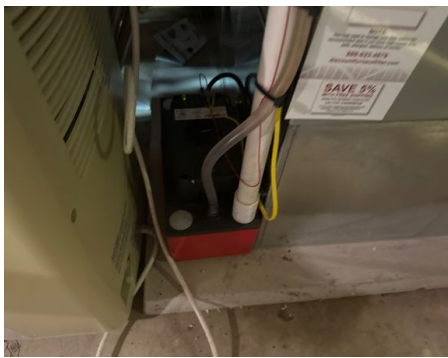
## Interior A/C Unit/Handler: Condensate Pump

The indoor unit cooling coil drains into a condensate pump. Testing or evaluation of this is beyond the scope of this inspection. The pump appeared serviceable at the time of this inspection.

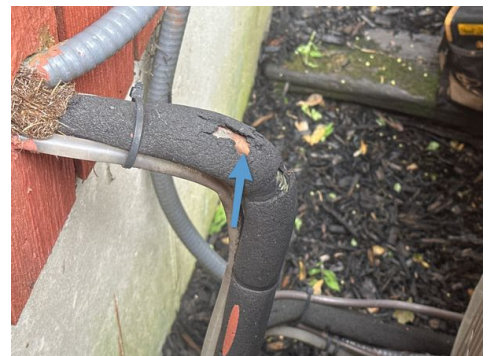
## DAMAGED OR MISSING REFRIGERANT LINE INSULATION

The refrigerant line insulation jacket is damaged or missing. This may cause a reduction in operational efficiency. The insulation jacket should be repaired or replaced.

Contact a qualified professional.

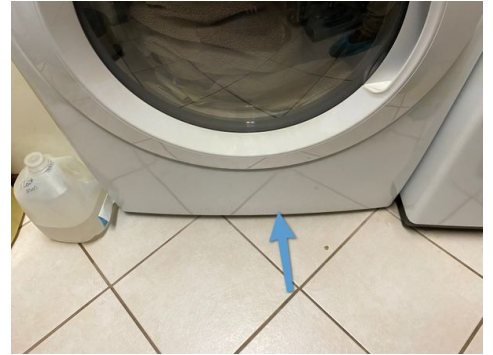
**MISSING DRIP PAN**

There is no drip pan present. When located on or above finished spaces you should have a drip pan installed beneath the washer to prevent possible moisture damage.

Contact a qualified professional.

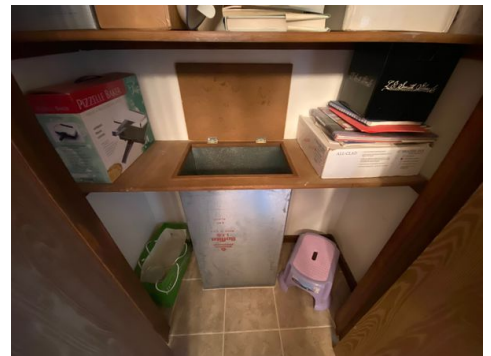
There is a laundry chute present. This is considered a safety hazard if small children are present.

Contact a qualified professional.

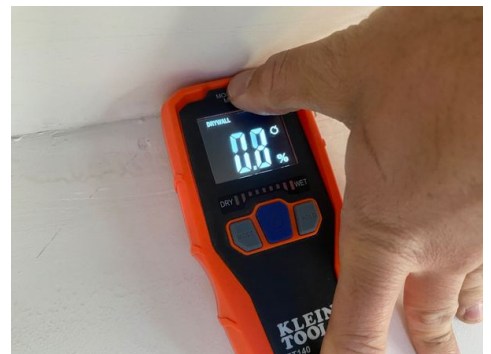
## 12.4.1 Ceilings

**STAINS WERE TESTED AND DRY**

There were stains that were tested and appeared to be dry at the time of this inspection. This appears to be from a previous water leak that was not active. You should monitor the area(s).

Contact a qualified professional.

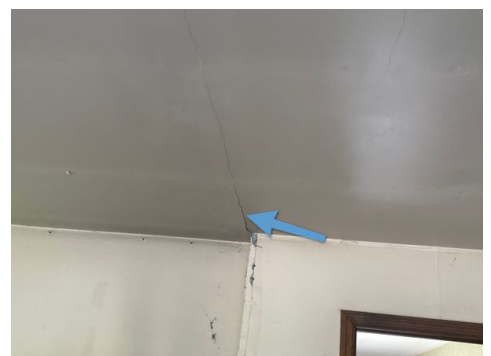
## 12.4.2 Ceilings

**DAMAGED CEILING**

There are areas of the ceiling which are damaged. It is unknown as to why this is present. Recommend to have a qualified contractor further evaluate and repair.

Contact a qualified professional.

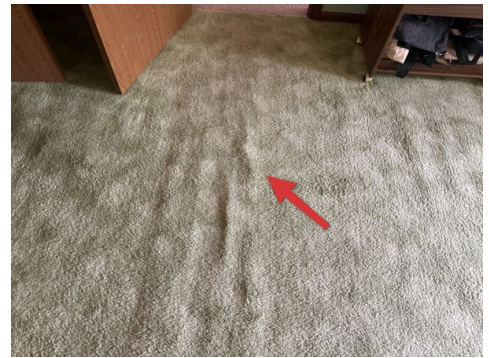
## 12.5.1 Floors

**LOOSE CARPET**

There is loose carpet at some area(s). This is a trip hazard. These area(s) should be repaired or replaced.

Contact a qualified professional.

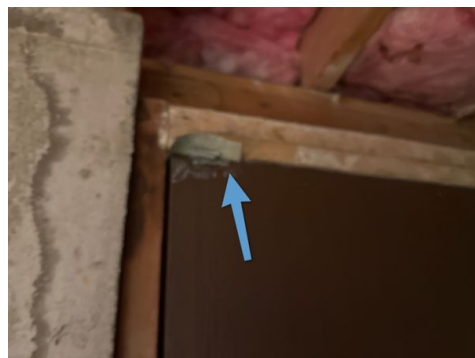
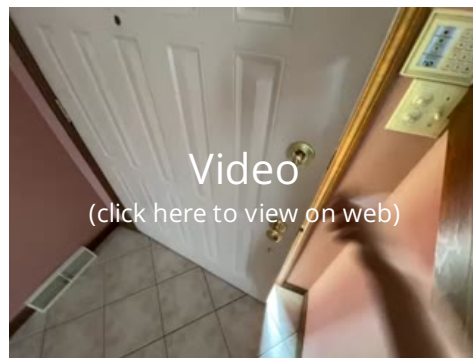
12.6.1 Doors

**DOOR(S) STICK OR RUB**

FRONT DOOR, BASEMENT EGRESS

Door(s) stick or rub and were difficult to open. Adjustment should be considered.

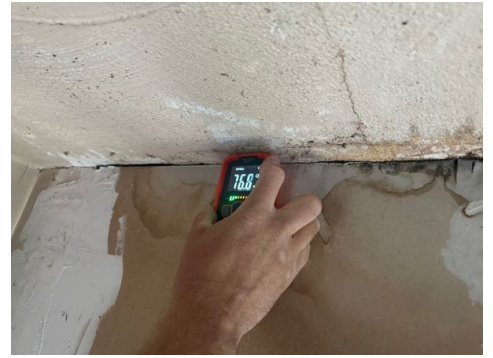
Major Items

Garage ceiling shows signs of moisture intrusion. To prevent further damage or growth of mold, you should contact a qualified contractor to evaluate the source of moisture intrusion.

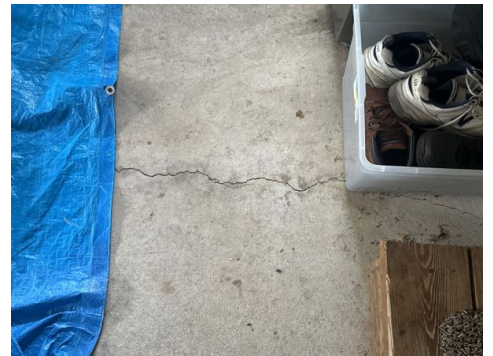
13.3.1 Floor

**TYPICAL SETTLEMENT CRACKS**

Typical settlement cracks were visible in the garage floor. The floor appeared serviceable at the time of this inspection.

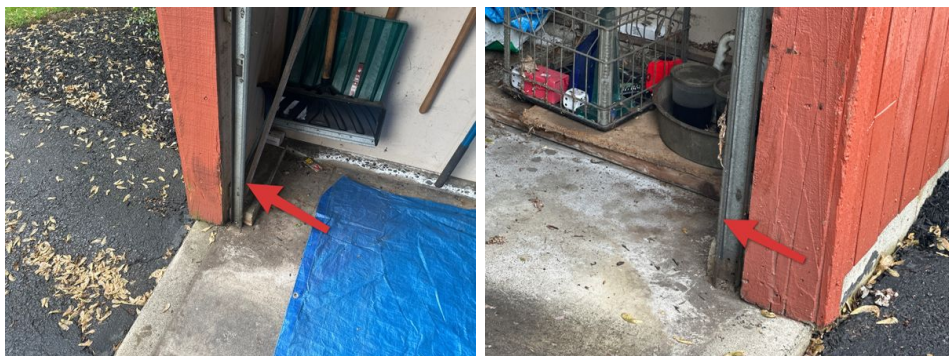
**MISSING SENSORS**

Contact a qualified professional.

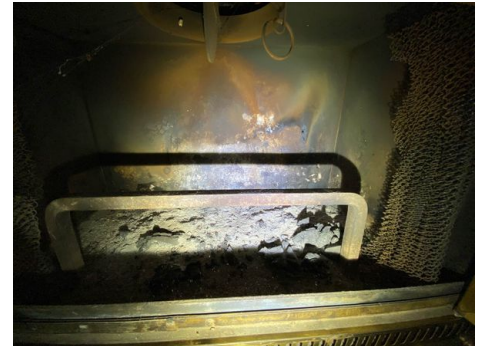
**Fireplace Components: Fire Chamber Material**

Metal

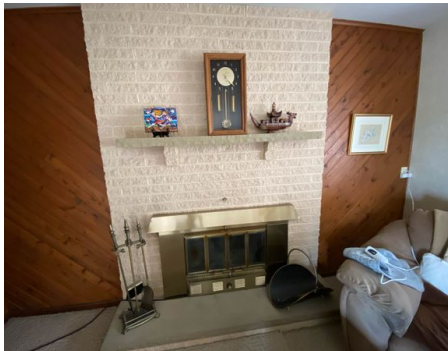
Functional

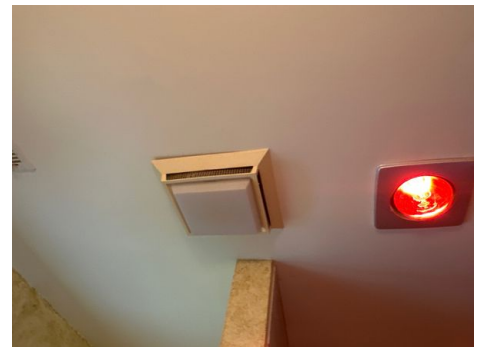
### Bath Exhaust Systems: Exhaust Fans

Present and Functional
