RESIDENTIAL REPORT

969 Natalie lane
Coopersburg, Pa 18036

JULY 8, 2024

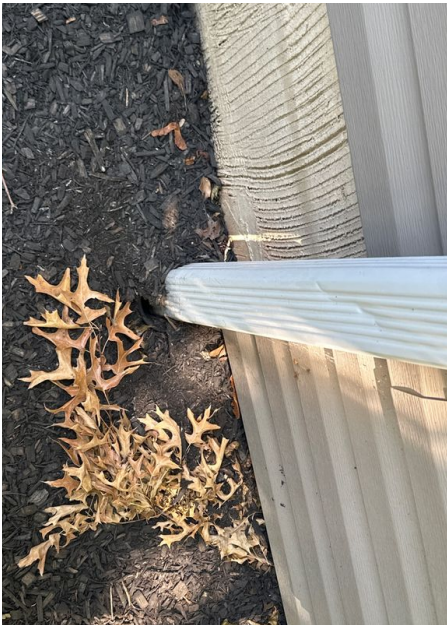
Roof Drainage Systems: Upper Roof Discharges onto Lower Roof

The upper downspouts are discharging onto the lower roof. This may cause premature wear to the roofing material. You may consider extending the downspouts to the lower gutter.

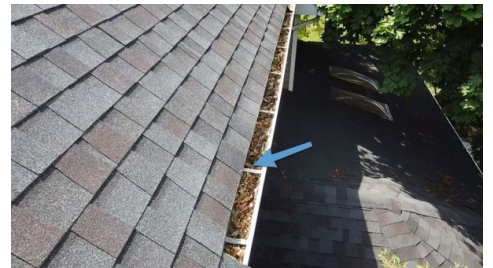
DEBRIS

Debris has accumulated in the gutters. The gutters should be maintained to correctly facilitate water flow.

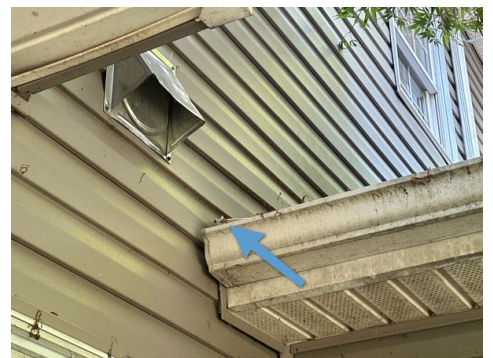
KICK OUT FLASHING(S) MISSING

A kick out flashing(s) is missing where the gutter intersects with the siding. This type of flashing is designed to divert roof water run off into the gutter and not overflowing to the lower foundation area. You should consider having this installed.

Recommendation

Contact a qualified professional.

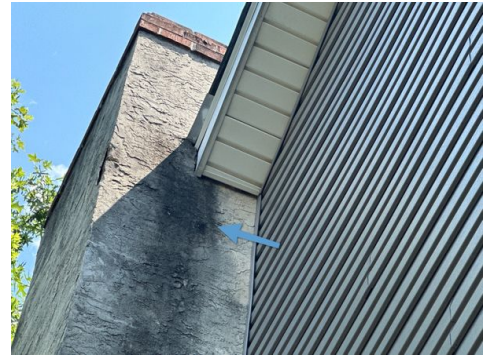
STAINING

There was staining on the siding present during the inspection.

Recommendation

Contact a qualified professional.

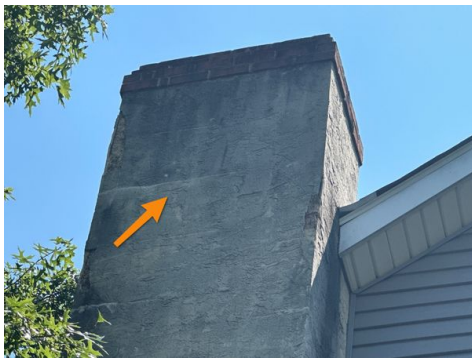
3.6.3 Chimney

STUCCO CRACKING

The stucco is cracking. Repair by a qualified professional is recommended.

Recommendation

Contact a qualified professional.

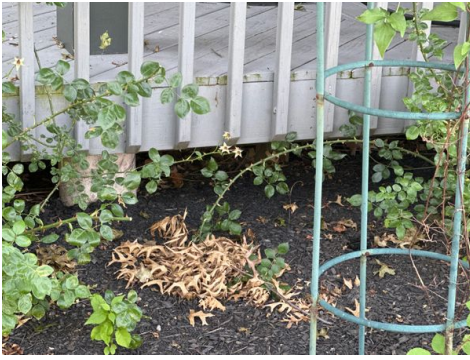
GROUND CLEARANCE

The deck is close to the ground for access or a complete visual inspection. Therefore we were unable to access the underside of the deck for hidden deficiencies. Undiscovered defects may exist.

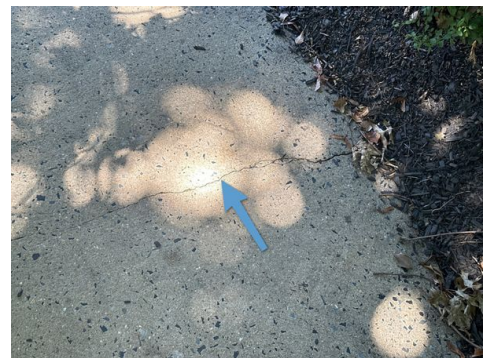
WALKWAY CRACKING

Cracks were observed. Recommend monitoring and/or patch/seal.

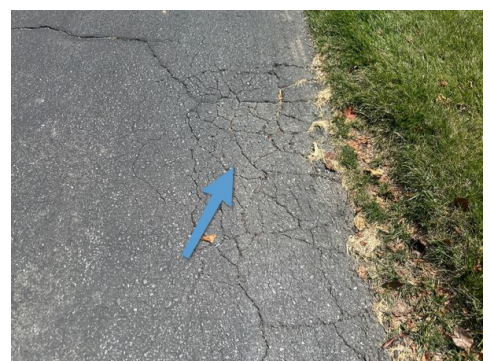
DRIVEWAY CRACKING

Cracking was observed. Recommend monitoring and/or have contractor patch/seal.

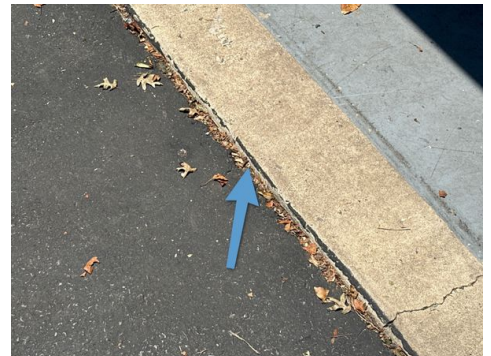
SEAL MISSING/DETERIORATED AT GARAGE

The seal at the driveway and garage connection should be replaced to prevent water intrusion and cracking from freeze thaw cycle.

Recommendation

Contact a qualified professional.

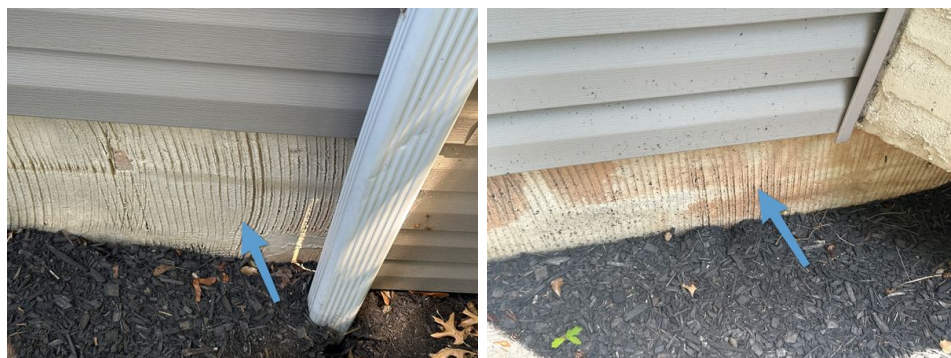
The parge coating is cracked or deteriorated at several areas. This can allow moisture to further penetrate. Exterior surface patching should be considered. You may also wish to contact a qualified contractor for further evaluation.

Recommendation

Contact a qualified professional.

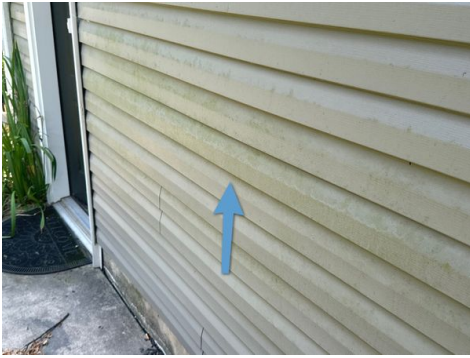
MILDEW/ALGAE

There are signs of a green bio-growth and/or mildew on the siding. This is a cosmetic issue and is not uncommon especially on shaded portions of the home. Recommend that said areas be washed or cleaned on a regular basis.

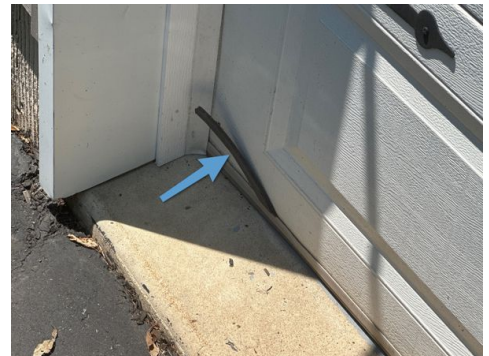
DAMAGED WEATHERSTRIP

Damaged door jamb, weatherstrip present. Repair or replacement needed.

Recommendation

Contact a qualified professional.

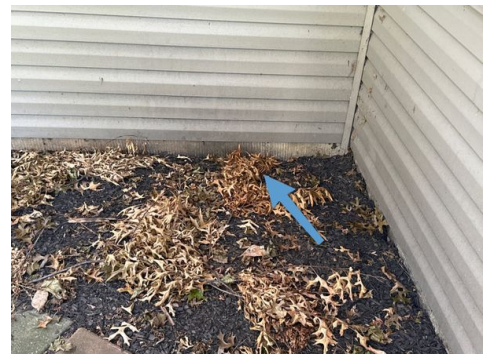
LOW GRADE

Grading is sloping towards the home in some areas. This could lead to water intrusion and foundation issues. You should consider contacting a qualified landscaper to regrade so water flows away from the foundation.

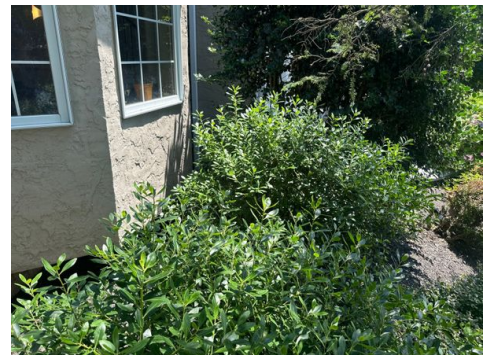
The trees or bushes are close or touching the dwelling. This can retain moisture at the siding areas which may allow for mold/mildew. You should trim these areas back to allow for proper air flow.

Recommendation

Contact a qualified professional.

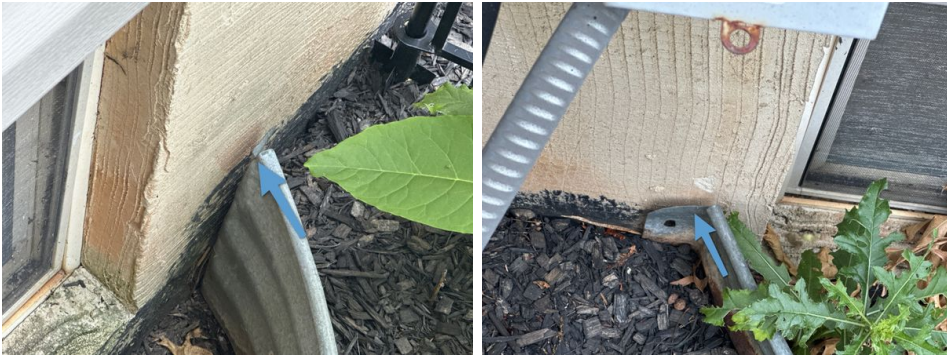
WINDOW WELL LOOSE

The metal window well is loose. This can allow moisture to penetrate this area. Consider reattaching or replacing the window well to prevent future moisture intrusion.

Recommendation

Contact a qualified professional.

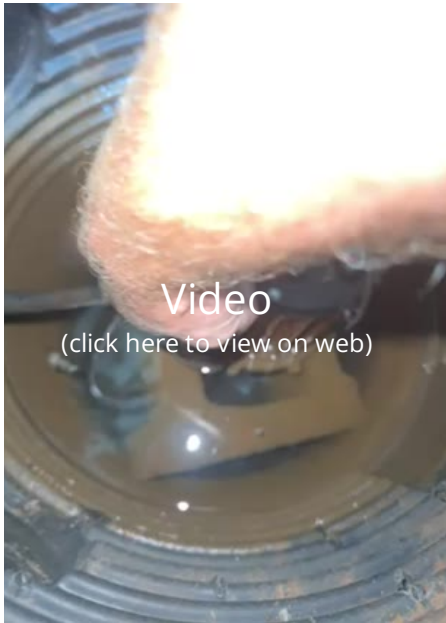
Sump Pump(s): Sump Pump(s) Present/Operational

There was a sump pump(s) present. Sump pumps are designed to discharge basement or crawlspace water to the exterior side of the dwelling. The sump pump(s) was tested and appeared to be functional at the time of this inspection.

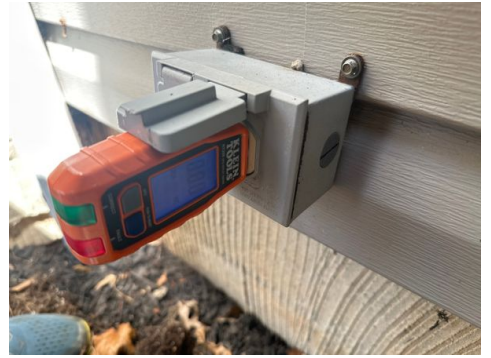
FRONT NEXT TO STOOP

There are outlets that did not respond when tested. This should be further evaluated and repaired or replaced.

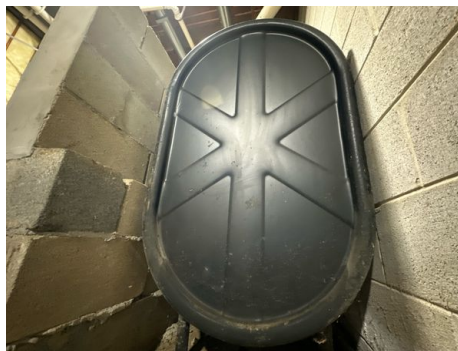
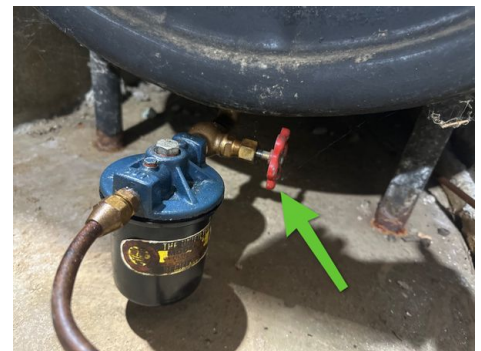
Fuel Storage & Distribution Systems: Oil Tank Shut Off

At the Tank

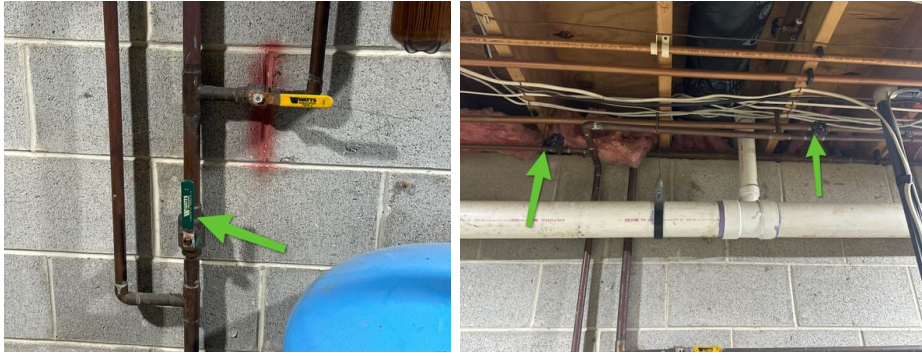
Main Water Shut-off Device: Location

Basement

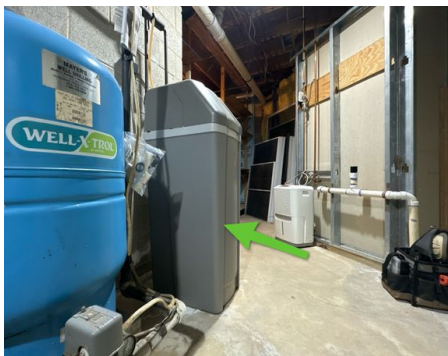
Water Supply, Distribution Systems & Fixtures: Water Treatment Equipment Installed

There is a treatment system installed. These are beyond the scope of this inspection. You should contact the owner for further information or a service company they may use.

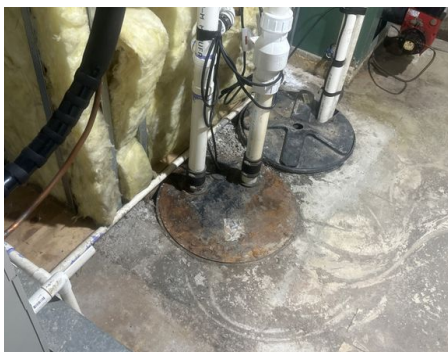
Drain, Waste, & Vent Systems: Lift Pump

There is an ejector lift pump serving the plumbing fixtures that are below the building sewer line. These are used to pump waste to the sewer line. These should be serviced every (5) years. You should not use the plumbing fixtures during a power outage.

At the time of inspection the sewage ejector pump appeared to be operational at the time of the inspection. Any defects will be listed separately in the report.

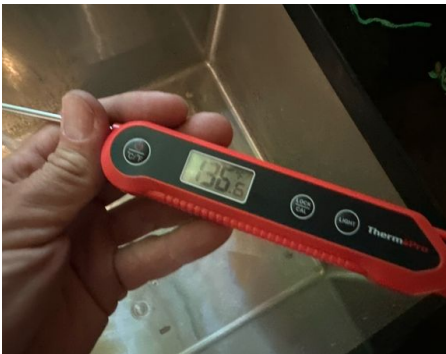
Hot Water Systems: Functional

The water heating system was tested at various areas. The hot water heating system was functional at the time of this inspection.

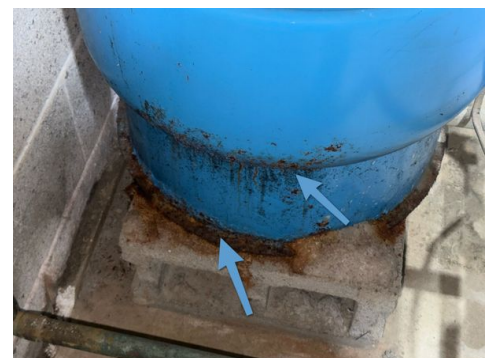
PRESSURE TANK RUSTED/CORRODED

The pressure tank is rusted/corroded. Replacement could be required in the future.

Contact a qualified professional.

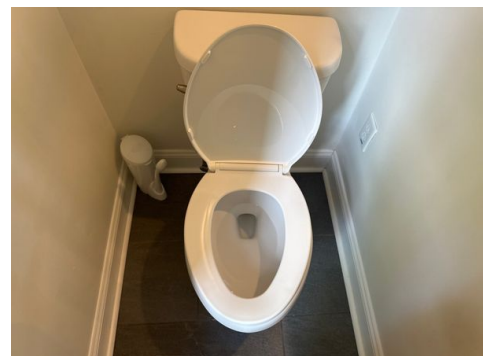
8.5.1 Sinks/Tubs/showers/Toilets

LOOSE TOILET(S)

The toilet is loose in the bathroom(s) This may allow for leakage or odors. The toilet(s) should be secured and further evaluation for possible floor damage should be considered.

Contact a qualified professional.

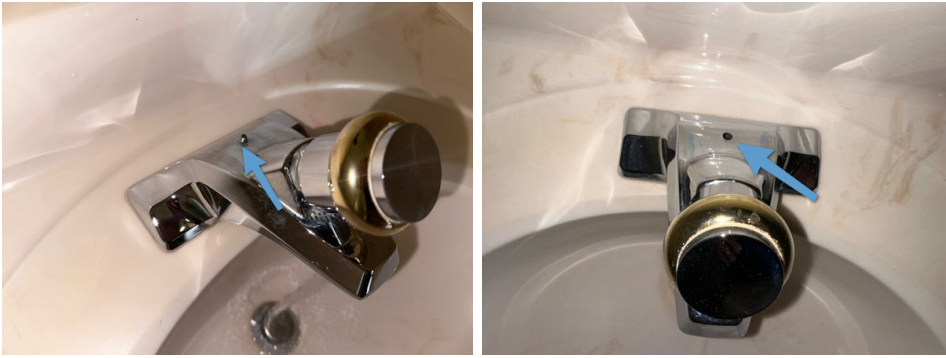
8.5.2 Sinks/Tubs/showers/Toilets

MISSING POPUP AND OR DRAIN CONTROLS AT THE SINK

The popup and or drain controls are missing. You may wish to have a qualified plumber repair the drain control.

Contact a qualified professional.

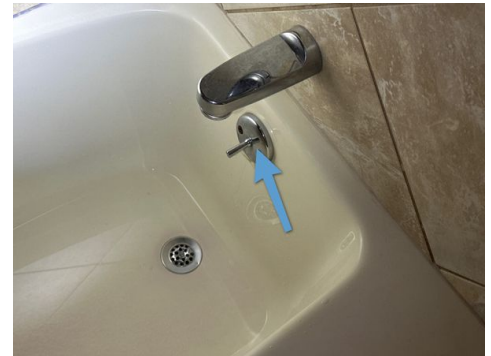
8.5.3 Sinks/Tubs/showers/Toilets

POPUP TUB DRAIN NOT WORKING/MISSING

The tub drain popup is not working or is missing. This should be repaired or replaced.

Contact a qualified professional.

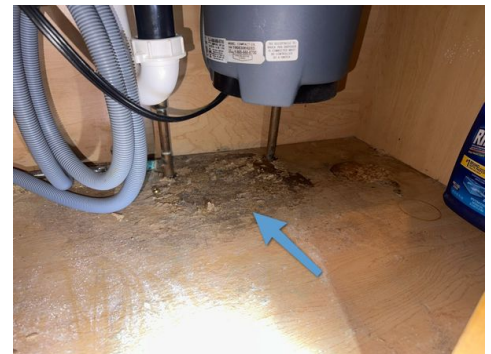
8.5.4 Sinks/Tubs/showers/Toilets

STAINS WERE TESTED AND DRY

There were stains that were tested and appeared to be dry at the time of this inspection. This appears to be from a previous water leak that was not active. You should monitor the area(s).

Contact a qualified professional.

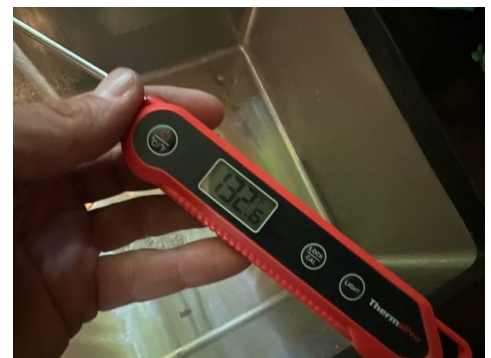
8.6.1 Hot Water Systems

The hot water temperature was over 125 degrees. This can cause injury. The temperature should be set below 125 degrees.

Contact a qualified professional.

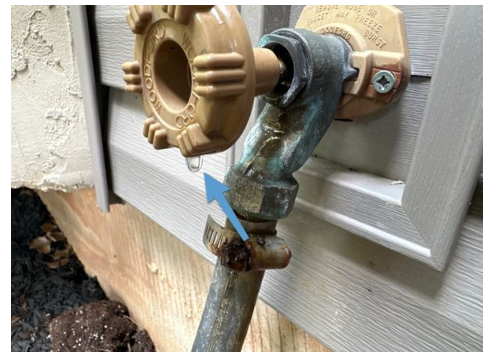
8.8.2 Hose Bibs

BIB LEAKS

The hose bib leaks at the handle when operated. This is a simple repair.

Contact a qualified professional.

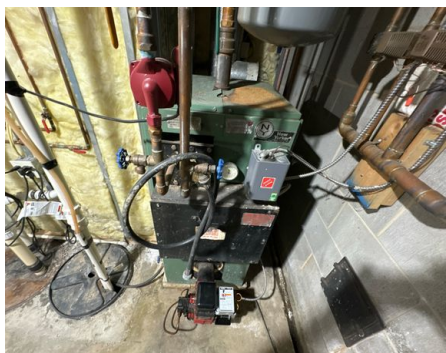
Boiler: Brand
New Yorker

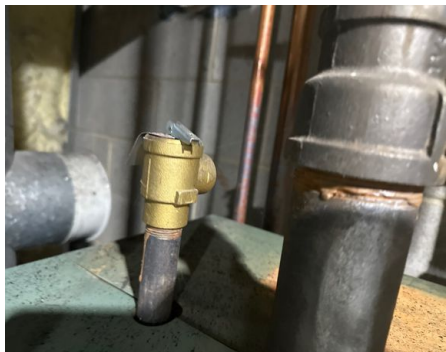
Boiler: Emergency Shut-Off Switch
Within Reach of Boiler

Boiler: Temperature Pressure Release Valve (TPR Valve)
Present

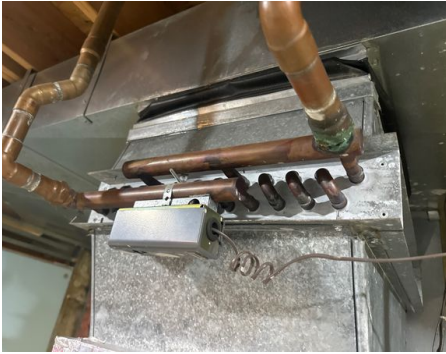
Distribution System/Hot Water Boiler: Hydronic Coil Forced Air Heating

Hydronic coil forced air heating present. A hydronic system combines hydronic (hot water) heating with a forced air delivery. Heat is produced via combustion of fuel (gas/propane/oil) in a boiler. A heat exchanger (hydronic coil) is placed in the air handler similar to the refrigerant coil in a Heat Pump system or a Central AC.

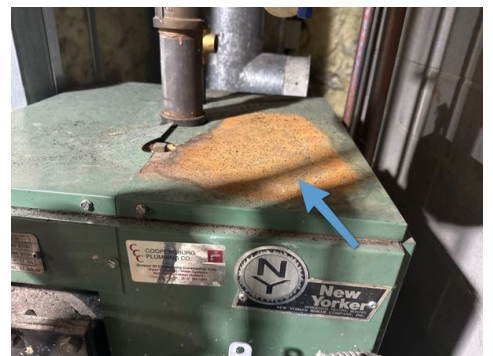
RUST ON THE BOILER

There is rust on the boiler. Rust can be caused by standing water on the floor, leakage from the boiler or overhead plumbing leaks. Rust may also be a result of condensation of the exhaust products. Prolonged exposure to rust inducing conditions can lead to failure of components. You should have a qualified HVAC technician evaluate the condition causing the rust.

Contact a qualified professional.

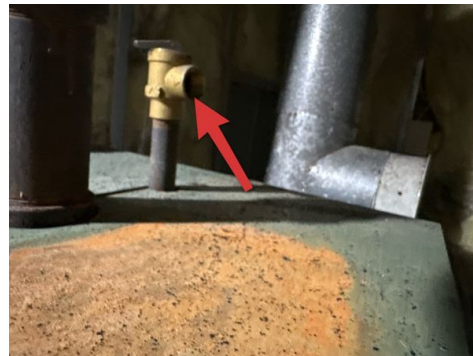
9.2.4 Boiler

TPR EXTENSION MISSING

The TPR is missing a extension.

Contact a qualified professional.

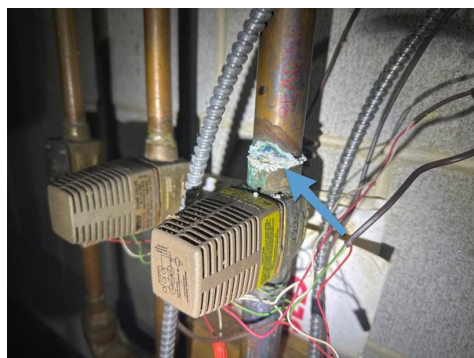
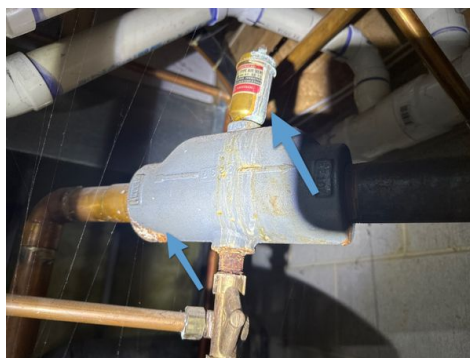
9.5.1 Distribution System/Hot Water Boiler

CORROSION AT PIPE/FITTINGS

There is some corrosion on the pipes or fittings. There were no signs of leakage at the time of this inspection. You should monitor the areas.

Contact a qualified professional.

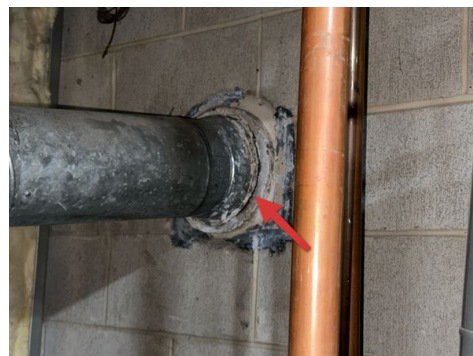
9.6.1 Vents/Flues

POOR SEAL AT CHIMNEY

The vent connector is not properly sealed at the chimney. This may allow exhaust to re-enter the dwelling. This should be further evaluated and repaired by a qualified HVAC contractor.

Contact a qualified professional.

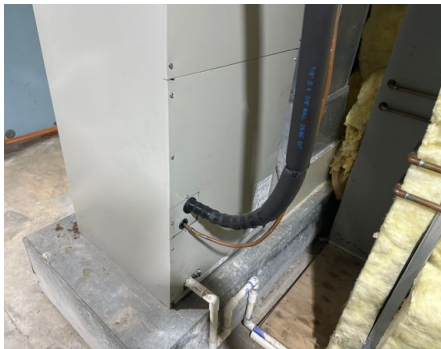
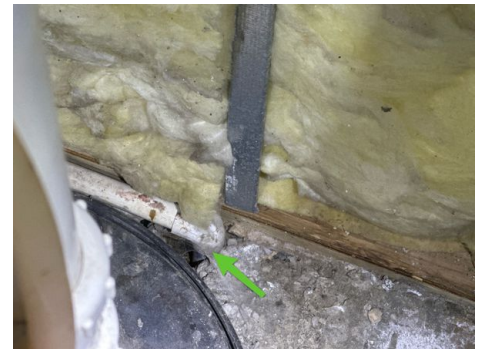
Indoor A/C Unit/Handler: Brand
AirTemp

Indoor A/C Unit/Handler: Condensate Drainage Type/Location
Below Floor Slab, Sump Pit

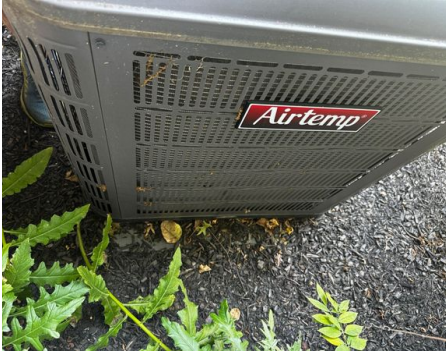
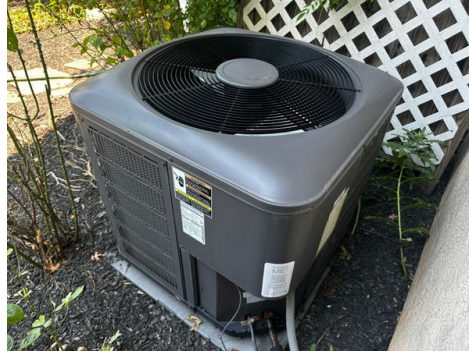
Exterior A/C Unit: Brand

AirTemp

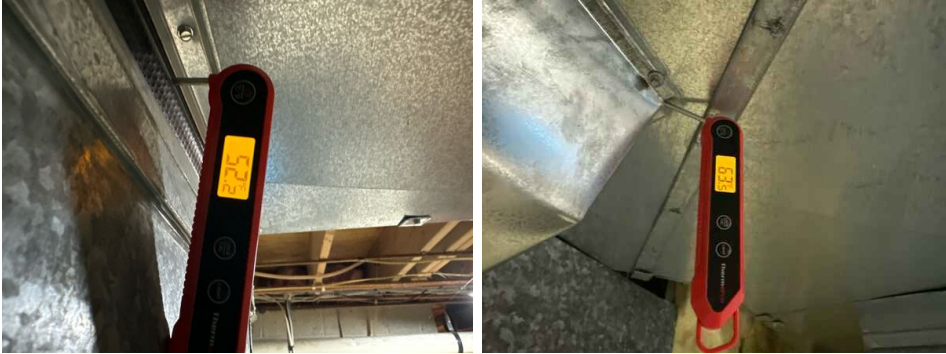
10.3.1 Indoor A/C Unit/Handler

The air conditioning was operated and appeared serviceable at the time of this inspection. A low temperature split was taken however this could just be due to the dirty air filter. Service is recommended.

Recommendation

Contact a qualified professional.

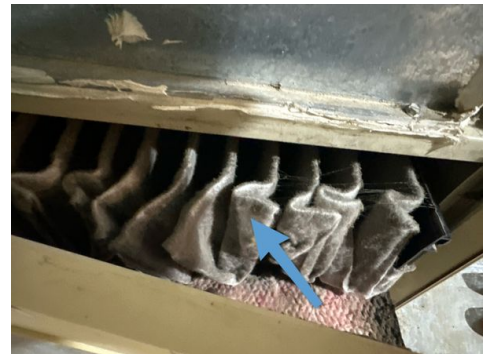
10.5.1 Air Filter(s)

FILTER DIRTY

The filter is dirty and needs to be replaced according to manufacturer's recommendation.

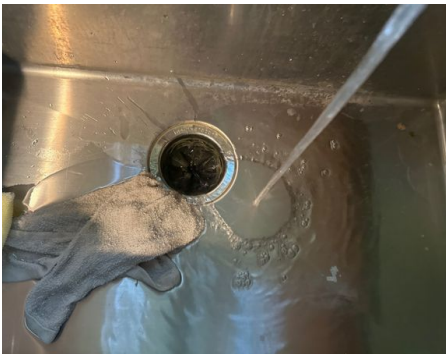
Garbage Disposal: Functional

The disposal was tested and appeared to be functional at the time of this inspection.

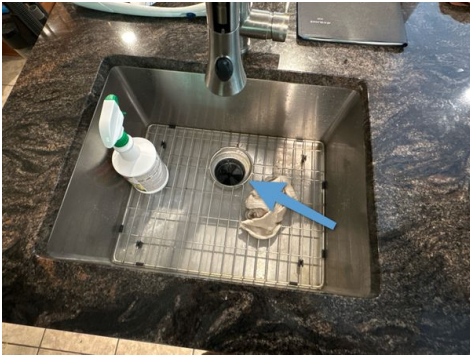
Garbage disposal was excessively noisy. This should be further evaluated for repair or replacement.

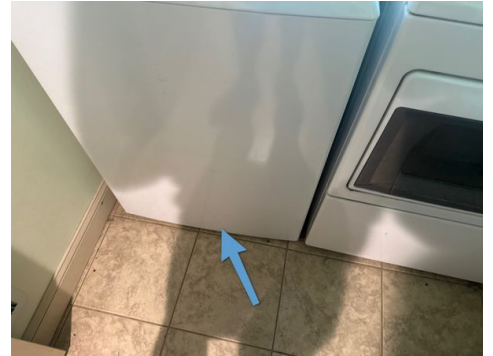
11.6.1 Laundry

MISSING DRIP PAN

There is no drip pan present. When located on or above finished spaces you should have a drip pan installed beneath the washer to prevent possible moisture damage.

Contact a qualified professional.

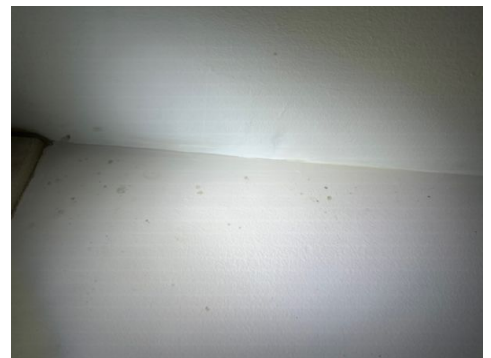
2ND FLOOR HALLWAY BATHROOM

There are possible signs of bio growth on wall. It is unknown if this is a safety hazard. Recommend a qualified mold inspector evaluate.

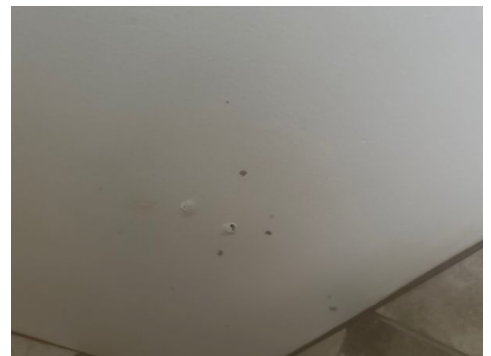
CRACKS & NAIL POPS

There are cracks and nail pops. These are associated with normal settlement of the building. The areas should be repaired.

Contact a qualified professional.

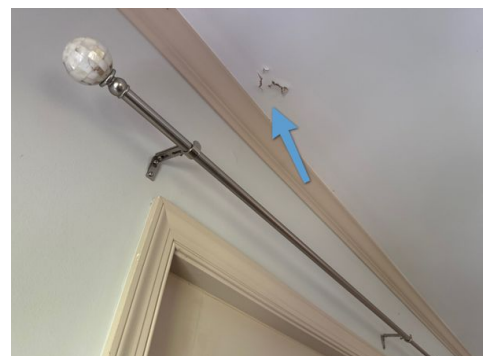
MINOR DAMAGE

Minor damage, cracking or deterioration to the ceiling was visible at the time of the inspection. Repair should be considered.

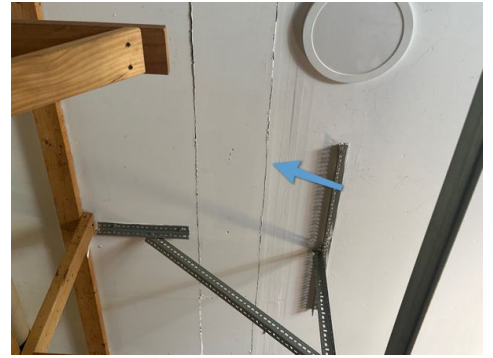
**NON-PROFESSIONAL REPAIRS**

There are Nonprofessional repairs present. Consider repair by qualified professional.

Contact a qualified professional.

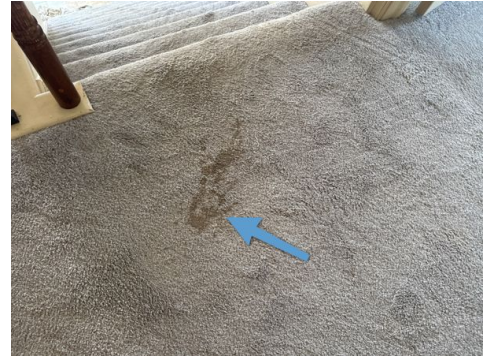
**CARPET STAINS**

Carpet had areas of staining or discoloration. A thorough steam cleaning by a qualified carpet cleaning company should be considered.

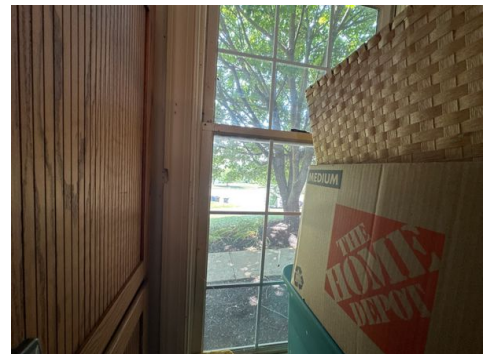
One or more window(s) will not stay open. This is a safety concern. The window(s) should be repaired.

Contact a qualified professional.

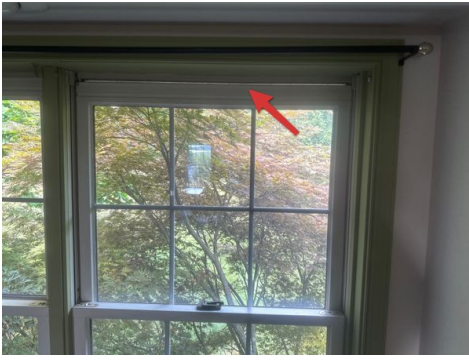
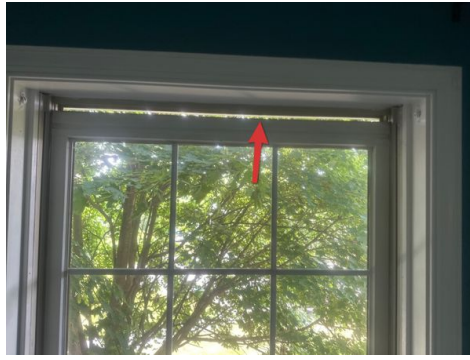
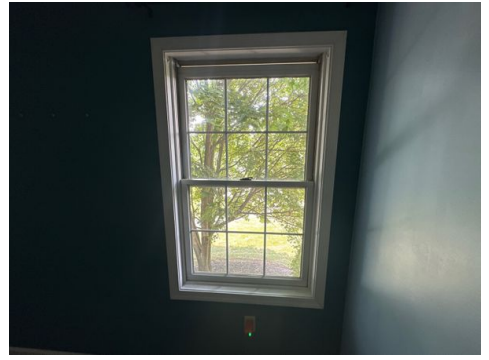
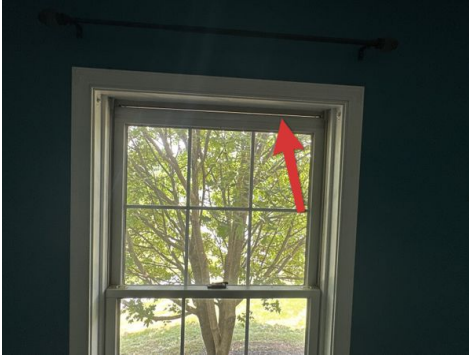
One or more of the upper sash(s) falls open when unlocked. This is a safety concern. The window(s) should be repaired.

Contact a qualified professional.

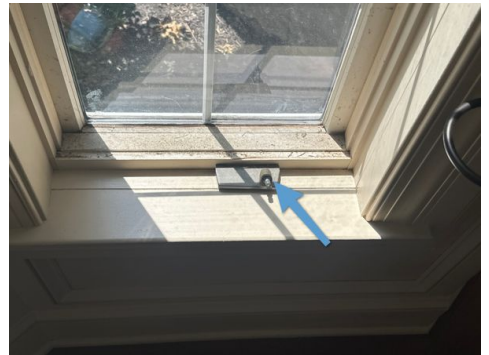
MISSING/LOOSE OR DAMAGED HARDWARE

One or more of the windows are missing, loose or have damaged hardware. Recommend further evaluation for repair or replacement.

Contact a qualified professional.

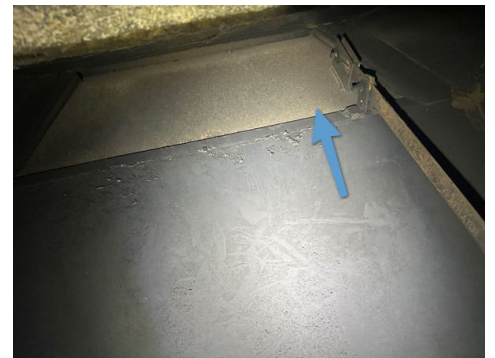
13.2.1 Fireplace Components

The damper was not functional or difficult to operate at the time of this inspection. You should have this further evaluated and repaired.

Contact a qualified professional.

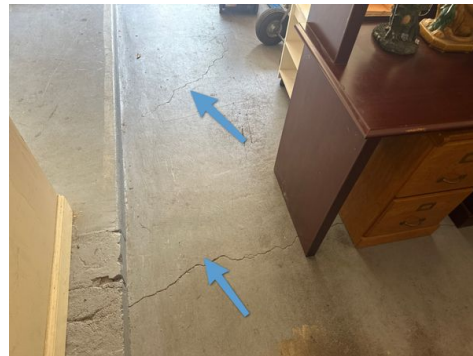
TYPICAL SETTLEMENT CRACKS

Typical settlement cracks were visible in the garage floor. The floor appeared serviceable at the time of this inspection.

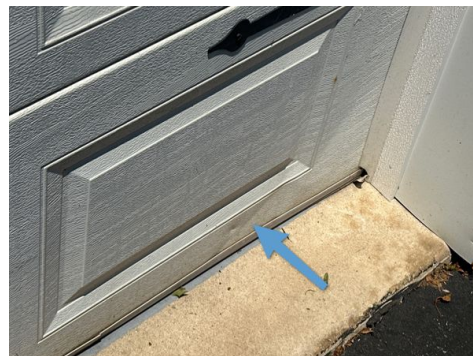
The panel is dented at some areas. You may consider repair.

Contact a qualified professional.
