RESIDENTIAL REPORT

1845 Lehigh Pkwy N
Allentown, PA 18103

05/09/2025

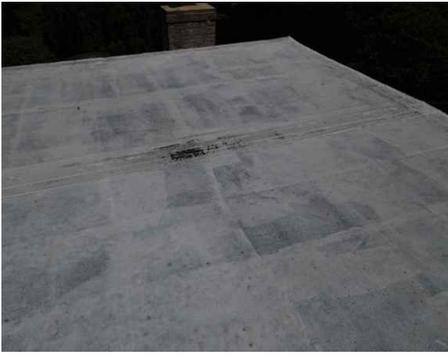
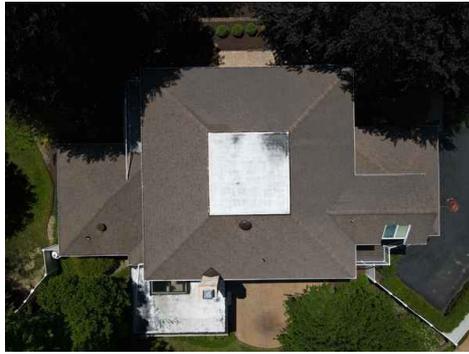
Roof Drainage Systems: Upper Roof Discharges onto Lower Roof

The upper downspouts are discharging onto the lower roof. This may cause premature wear to the roofing material. You may consider extending the downspouts to the lower gutter.

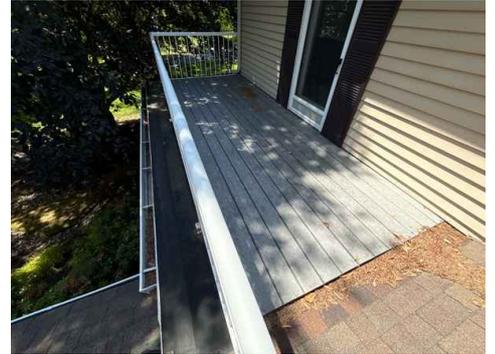
DECK OVER ROOFING

There is a deck installed over the flat roofing. We were unable to inspect the area beneath the decking.

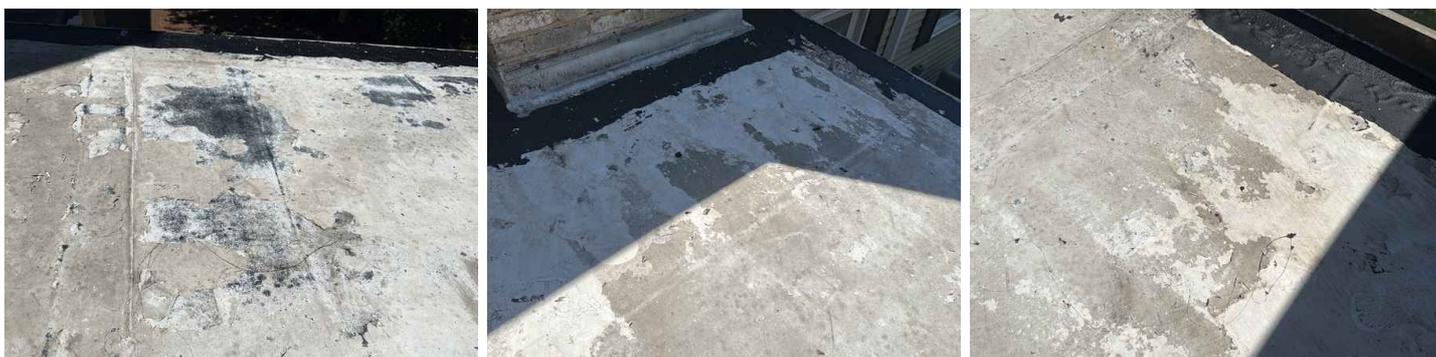
3.3.1 Flat Roof/Low Slope

ROOF COATING CRACKED OR DETERIORATED

The roof coating shows signs of cracking or deterioration. At some point this may allow moisture to penetrate the structure. You should have this further evaluated by a qualified roofing contractor and repair as needed.

Contact a qualified professional.

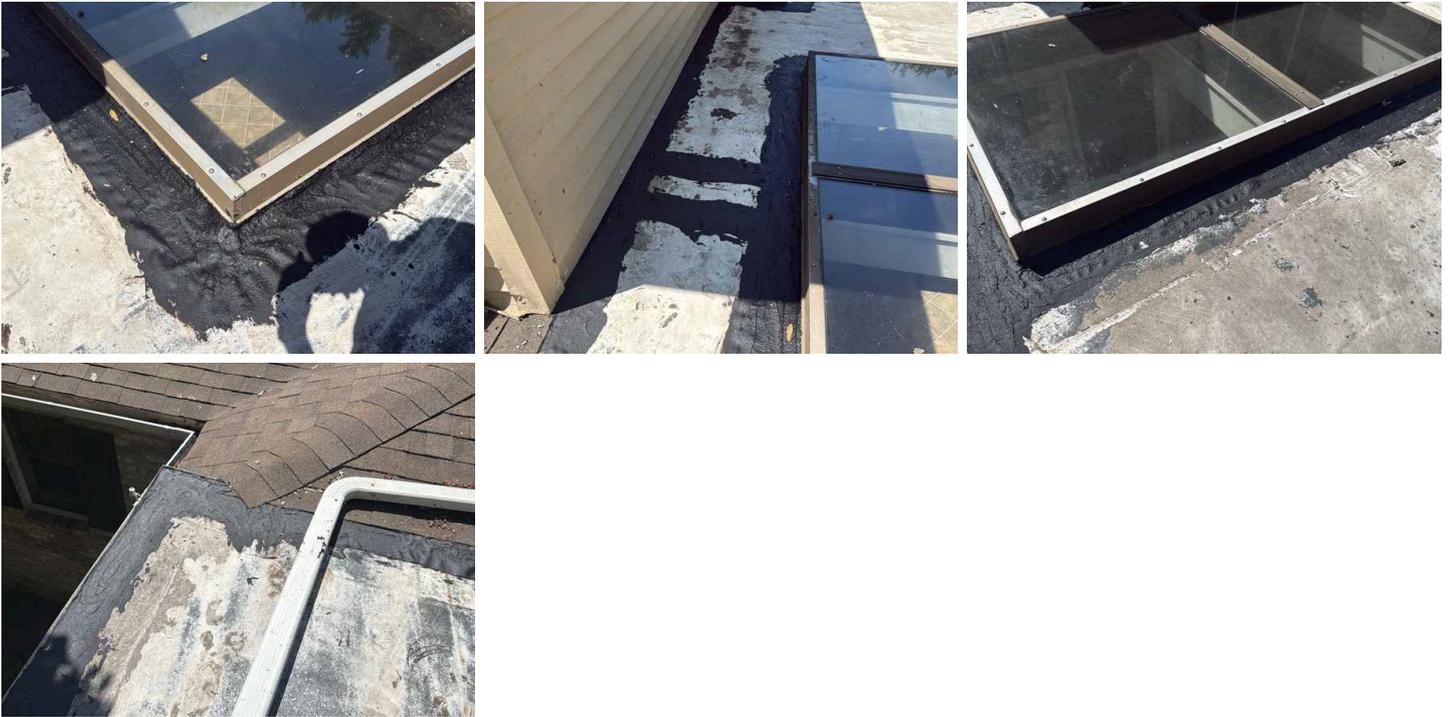
3.3.2 Flat Roof/Low Slope

PREVIOUS REPAIRS

The flat roof shows signs of previous repairs. The repairs appear to be done correctly. Extra attention for future leaks should be paid to this area during your time in the building.

Contact a qualified professional.

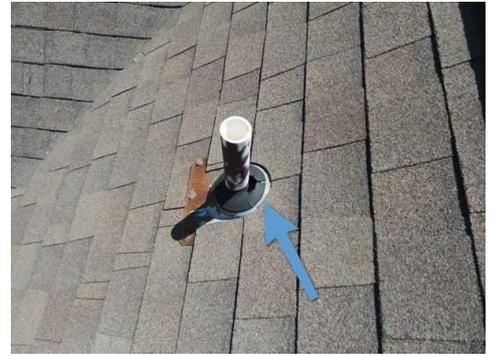
LOOSE/SEPARATED/DAMAGED

Flashings were observed to be loose, separated and or damaged. This can lead to water intrusion into the structure. Repair or replacement of the flashing is needed.

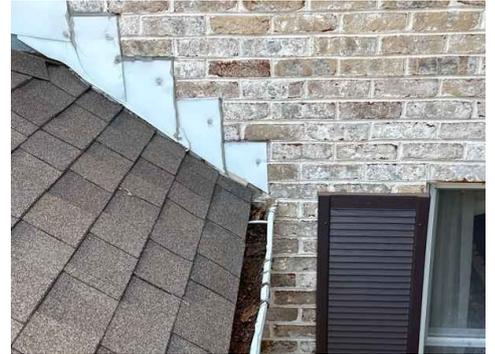
3.5.2 Flashings

KICK OUT FLASHING(S) MISSING

A kick out flashing(s) is missing where the gutter intersects with the siding. This type of flashing is designed to divert roof water run off into the gutter and not overflowing to the lower foundation area. You should consider having this installed.

Contact a qualified professional.

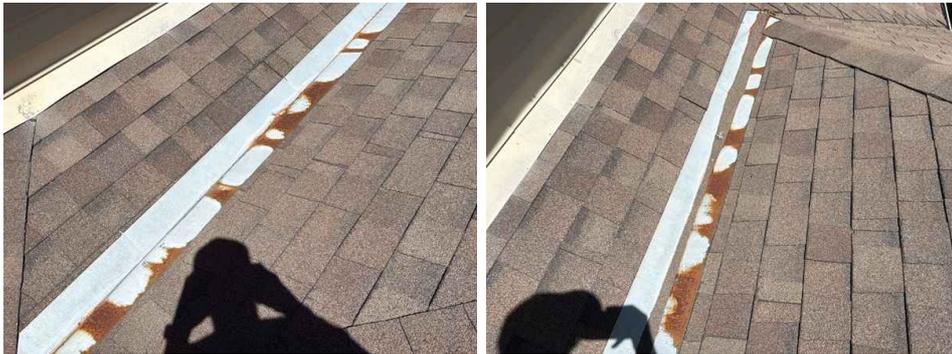
3.5.3 Flashings

CORRODED

Roof flashing showed signs of corrosion, but are still in working condition. Flashing should be monitored to prevent severe corrosion leading to moisture intrusion.

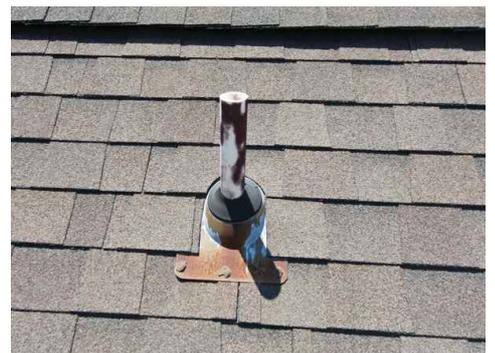
3.5.4 Flashings

RUSTED COLLAR FLASHING

The metal plumbing vent collar flashings are rusted. These will eventually begin to leak. There were no visible signs of leakage at the time of this inspection. You should monitor these areas or have them replaced as needed.

Contact a qualified professional.

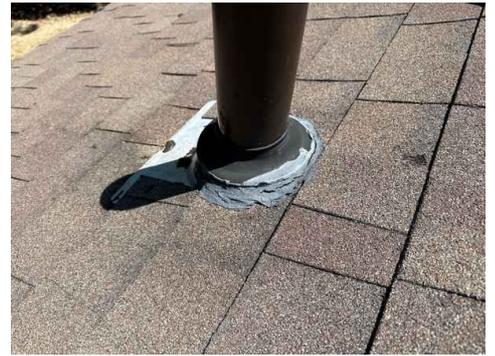
3.5.5 Flashings

PREVIOUS REPAIRS TO FLASHINGS

There has been previous repairs to the flashings which indicate heightened future maintenance and reduced further life.

Contact a qualified professional.

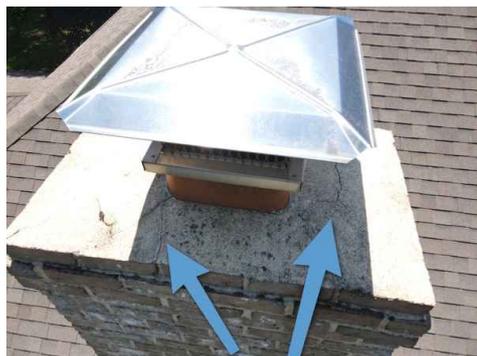
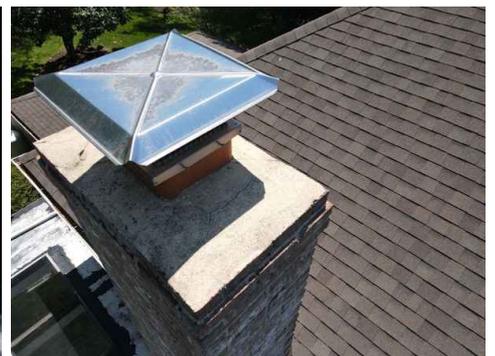
3.6.1 Chimney

CHIMNEY CROWN CRACKED OR DETERIORATED

The masonry cap or crown is cracked or deteriorated. This can allow water to penetrate and damage the structure. The cap should be repaired or replaced as needed.

Contact a qualified professional.

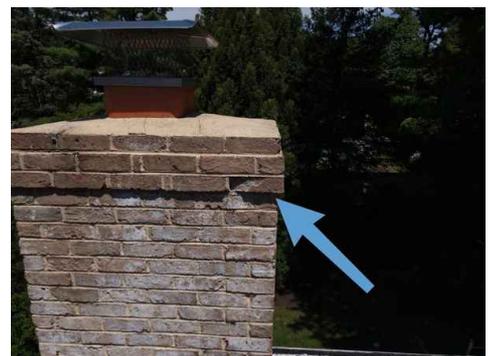
3.6.2 Chimney

CHIMNEY BRICK SPALLING

The brick shows signs of spalling or flaking. This appears to be due to age or moisture. Recommend further evaluation by a qualified contractor.

Contact a qualified professional.

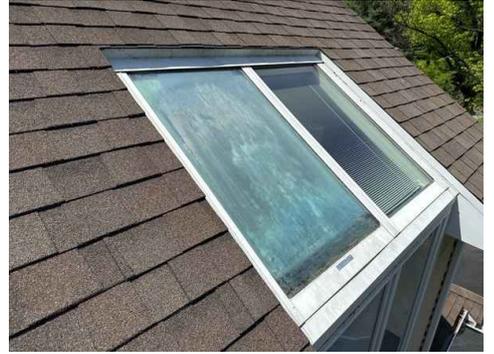
3.7.1 Skylights & Other Roof Penetrations

The double pane skylights are clouded or have condensation present. This typically indicates seal failure. You should consider further evaluation by a qualified contractor for repair or replacement of the stationary or operating sash.

Contact a qualified professional.

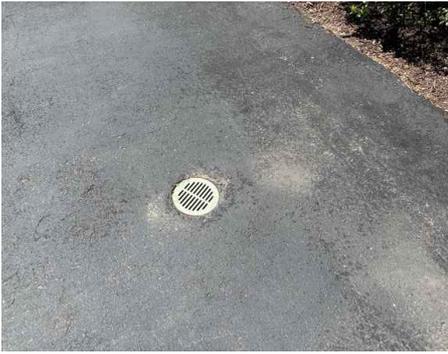
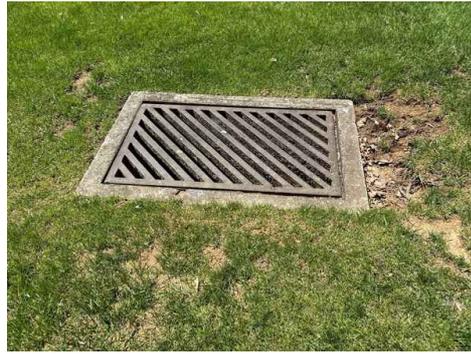
Vegetation, Grading & Drainage: Catch Basin or Surface Drainage

There is a catch basin or surface drainage on the property. Determining where the drainage system terminates is beyond the scope of this inspection.

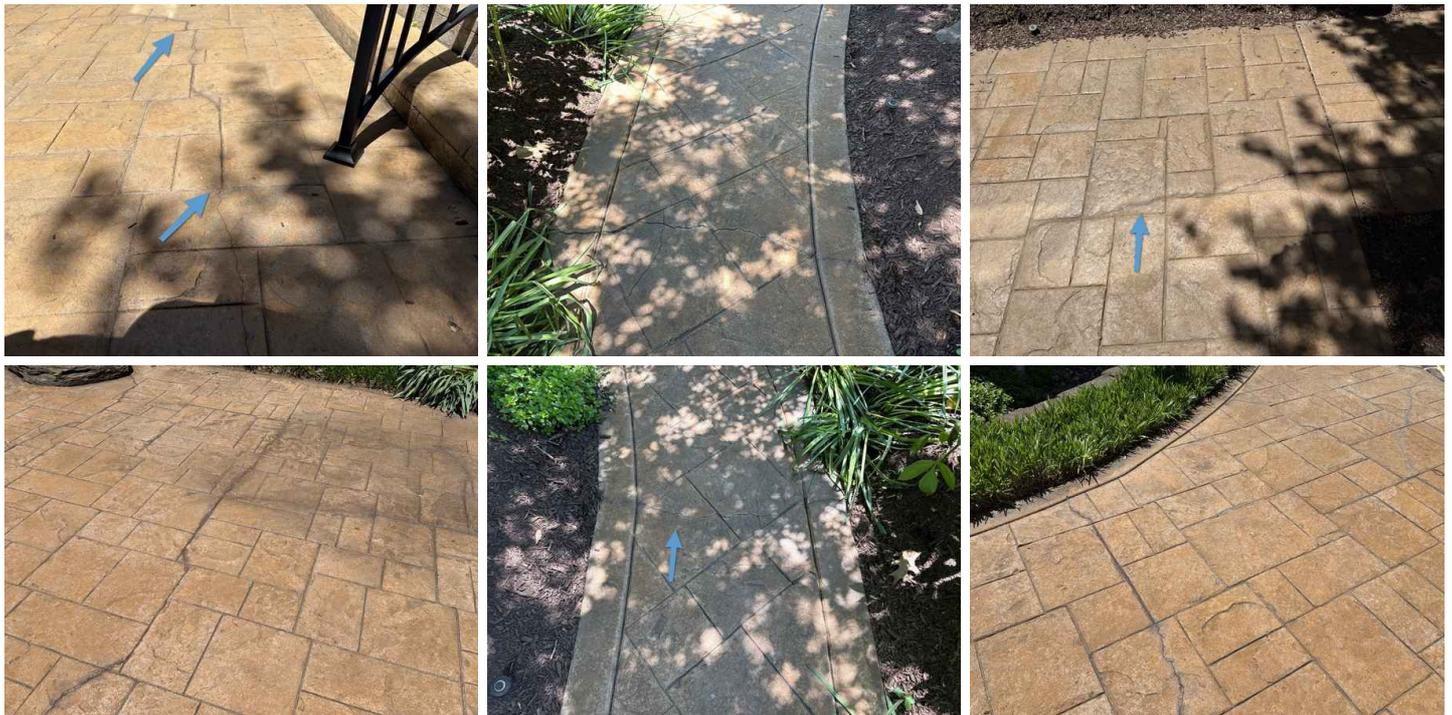
WALKWAY CRACKING

Cracks were observed. Recommend monitoring and/or patch/seal.

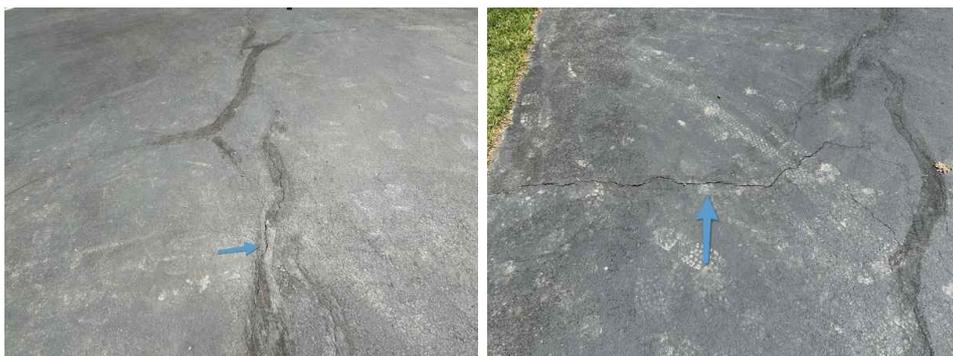
4.2.2 Walkways, Stoops, Steps, Patios & Driveways

DRIVEWAY CRACKING

Cracking was observed. Recommend monitoring and/or have contractor patch/seal.

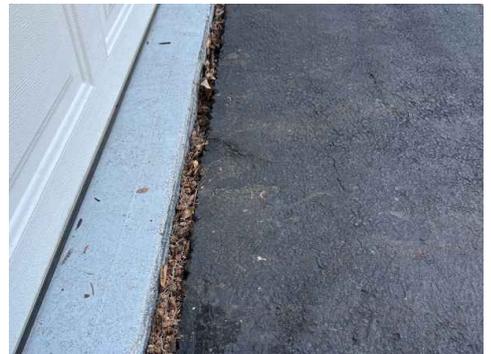
SEAL MISSING/DETERIORATED AT GARAGE

The seal at the driveway and garage connection should be replaced to prevent water intrusion and cracking from freeze thaw cycle.

Contact a qualified professional.

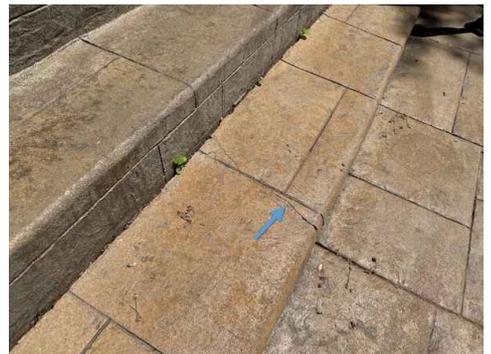
4.2.5 Walkways, Stoops, Steps, Patios & Driveways

STOOP/STAIRS CRACKING

The front stoop/stairs are cracking. You should monitor this area and repair as needed.

Contact a qualified professional.

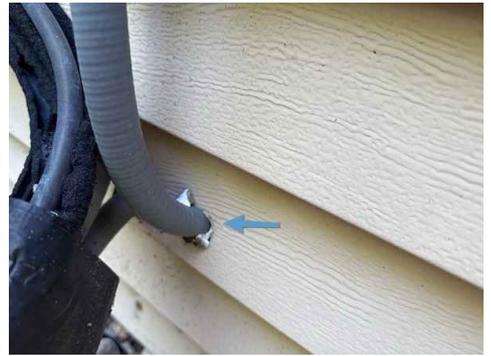
Caulking is missing where the utility lines or piping enter through the exterior wall. Moisture, pests or insects intrusion is possible. These areas should be caulked with appropriate caulking material.

Contact a qualified professional.

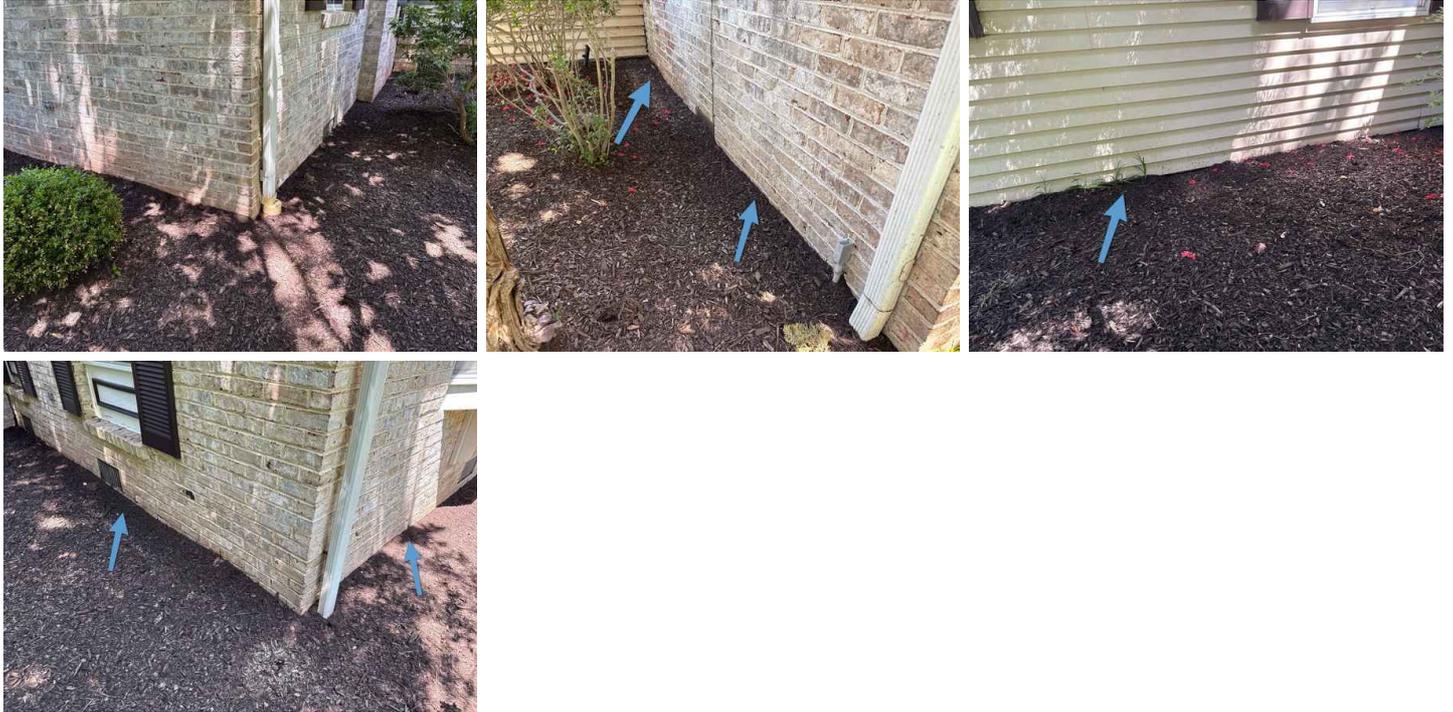
4.4.3 Siding

MULTIPLE LOCATIONS

Inadequate clearance between siding and ground. Recommend a minimum ground clearance between the bottom of siding and ground of approximately 3 to 4 inches to allow for an air space behind the siding. Siding in contact with the ground or soil can be a concern because the condition can provide direct access for wood destroying insects.

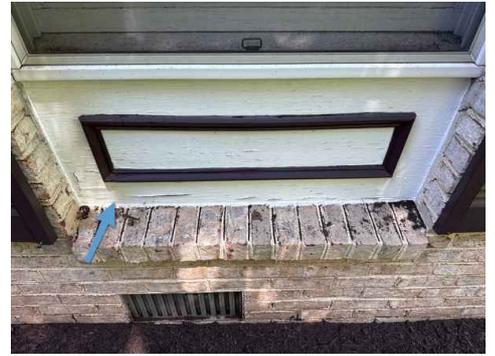
4.7.1 Windows

DETERIORATED PAINT

The paint is missing or deteriorating. You should have the windows finished or painted to ensure protection from the weather.

Contact a qualified professional.

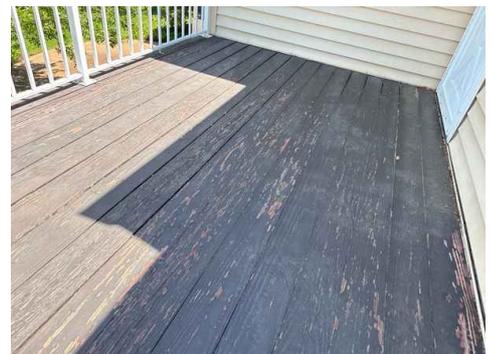
4.8.2 Decks, Balconies, Porches & Steps

STAIN/PAINt NEEDED

The wood finish is deteriorating. You should stain or paint the decking with the appropriate decking finish.

Contact a qualified professional.

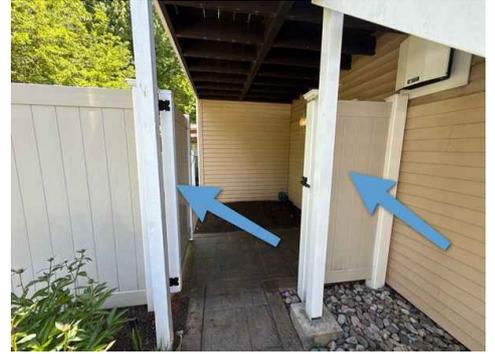
The support appear to be undersized for the elevation of the deck. Recommend further evaluation by qualified contractor.

Contact a qualified professional.

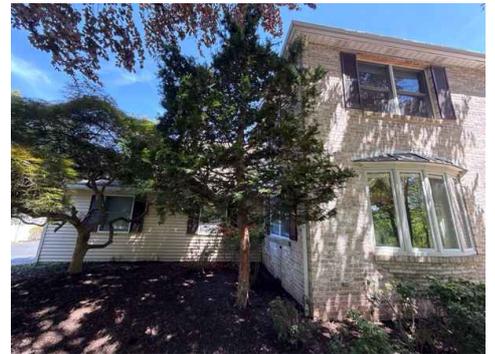
4.10.1 Vegetation, Grading & Drainage

The trees or bushes are close or touching the dwelling. This can retain moisture at the siding areas which may allow for mold/mildew. You should trim these areas back to allow for proper air flow.

Contact a qualified professional.

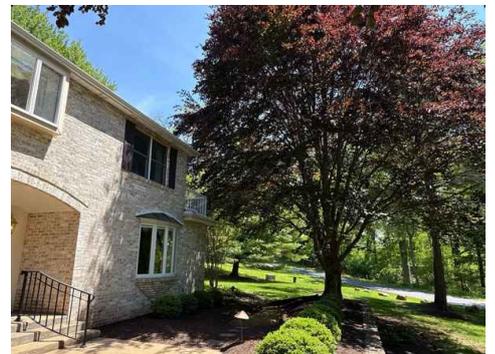
4.10.2 Vegetation, Grading & Drainage

TREE OVERHANG

Tree's were observed overhanging the roof. This can cause damage to the roof and prevent proper drainage. The overhang should be trimmed back to allow for proper drainage and deter possible damage.

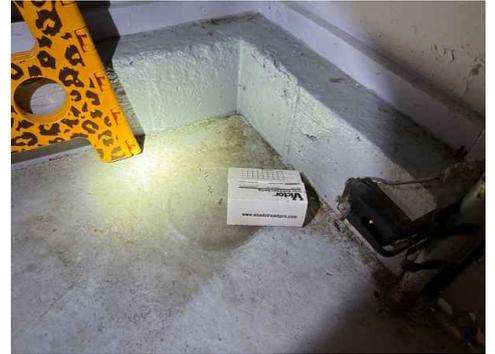
4.11.2 Pest Indications

CURRENT PEST TREATMENT PRESENT

There are signs of current treatment for pests. We recommend that you continue this treatment.

Contact a qualified professional.

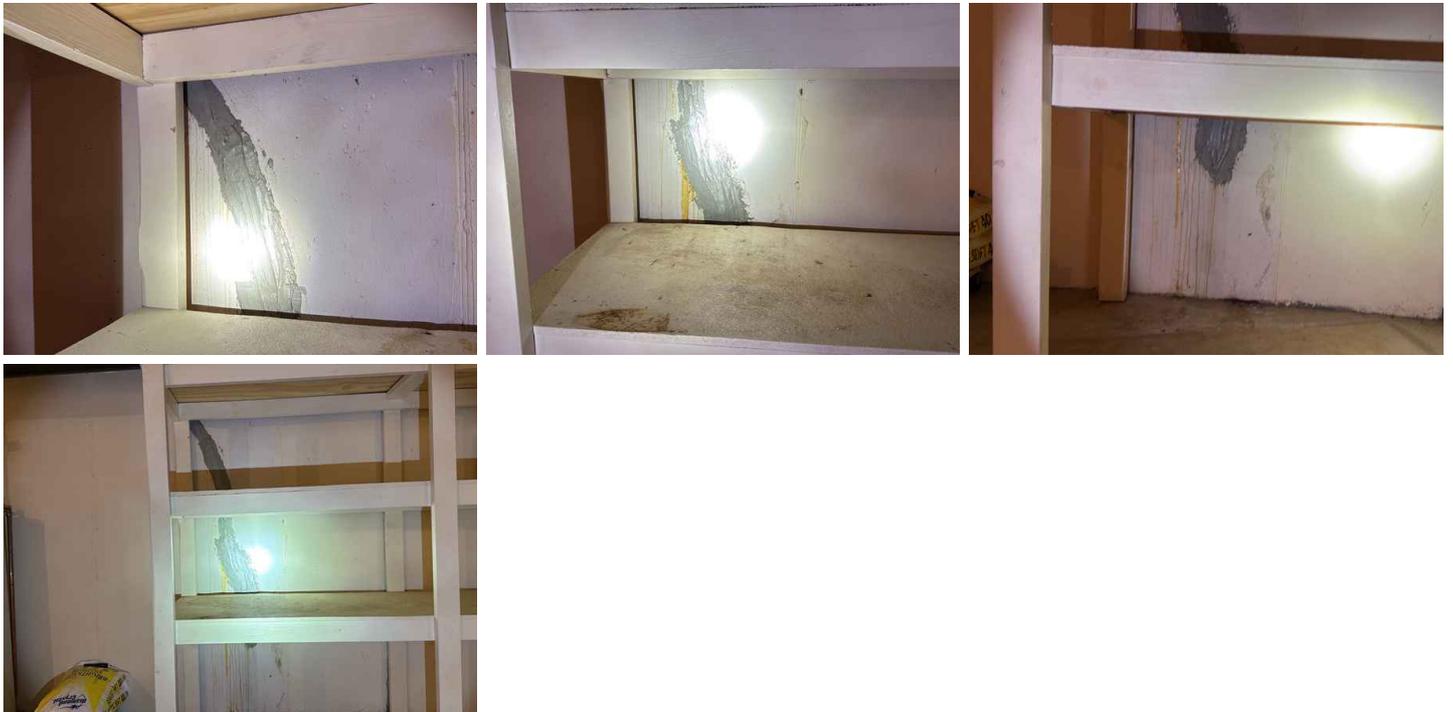
5.2.1 Foundation

**FOUNDATION CRACKS SEALED**

There are previous cracks in the wall which have been sealed with epoxy or a concrete surface patch. These are typical repair methods and are effective in reducing moisture entry. There was no active leakage at the time of this inspection. You should monitor these areas for any new cracking or leakage and repair as needed.

Recommendation

Contact a qualified professional.

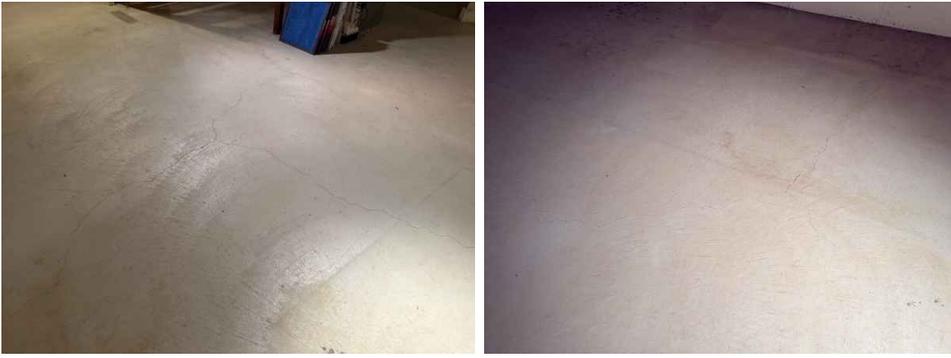
5.3.1 Floor Structure

**TYPICAL SETTLEMENT CRACKING**

There is typical settlement cracking in the basement concrete floor.

Recommendation

Contact a qualified professional.

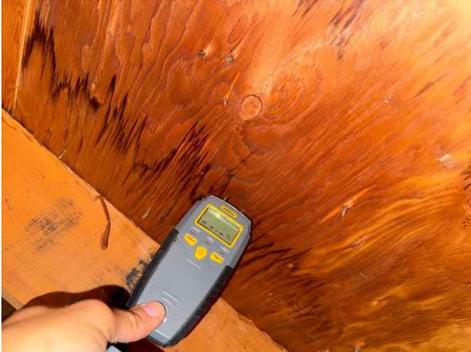
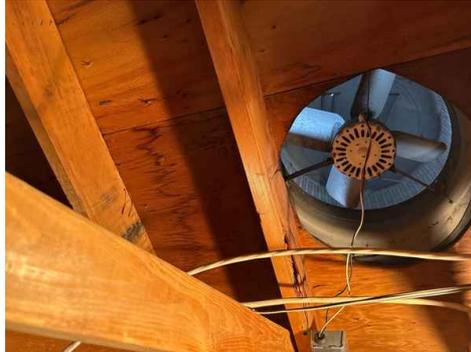
**STAINS TESTED AND DRY 2**

There were stains that were tested and appeared to be dry at the time of this inspection. This appears to be from a previous water leak that was not active. You should monitor the area(s).

Recommendation

Contact a qualified professional.

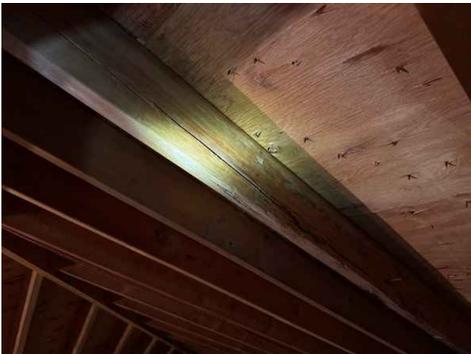
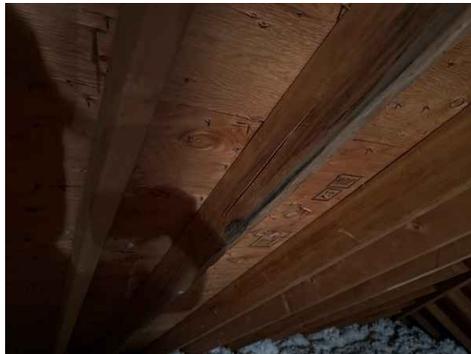
5.6.3 Roof Structure

There are split wood rafter(s) present. This weakens the structure. In most cases the rafter(s) can be sistered for support. Recommend further evaluation by a qualified contractor.

Recommendation

Contact a qualified professional.

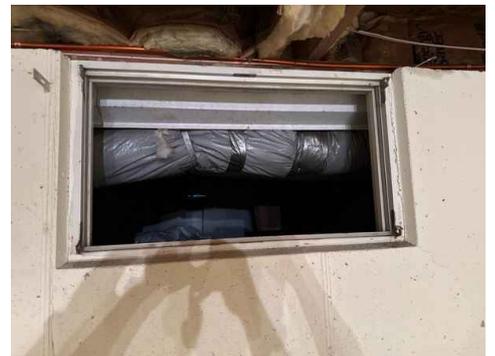
ACCESS LIMITED

Access to the crawlspace was limited or unsafe. Lack of full access restricted the ability to inspect for hidden damage, concerns or safety issues.

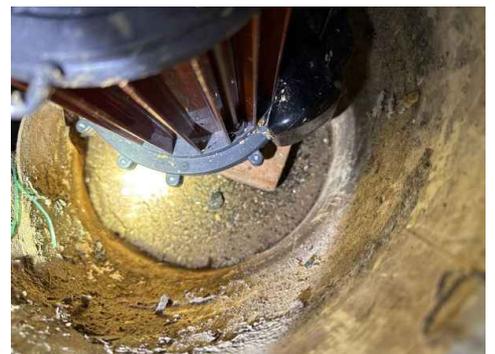
Sump Pump(s)

SUMP NOT TESTED DRY PIT

The sump pump was not tested due to the pit being dry. Testing a pump dry can cause damage to the pump.

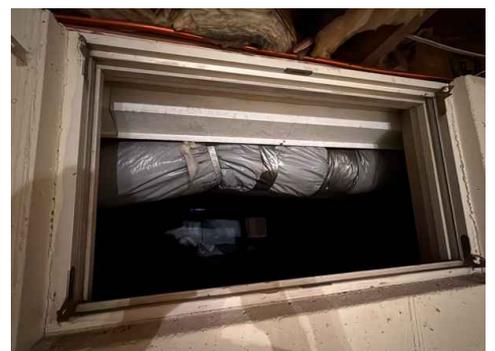
LIMITED ACCESS

There was circumstances at the time of the inspection that limited safe access to the crawlspace for complete evaluation.

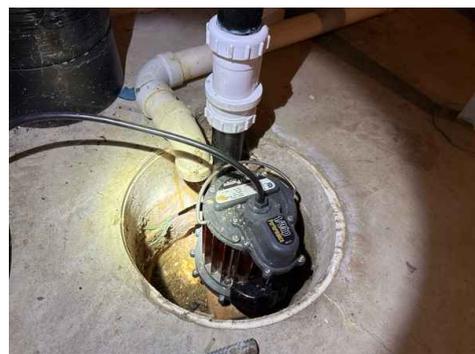
COVER MISSING

The sump pump cover is missing. This is a safety concern. You should install a cover.

Recommendation

Contact a qualified professional.

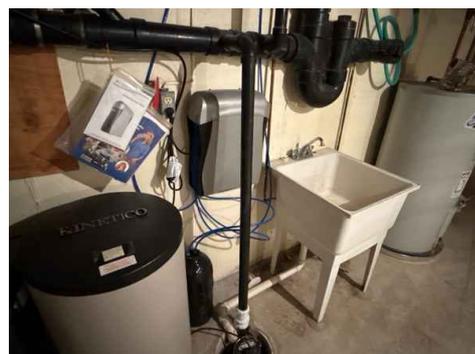
6.3.2 Sump Pump(s)

SUMP PUMP DISCHARGE/SEWER

The sump pump discharges into the sewer. This is not recommended. The water should be discharged to the exterior side of the dwelling.

Recommendation

Contact a qualified professional.

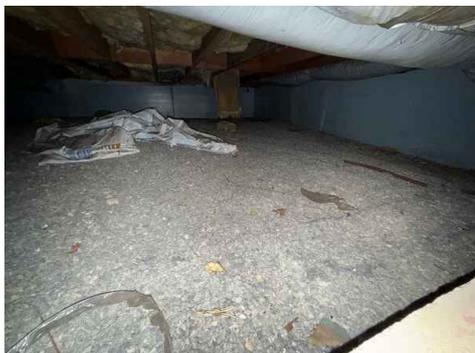
6.4.1 Vapor Retarders (Crawlspace or Basement)

NO VAPOR BARRIER

There is no vapor barrier beneath the flooring. This can result in unwanted moisture.

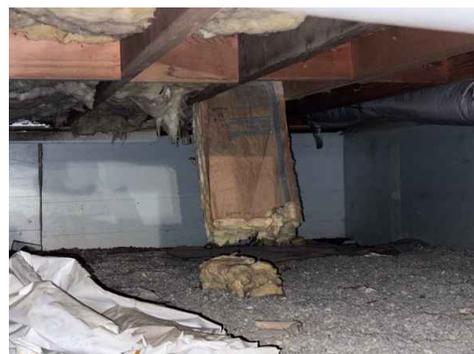
LOOSE OR FALLEN

Some of the insulation is loose or fallen. You should repair or replace any areas needed.

Recommendation

Contact a qualified professional.

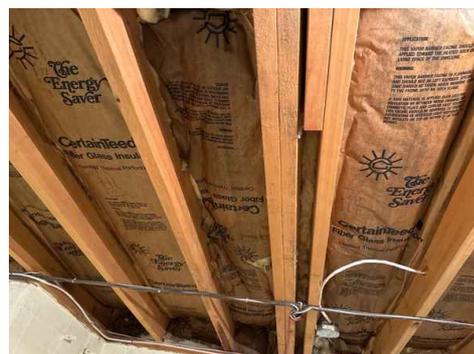
6.7.2 Insulation

The vapor barrier faces the basement. This may allow moisture to be trapped in the insulation. You may consider removing the paper vapor barrier or cutting small slits to allow for air movement.

Recommendation

Contact a qualified professional.

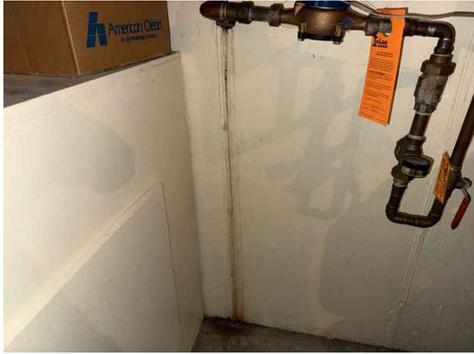
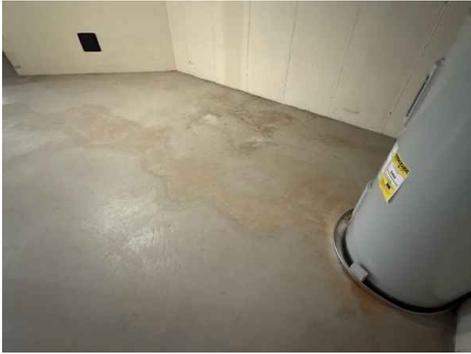
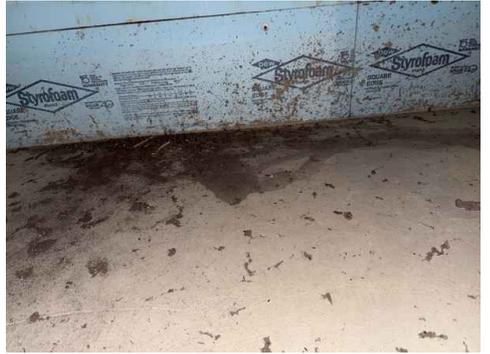
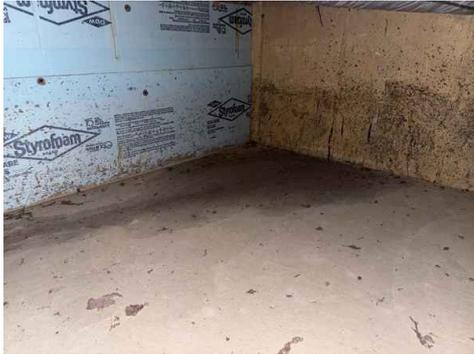
6.8.1 Moisture

STAINS

There is past or present stains. This is an indication of previous moisture entry. You should monitor the areas.

Recommendation

Contact a qualified professional.

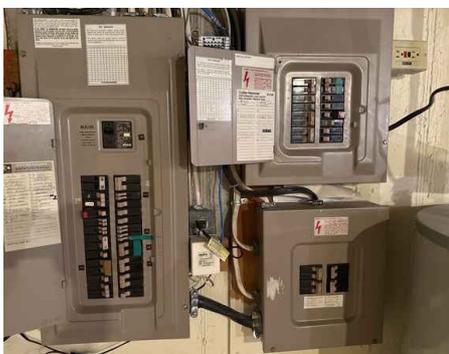
Main & Subpanels & Main Overcurrent Device: No additional room for expansion

There is no room for additional breakers inside the panel. If you need additional breakers you will need an additional subpanel or a larger panel box.

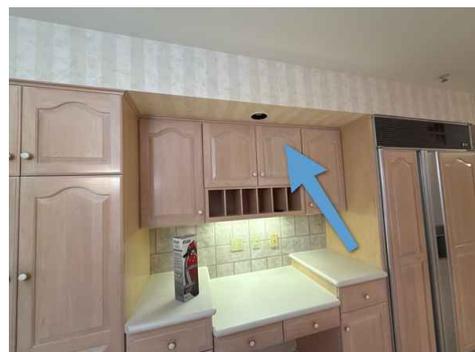
7.6.1 Lighting Fixtures, Switches & Receptacles

BULBS MISSING/BURNED OUT

There is missing and or burned out bulbs. Replacement is recommended.

Recommendation

Contact a qualified professional.

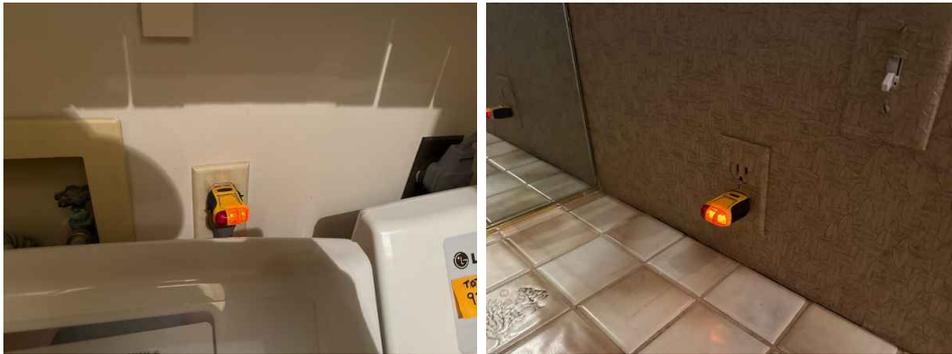
7.7.1 GFCI/AFCI

GFCI OUTLET(S) MISSING

GFCI outlet(s) missing at recommended area(s). You should have GFCI outlets installed to avoid possible injury.

Recommendation

Contact a qualified professional.

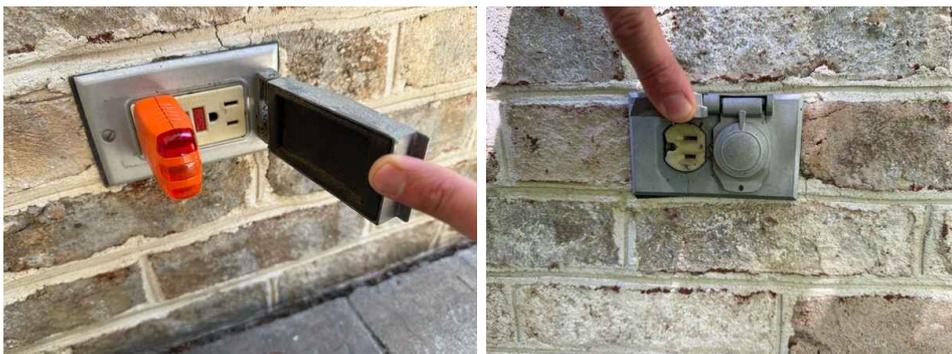
7.7.2 GFCI/AFCI

RECEPTACLES NOT WEATHERPROOF WHEN IN USE

The exterior covers may not be fully weather proof when in use or missing covers. You should have the covers updated to the current standard.

Recommendation

Contact a qualified professional.

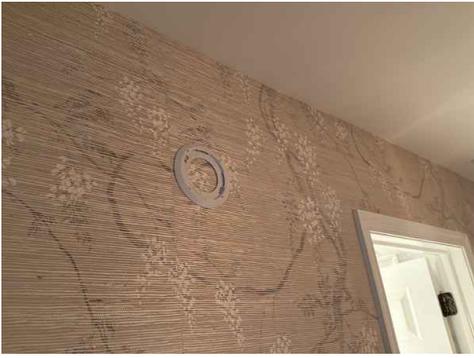
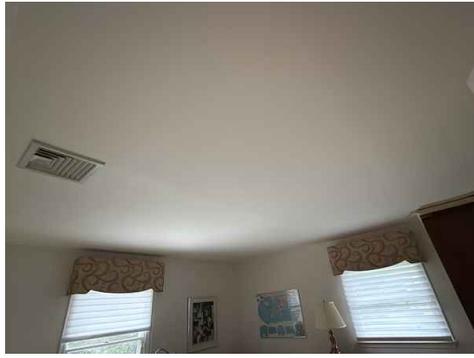
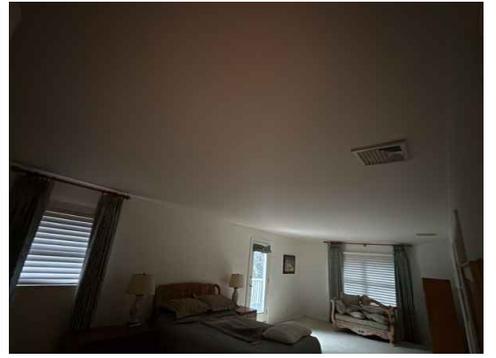
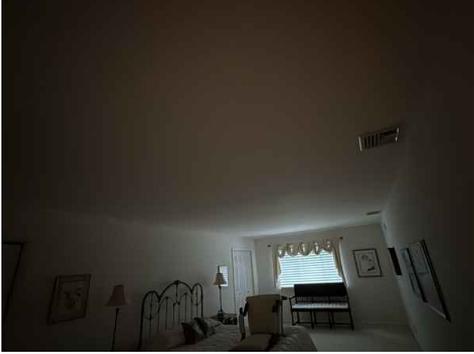
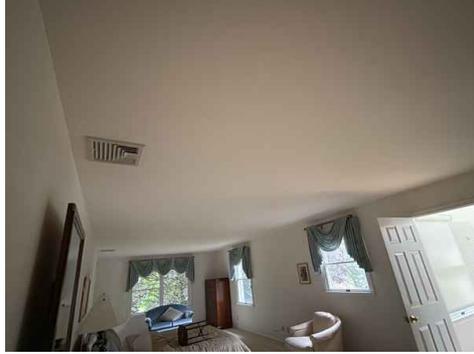
7.8.1 Smoke Detectors

MISSING SMOKE DETECTORS

Some smoke detectors were missing at the time of this inspection. This is a safety concern. Smoke alarms should be installed at all appropriate locations according to current safety standards.

Recommendation

Contact a qualified professional.

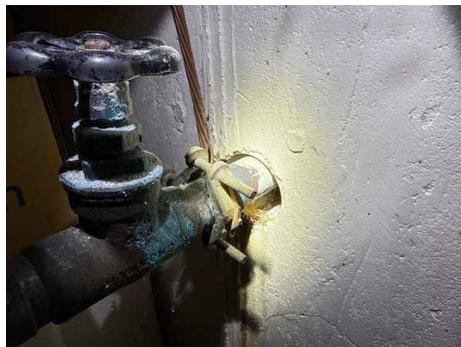
Water Supply, Distribution Systems & Fixtures: Water Supply Material

Copper

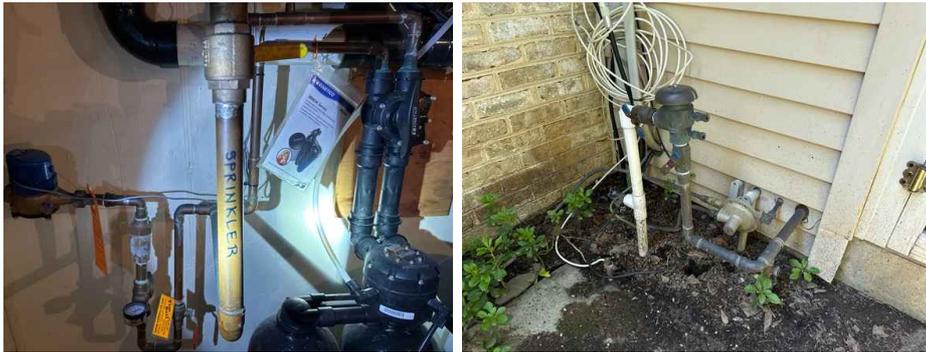
General: Lawn Irrigation (NOT INSPECTED)

There is a below grade sprinkling system present. Inspection of this type of system is beyond the scope of this inspection. If further evaluation is necessary, you should have this further evaluated by a qualified professional in this field.

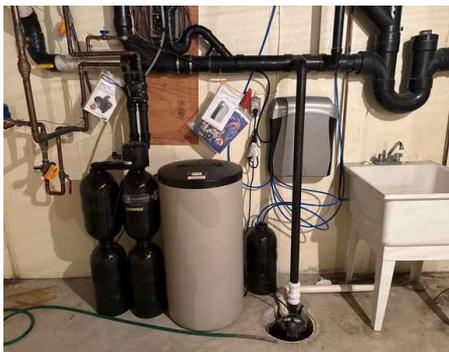
Water Supply, Distribution Systems & Fixtures: Water Treatment Equipment Installed

There is a treatment system installed. These are beyond the scope of this inspection. You should contact the owner for further information or a service company they may use.

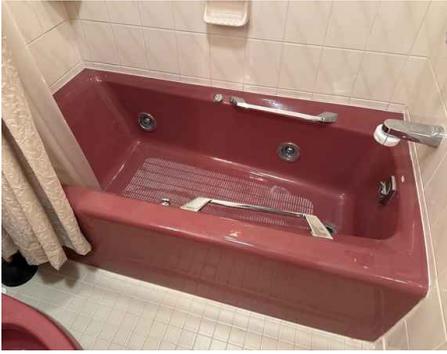
Not Tested - Pop Up Missing

The Jacuzzi was filled and operated. All areas were functional at the time of this inspection.

The jacuzzi tub pop up drain control is missing. Due to this the tub could not be filled and tested. Recommend to have a qualified plumber repair and fully evaluate.

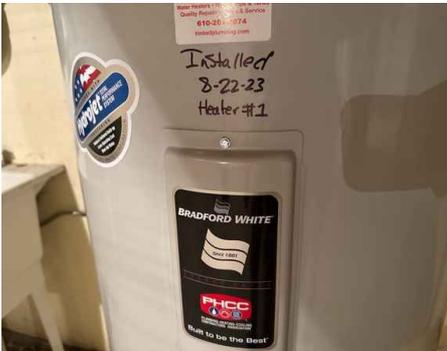
**Hot Water Systems: Manufacturer**

Bradford & White

We recommend flushing & servicing your water heater tank annually for optimal performance. Water temperature should be set to at least 125 degrees F to kill microbes and no higher than 130 degrees F to prevent scalding.

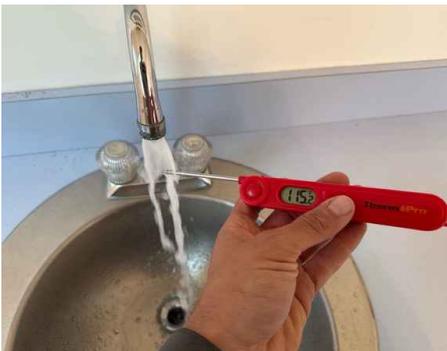
**Hot Water Systems: Functional**

The water heating system was tested at various areas. The hot water heating system was functional at the time of this inspection.

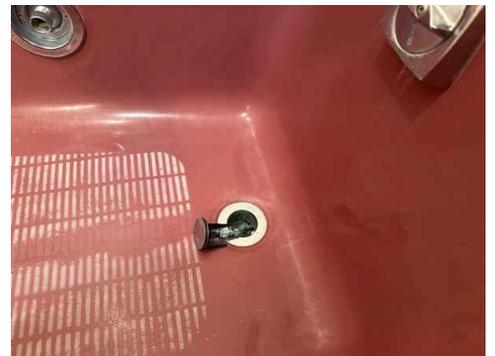
Sinks/Tubs/Showers/Toilets

JACIZZI TUB NOT TESTED

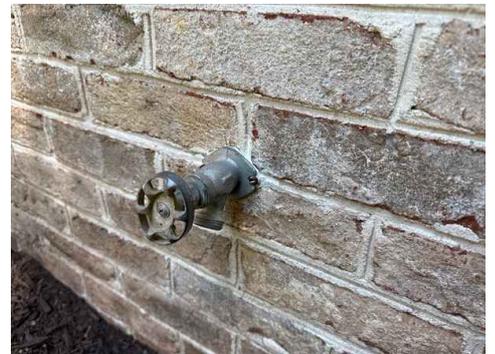
Hose Bibs

HOSE BIB SHUT OFF

There is a hose bib that has been shut off or is abandoned. The bib(s) could not be tested at the time of this inspection. The bib(s) should be active at your final walk through.

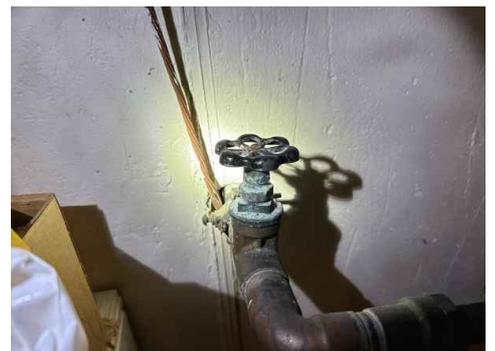
There is an old style gate valve at the main shut off. These have a tendency to leak after using the gate valve. Consider having a ball valve shut off on hand to replace the gate valve, if you ever need to use it.

Contact a qualified professional.

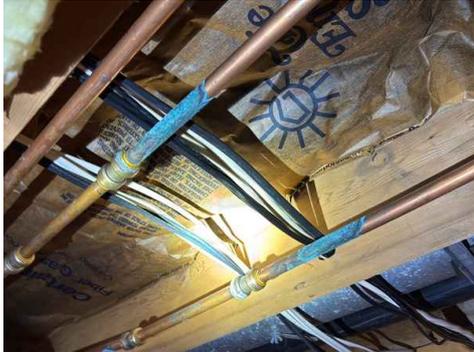
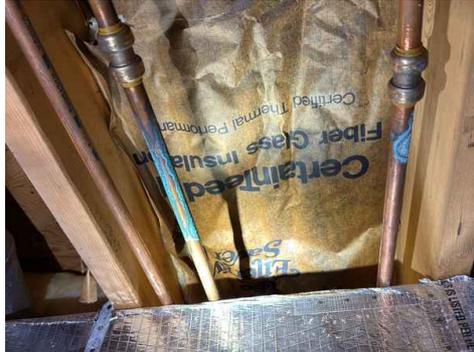
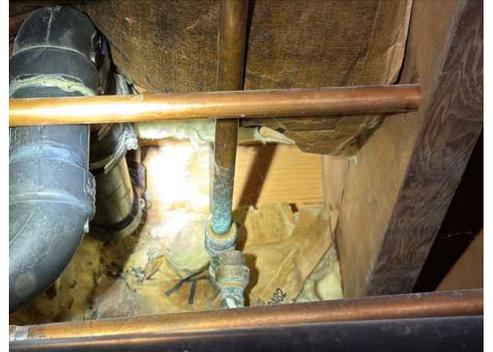
8.3.1 Water Supply, Distribution Systems & Fixtures

CORRODED VALVES/FITTINGS AND/OR PIPES

Some of the water supply valves, fittings and/or pipes are corroded. Recommend to have a qualified plumber further evaluate and follow their recommendations.

Contact a qualified professional.

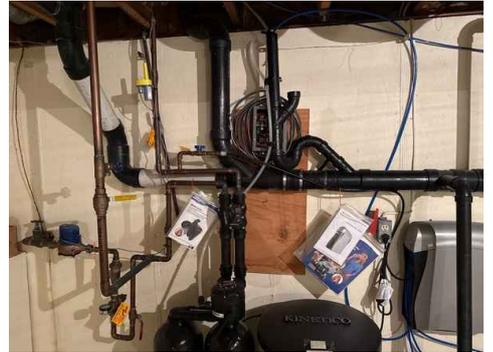
8.4.1 Drain, Waste, & Vent Systems

AIR GAP MISSING

Contact a qualified professional.

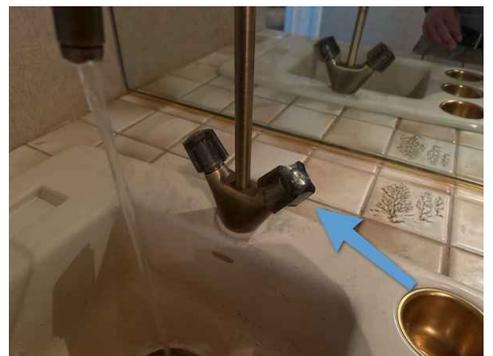
8.5.1 Sinks/Tubs/Showers/Toilets

HANDLE DIFFICULT TO OPERATE

The faucet is stuck or difficult to operate. This should be repaired by a qualified plumber.

Contact a qualified professional.

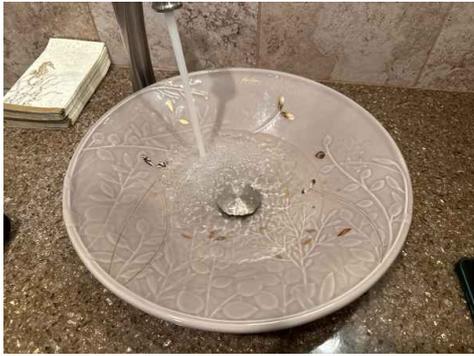
8.5.2 Sinks/Tubs/Showers/Toilets

SLOW DRAIN

Contact a qualified professional.

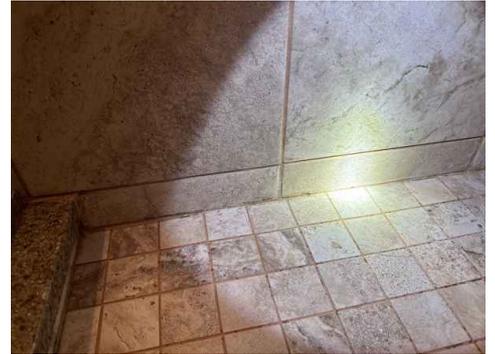
8.5.3 Sinks/Tubs/showers/Toilets
CAULK/GROUT LOOSE OR MISSING

The caulking or grout is loose or missing. This area should be maintained to deter moisture entry.

Contact a qualified professional.

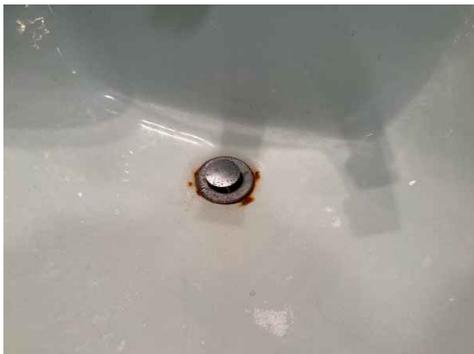
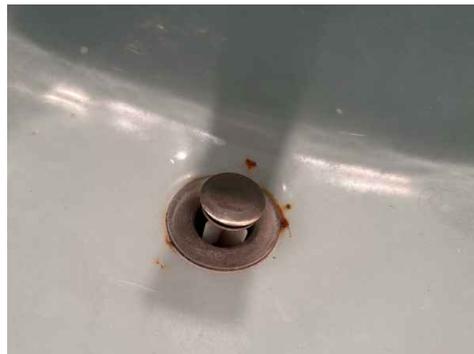
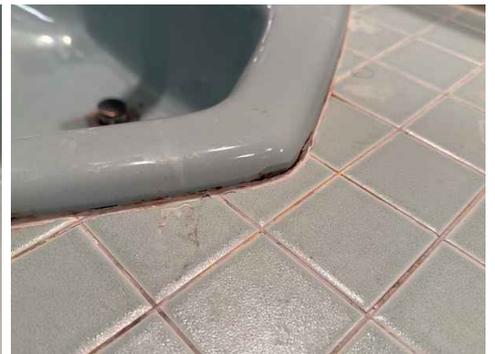
8.5.4 Sinks/Tubs/showers/Toilets
RUST/DAMAGE AT THE SINK

There is rust and/or damage at the sink. This could lead to leakage or further damage. Recommend to have a qualified contractor further evaluate and follow their recommendations.

Contact a qualified professional.

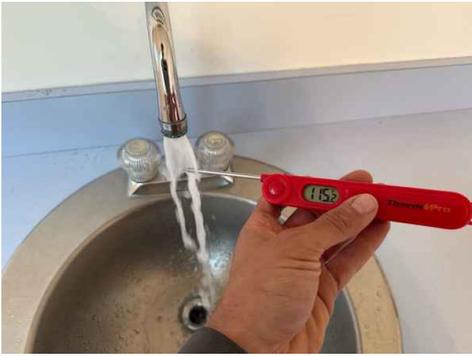
8.6.1 Hot Water Systems
LOW TEMP

The hot water is not reaching the recommended temperature of 125 degrees. This should be further evaluated by a qualified plumber.

Contact a qualified professional.

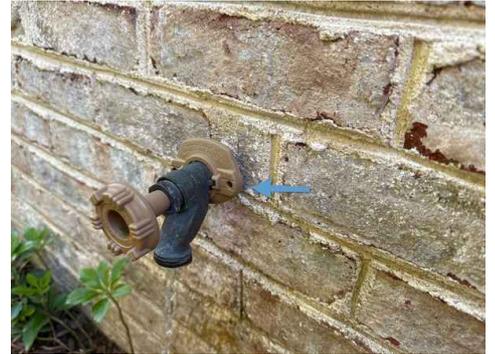
8.9.1 Hose Bibs

NOT FASTENED AT WALL

Contact a qualified professional.

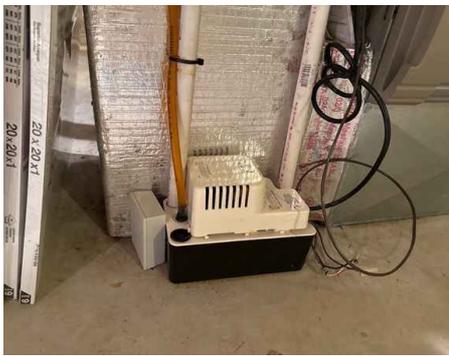
**Interior A/C Unit/Handler: Condensate Pump**

The indoor unit cooling coil drains into a condensate pump. Testing or evaluation of this is beyond the scope of this inspection. The pump appeared serviceable at the time of this inspection.

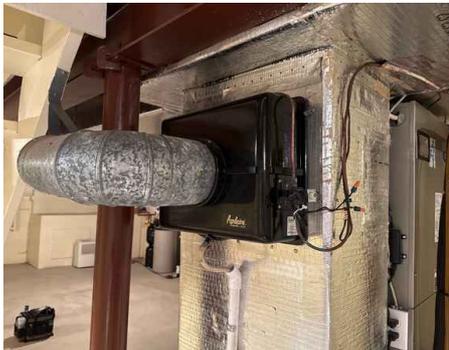
**Interior A/C Unit/Handler: Humidifier Present**

There is a humidifier installed at the interior unit. These supply moisture to the air. These are beyond the scope of this inspection. You should follow the manufactures instructions for maintenance.

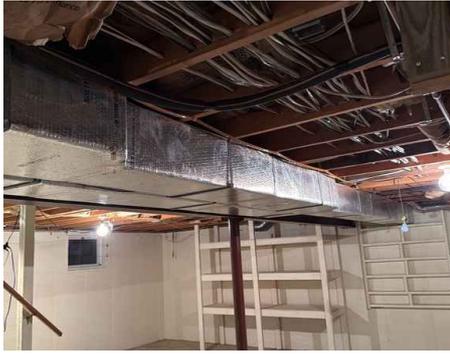
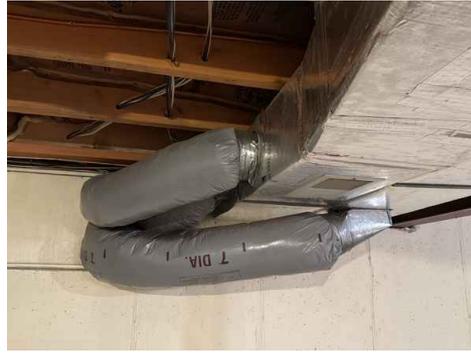
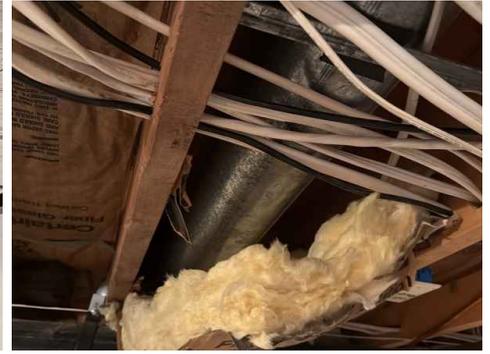
Distribution System : Duct/Materials

Flexible, Insulated, Non-Insulated, Metal, Rigid Fiberglass

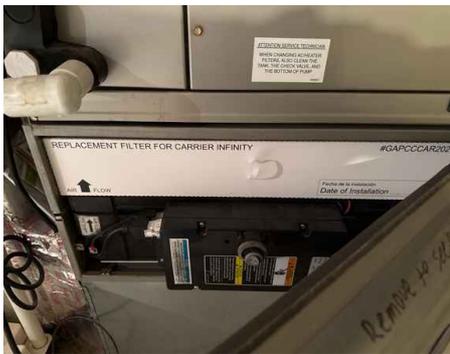
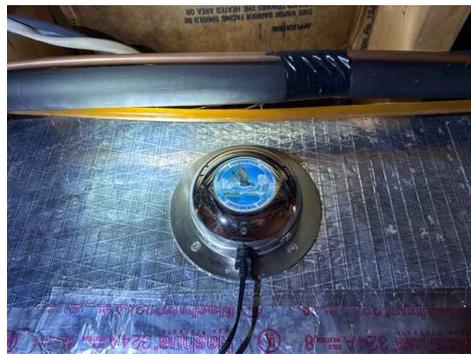
Air Filter(s): Type

High Efficiency, Electronic Air Cleaner, UV Light

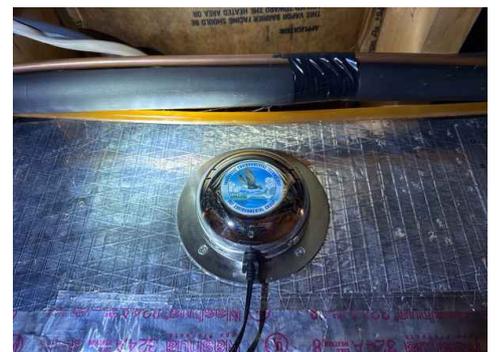
UV LIGHT - NOT TESTED

There is a UV light present. Testing of these is beyond the scope of this inspection.
