RESIDENTIAL REPORT

1845 Lehigh Pkwy N
Allentown, PA 18103

05/09/2025

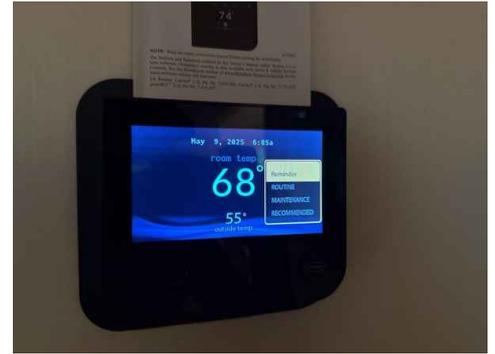
9.2.1 Heat Pump

SERVICE RECOMMENDED

Recommendation

Contact a qualified professional.

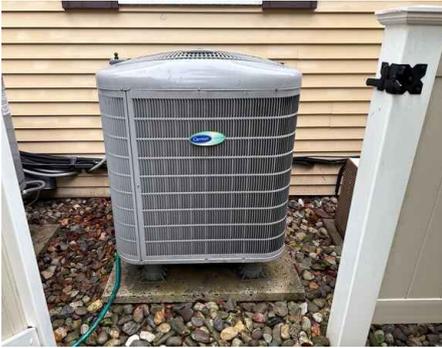
Heat Pump: Brand
Carrier

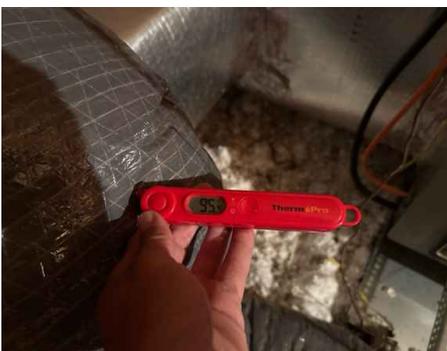
Functioned when tested

The heat pump was tested and appeared to be functional at the time of this inspection.

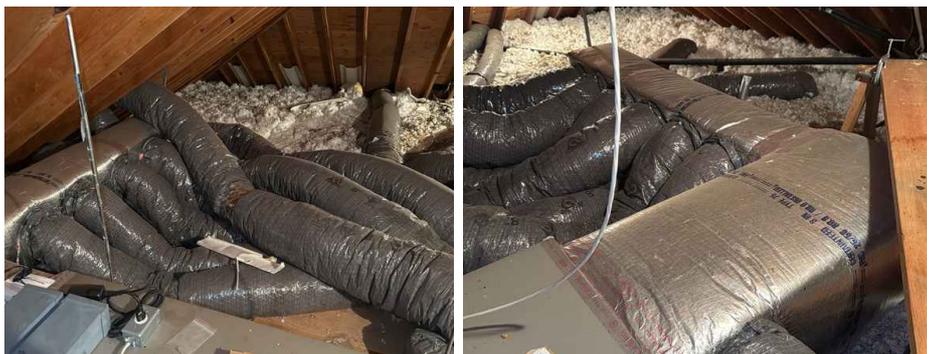
Distribution System : Duct/Materials

Metal, Flexible, Insulated

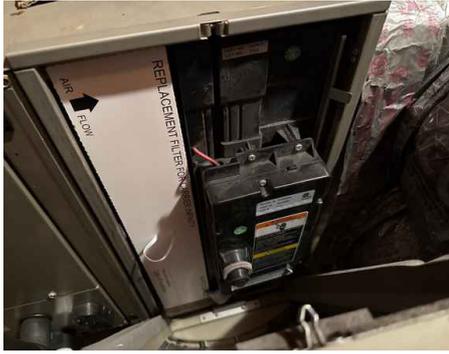
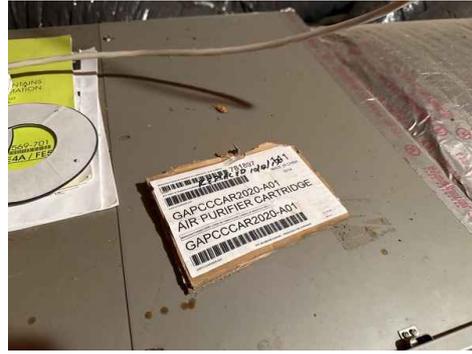
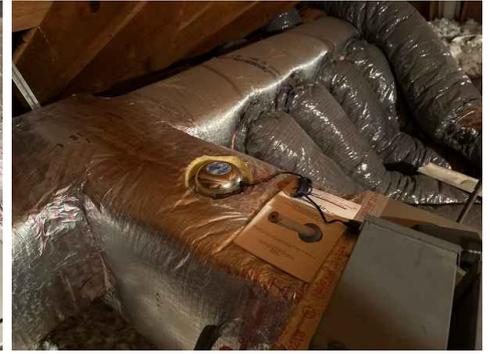
Air Filter(s): Type

High Efficiency, Electronic Air Cleaner, U/V Light

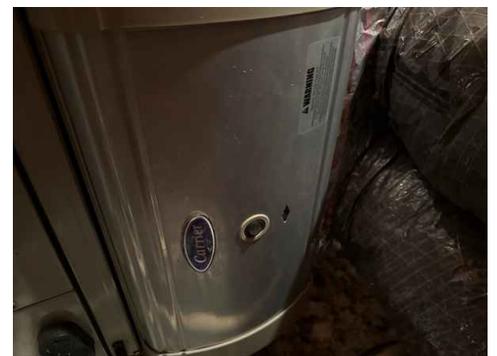
ELECTRONIC AIR CLEANER - NOT TESTED

There is an electronic air cleaner present. Testing of these is beyond the scope of this inspection.

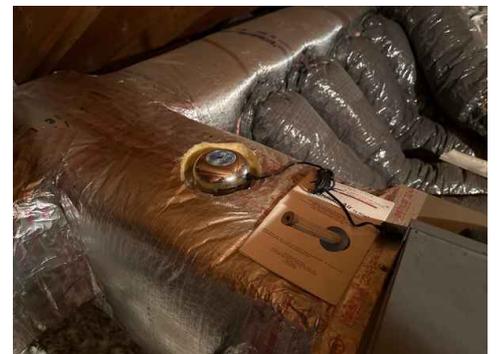
UV LIGHT - NOT TESTED

There is an UV light present. Testing of these is beyond the scope of this inspection.

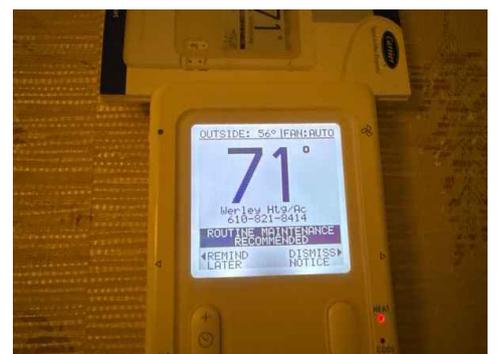
10.2.1 Heat Pump

SERVICE RECOMMENDED

Recommendation

Contact a qualified professional.

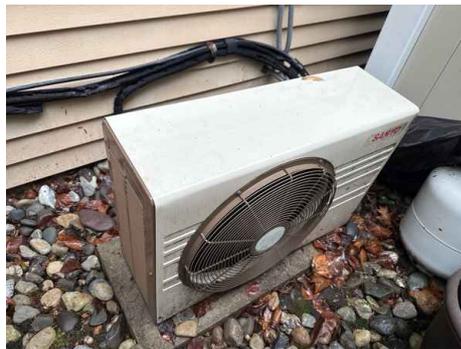
Exterior A/C Unit: Brand
Sanyo

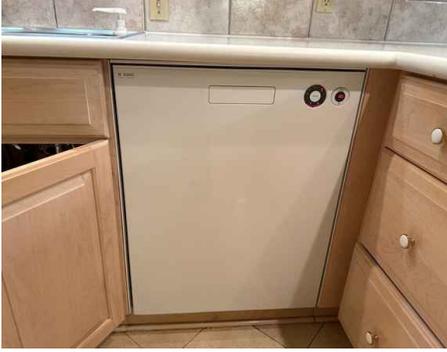
Dishwasher: Functional

The dishwasher was tested in a short cycle and was functional at the time of this inspection.

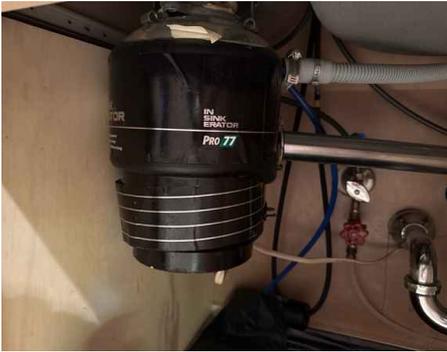
**Garbage Disposal: Functional**

The disposal was tested and appeared to be functional at the time of this inspection.

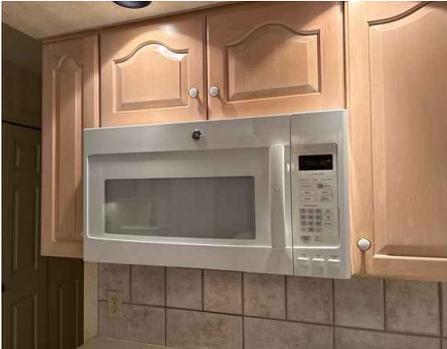
**Built-in Microwave: Functional**

The microwave was tested and appeared to be in serviceable condition at the time of this inspection.

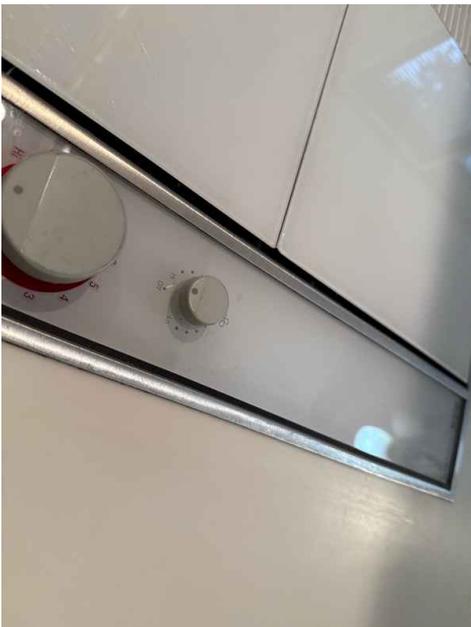
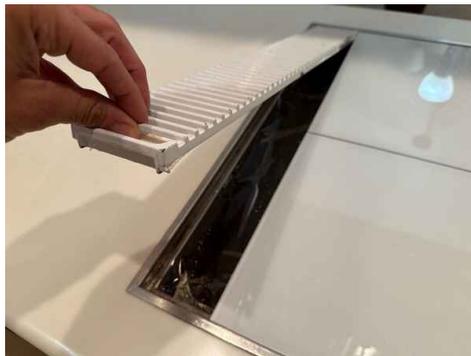
EXHAUST NOT PRESENT

The exhaust system at the electric cooktop was not installed.

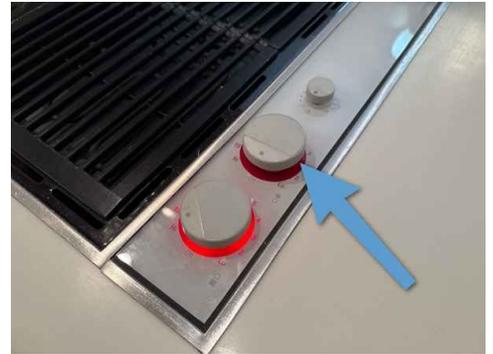
The cooktop control knob was not functional. This should be repaired.

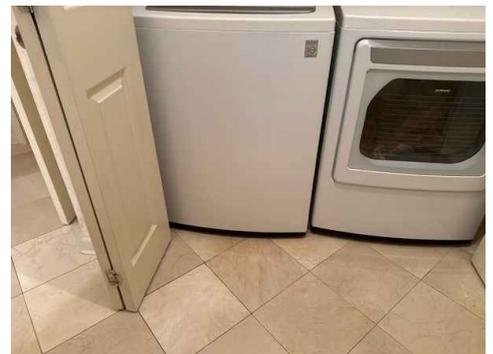
MISSING DRIP PAN

There is no drip pan present. When located on or above finished spaces you should have a drip pan installed beneath the washer to prevent possible moisture damage.

Recommendation

Contact a qualified professional.

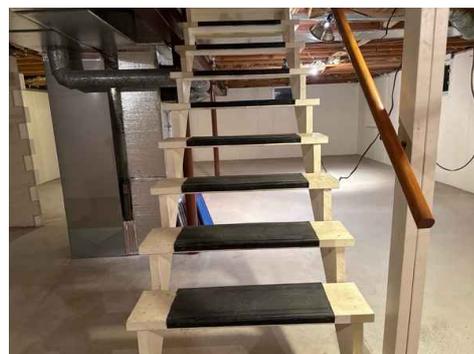
Risers are missing. Risers should be installed to prevent small children from falling through them.

Recommendation

Contact a qualified professional.

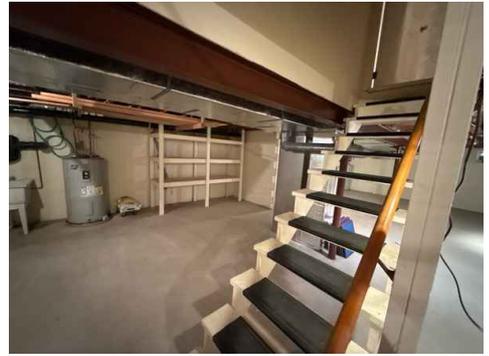
14.2.2 Steps, Stairways & Railings

OPEN SIDED STAIRWAY

Recommendation

Contact a qualified professional.

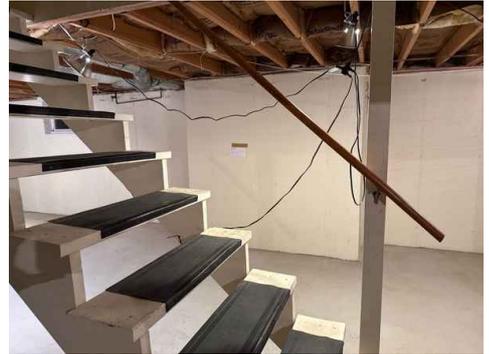
14.2.3 Steps, Stairways & Railings

OPEN BELOW HANDRAIL/GUARDRAIL

Recommendation

Contact a qualified professional.

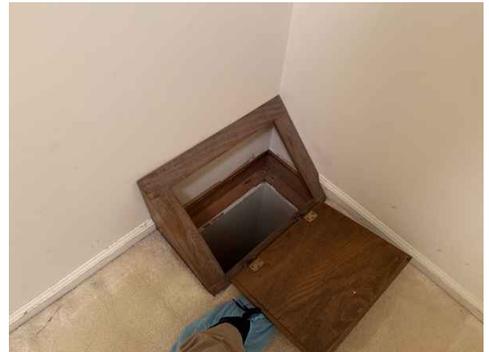
14.3.1 Walls

LAUNDRY CHUTE

There is a laundry chute present. This is considered a safety hazard if small children are present.

Recommendation

Contact a qualified professional.

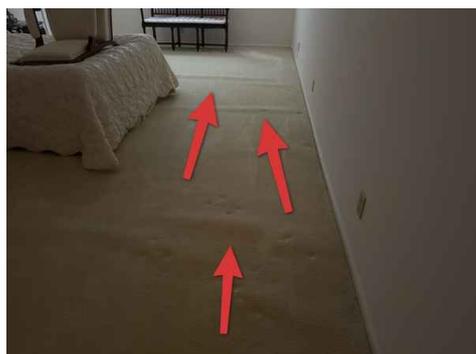
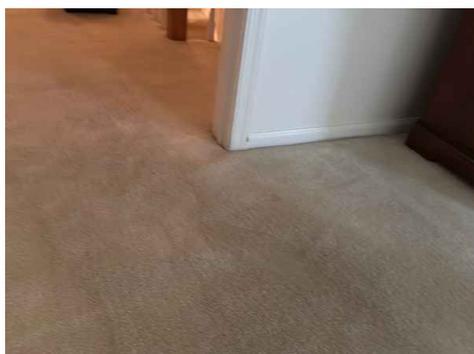
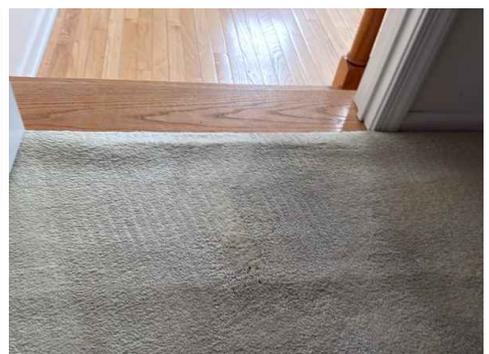
14.5.1 Floors

LOOSE CARPET

There is loose carpet at some area(s). This is a trip hazard. These area(s) should be repaired or replaced.

Recommendation

Contact a qualified professional.

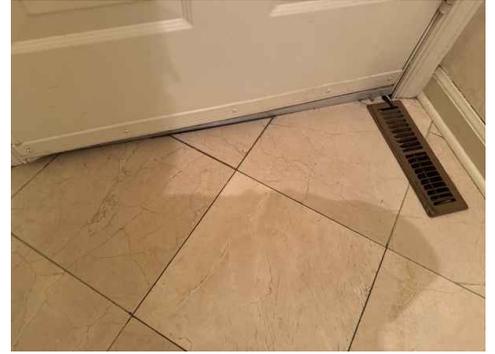
14.5.2 Floors

TILE(S) CRACKED

Tile(s) are cracked at some areas. The tiles should be replaced.

Recommendation

Contact a qualified professional.

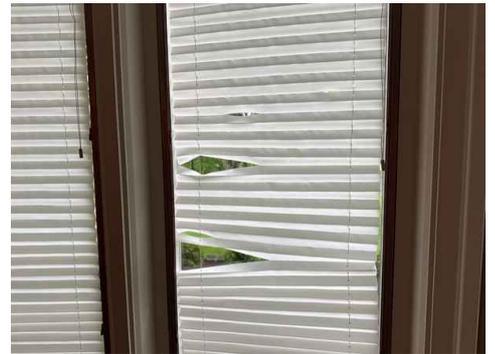
14.7.1 Windows

BLINDS DAMAGED

The internal blinds in the window were damaged. You may wish to have this further evaluated and repaired.

Recommendation

Contact a qualified professional.

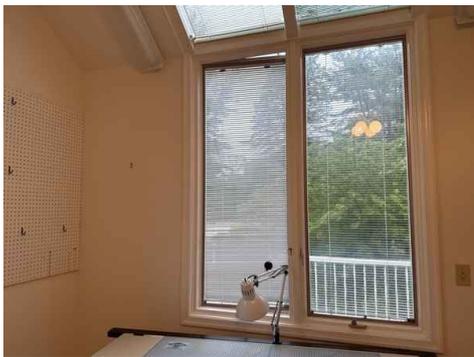
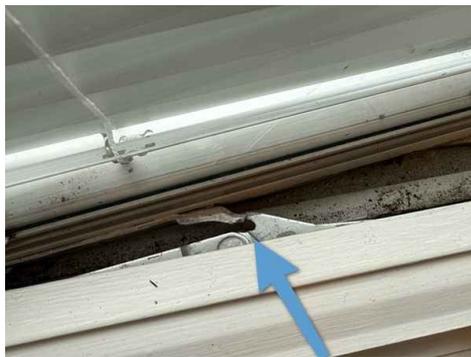
14.7.2 Windows

One or more of the casement windows does not close completely without assistance. This is typically an easy hardware fix. Recommend repair by a qualified professional.

Recommendation

Contact a qualified professional.

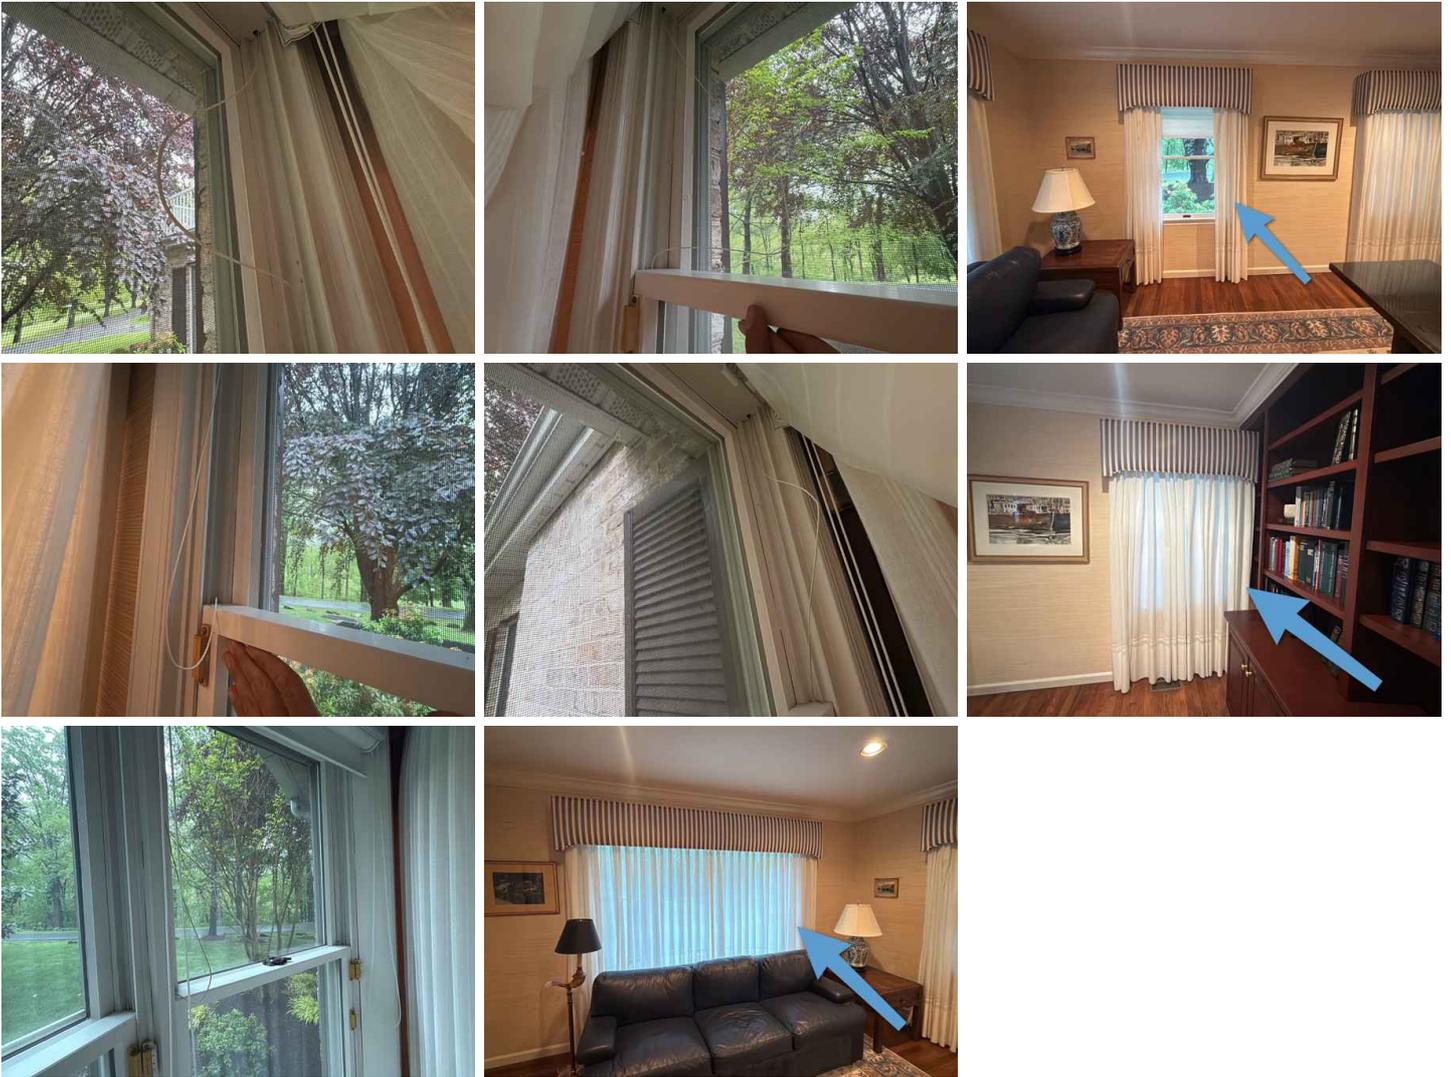
14.7.3 Windows

The sash cord does not retract. You should have this repaired by a qualified contractor.

Recommendation

Contact a qualified professional.

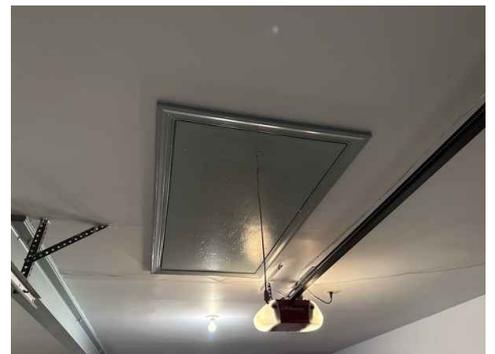
14.8.1 Firewall Separation

ACCESS HATCH NOT FIRE RATED

Recommendation

Contact a qualified professional.

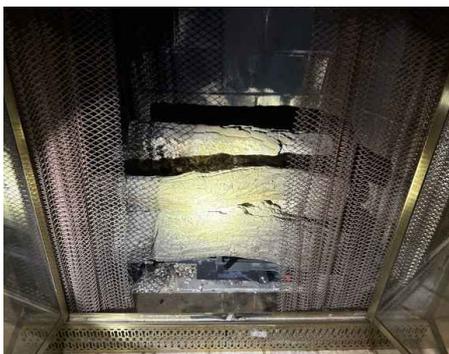
Fireplace: Gas log inserted in the fire place

There is a gas log in the fireplace. Inspection and testing of gas logs is beyond the scope of this inspection. You should consult the owner's manual for information about proper operation.

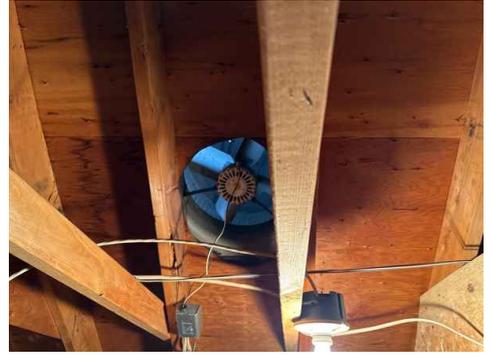
THERMOSTATICALLY CONTROLLED FAN - NOT TESTED

We were unable to test the thermostatically controlled attic fan. You should confirm with the seller that this is functional prior to closing.

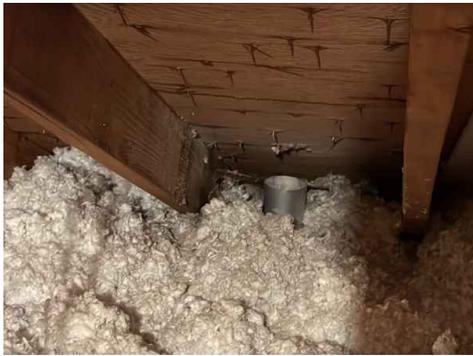
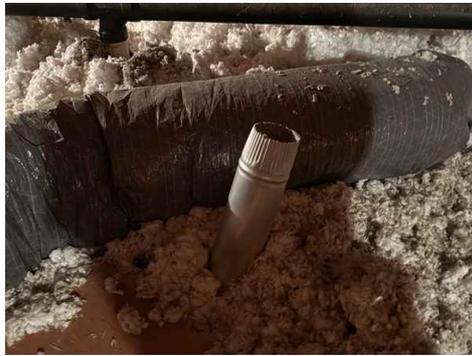
BATHROOM VENTS INTO ATTIC

Bathroom fan vents into the attic, which can cause moisture and mold. Recommend a qualified attic contractor properly install the exhaust fan to terminate to the exterior.
