RESIDENTIAL REPORT

2319 Fox Meadow Dr
Allentown, PA 18104

Creighton Faust
NOVEMBER 8, 2024

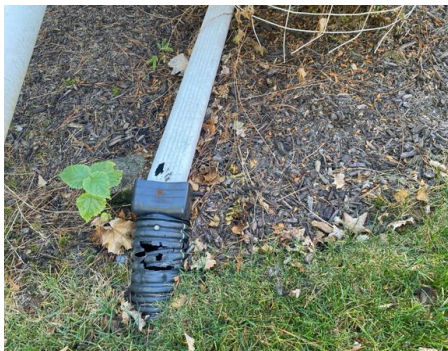
Roof Drainage Systems: Underground Drains

There are underground drains on the property. This type of drainage requires regular maintenance due to clogging or backup of water to the lower structure. It may be difficult to determine the discharge location. You should monitor or install the downspout above grade a safe distance away from the foundation.

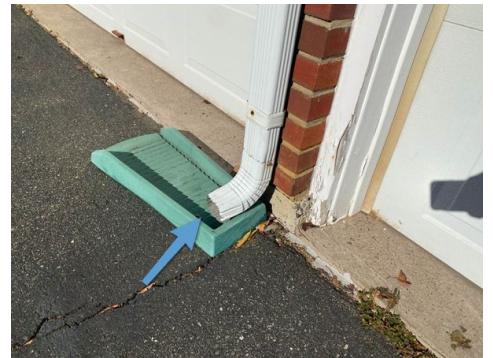
One or more downspouts drain too close to the home's foundation. This can result in excessive moisture in the soil at the foundation, which can lead to foundation/structural movement. You should install downspout extensions to drain at least 6 feet from the foundation.

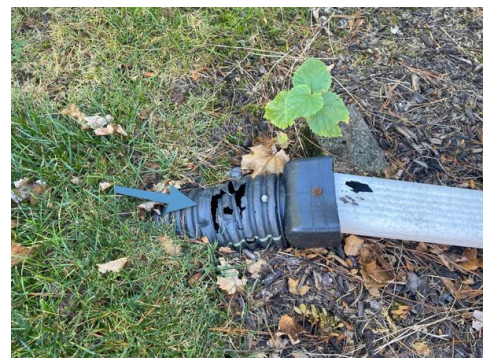
3.3.2 Roof Drainage Systems

DOWNSPOUT EXTENSION DAMAGED

One or more of the downspout extensions were damaged at the time of inspection. This may allow moisture to collect close to the foundation. The extensions should be replaced.

Recommendation

Contact a qualified professional.

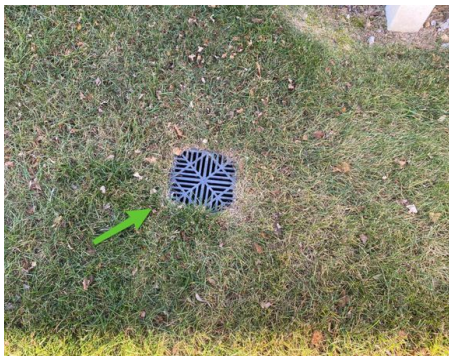
Vegetation, Grading & Drainage: Catch Basin or Surface Drainage

There is a catch basin or surface drainage on the property. Determining where the drainage system terminates is beyond the scope of this inspection.

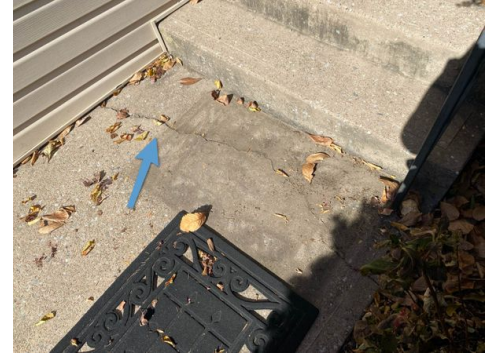
WALKWAY CRACKING

Cracks were observed. Recommend monitoring and/or patch/seal.

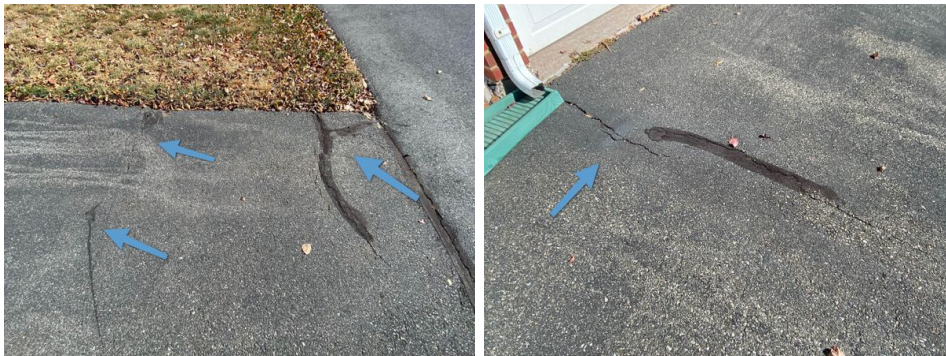
4.2.2 Walkways, Stoops, Steps, Patios & Driveways

DRIVEWAY CRACKING

Cracking was observed. Recommend monitoring and/or have contractor patch/seal.

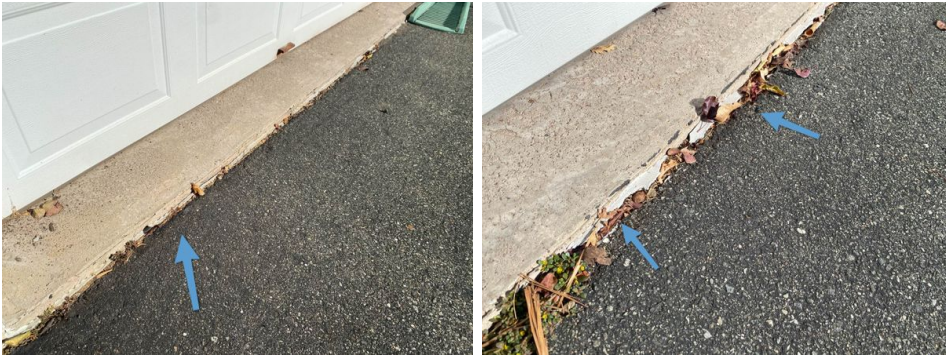
4.2.3 Walkways, Stoops, Steps, Patios & Driveways

SEAL MISSING/DETERIORATED AT GARAGE

The seal at the driveway and garage connection should be replaced to prevent water intrusion and cracking from freeze thaw cycle.

Recommendation

Contact a qualified professional.

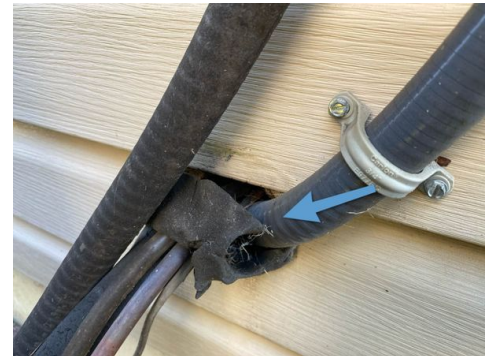
4.4.1 Siding

Caulking is missing where the utility lines or piping enter through the exterior wall. Moisture, pests or insects intrusion is possible. These areas should be caulked with appropriate caulking material.

Recommendation

Contact a qualified professional.

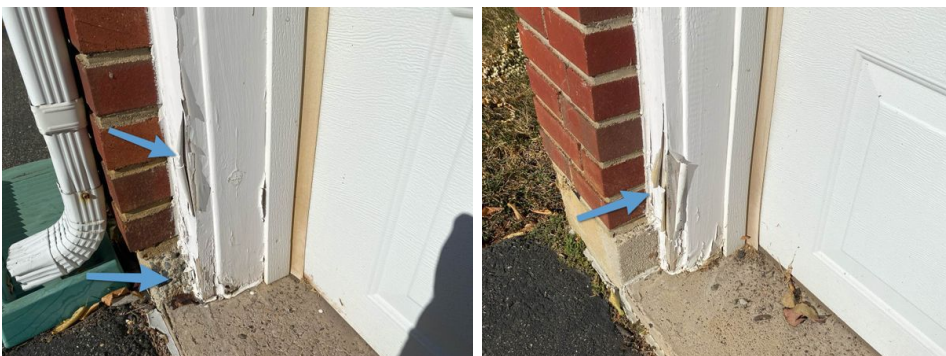
4.5.1 Trim

DETERIORATED PAINT

The paint is deteriorated at various areas of trim. The trim should be re-painted to protect the wood from the exterior extremities.

Recommendation

Contact a qualified professional.

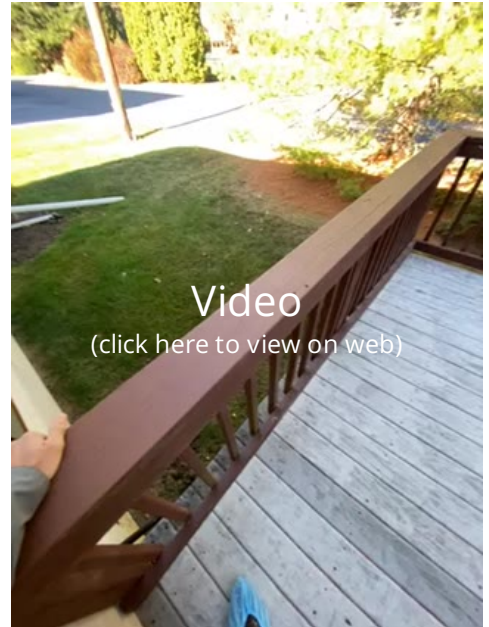
4.8.1 Decks, Balconies, Porches & Steps

GUARDRAIL/HANDRAIL LOOSE OR DETERIORATED

Some areas of the guardrail or handrail are damaged or loose. This is a safety concern. Repair or replacement is needed.

Recommendation

Contact a qualified professional.

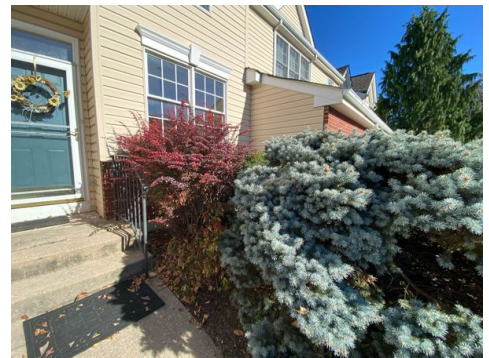
4.9.1 Vegetation, Grading & Drainage

VEGETATION CLOSE OR TOUCHING THE DWELLING

The trees or bushes are close or touching the dwelling. This can retain moisture at the siding areas which may allow for mold/mildew. You should trim these areas back to allow for proper air flow.

4.9.1 -the vegetation has been cut back, (they must have done fall maintenance recently).

Recommendation

Contact a qualified professional.

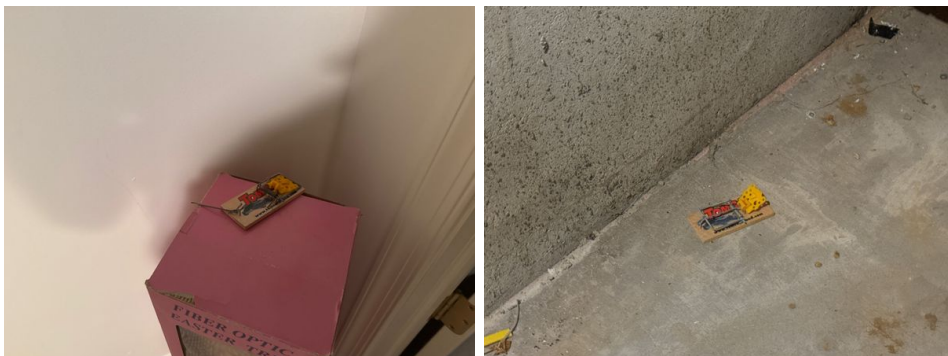
There are signs of current treatment for pests. We recommend that you continue this treatment.

4.10.1-mousetraps removed, in place 17 years never had a mouse

Recommendation

Contact a qualified professional.

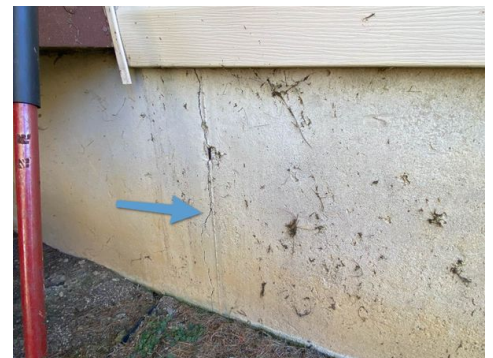
5.2.1 Foundation

FOUNDATION CRACKS

There are typical crack(s) present at some areas of the foundation wall. This is common as concrete ages and shrinks where surface cracks are normal at approximately 1/16". You should monitor for any additional change or moisture at these areas. If leakage should occur these can be sealed by a qualified contractor.

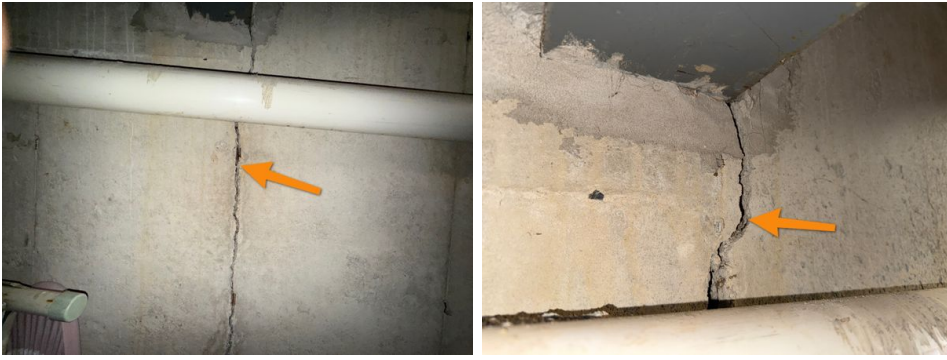
5.2.2 Foundation

SIGNIFICANT FOUNDATION CRACKS

Significant cracking is noted at the foundation. This is typically consistent with soil movement and could lead to serious damage to structural components, foundation and/or slabs. Recommend contacting a qualified contractor or structural engineer for further evaluation and follow their recommendations prior to settlement.

5.2.2. foundation is an HOA item

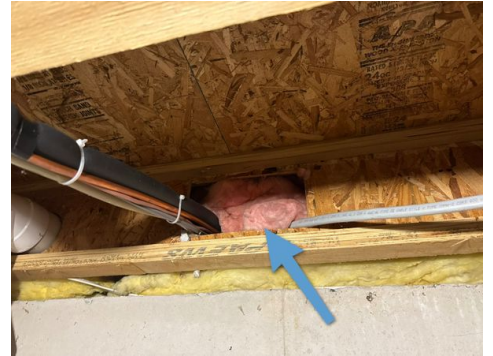
5.3.1 Floor Structure

MODIFIED I-JOIST

The I-Joist has been drilled, cut, notched, and/or modified. This could compromise the integrity of the I-Joist. Further evaluation by a qualified professional is recommended.

Recommendation

Contact a qualified professional.

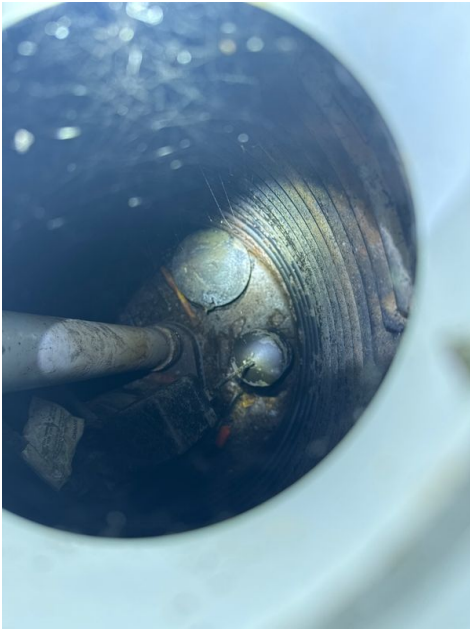
SUMP NOT TESTED DRY PIT

The sump pump was not tested due to the pit being dry. Testing a pump dry can cause damage to the pump.

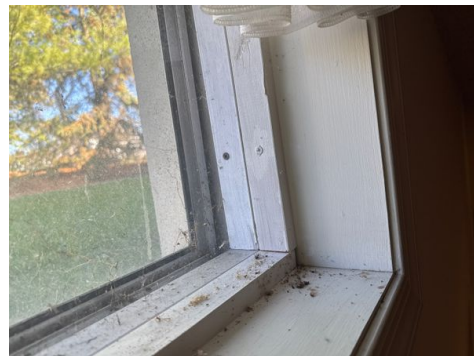
NOT TESTED - INACCESSIBLE

One or more basement windows could not be tested due to access. This could include stored items, insulation/plastic covering or limited access. You should ensure all basement windows are tested and functional prior to closing.

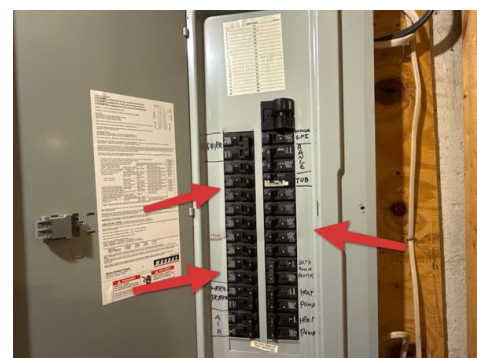
7.4.2 Main & Subpanels & Main Overcurrent Device

MISSING LABELS ON PANEL

At the time of inspection the main or sub-panels was missing labeling. You should have this further evaluated by a qualified electrician and correctly map out locations.

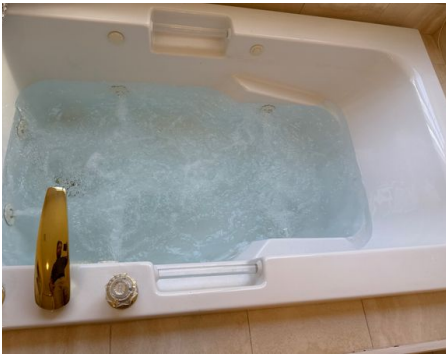
The Jacuzzi was filled and operated. All areas were functional at the time of this inspection.

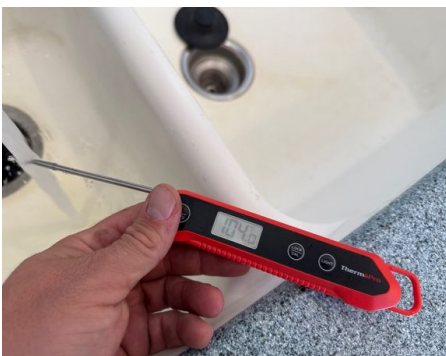
Hot Water Systems: Functional

The water heating system was tested at various areas. The hot water heating system was functional at the time of this inspection.

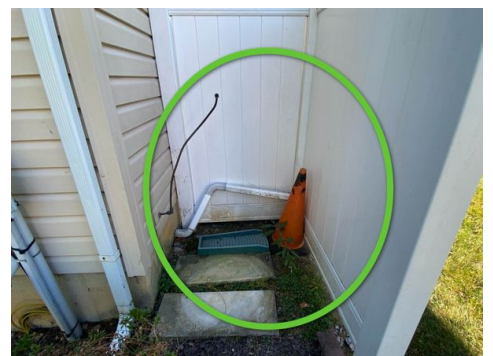
MISSING PROPANE TANK

The propane tank was missing or empty. We were unable to evaluate the condition or supply to components at the time of this inspection.

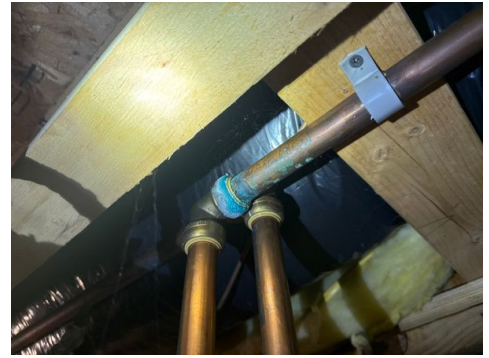
8.3.1 Water Supply, Distribution Systems & Fixtures

CORRODED VALVES/FITTINGS AND/OR PIPES

Some of the water supply valves, fittings and/or pipes are corroded. Recommend to have a qualified plumber further evaluate and follow their recommendations.

Contact a qualified professional.

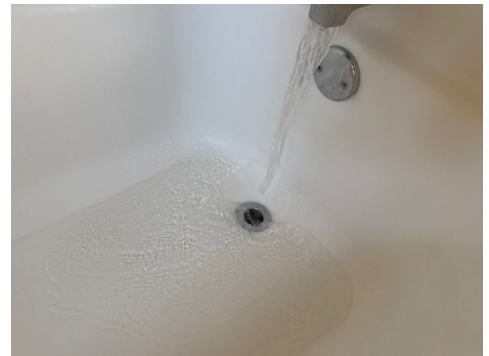
8.5.1 Sinks/Tubs/Showers/Toilets

POPUP TUB DRAIN NOT WORKING/MISSING

The tub drain popup is not working or is missing. This should be repaired or replaced.

Contact a qualified professional.

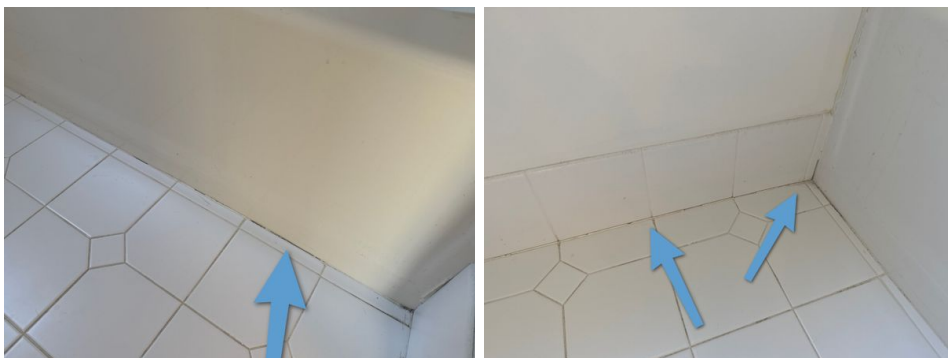
8.5.2 Sinks/Tubs/Showers/Toilets

CAULK/GROUT LOOSE OR MISSING

The caulking or grout is loose or missing. This area should be maintained to deter moisture entry.

Contact a qualified professional.

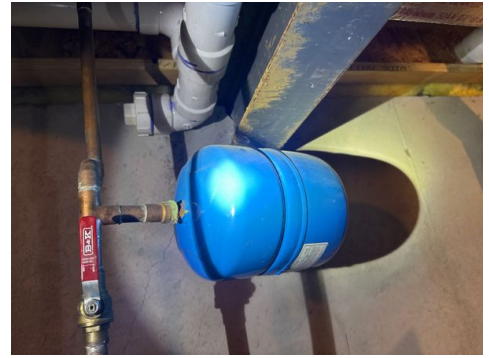
MISSING EXPANSION TANK STRAPS

The support straps are missing at the tank. Support straps should be considered as they support the water weight of the tank. The tanks can weigh 15 to 30 pounds depending on the size.

Contact a qualified professional.

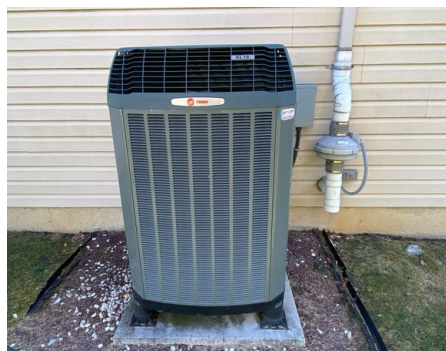
Heat Pump: Brand
Trane

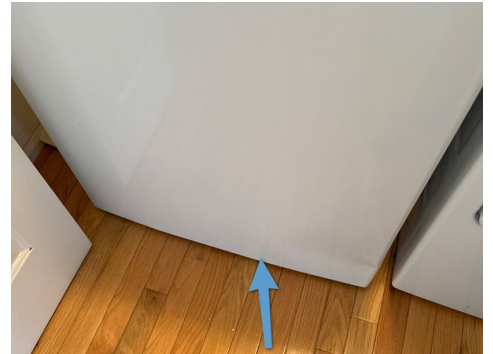
MISSING DRIP PAN

There is no drip pan present. When located on or above finished spaces you should have a drip pan installed beneath the washer to prevent possible moisture damage.

Contact a qualified professional.

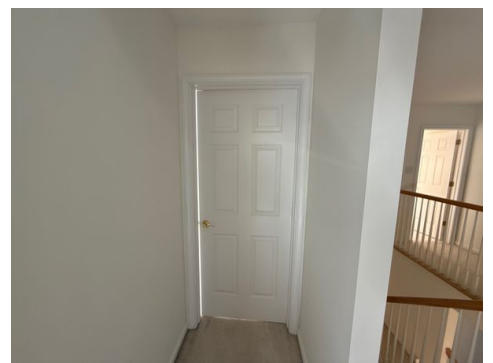
11.6.1 Doors

DOOR(S) STICK OR RUB

2ND FLOOR BEDROOM

Door(s) stick or rub and were difficult to open. Adjustment should be considered.

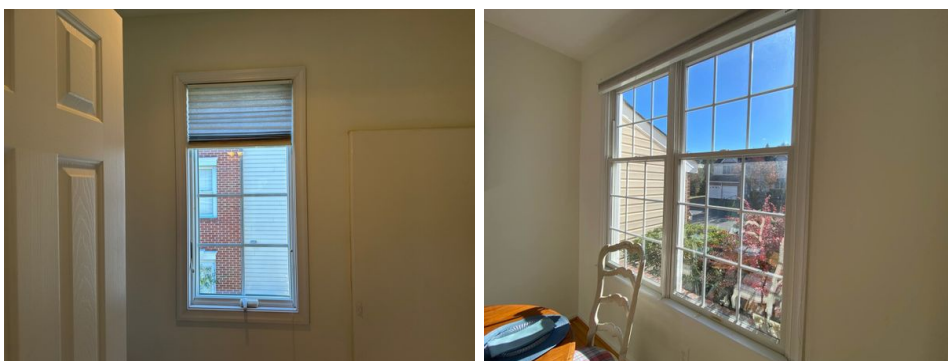
11.7.1 Windows

SCREENS MISSING OR DAMAGED

KITCHEN

Some of the screens were missing or damaged. The screens should be repaired or replaced.

11.7.1 window screens are in basement, had been removed for paint touch up

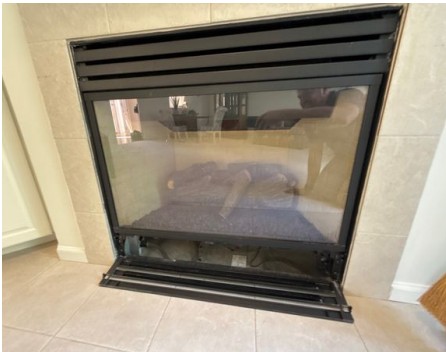
Fireplace: Vented Gas Fireplace

There is a vented gas fireplace present. Inspection and testing of a gas fireplace is beyond the scope of this inspection. You should contact the seller for further information.

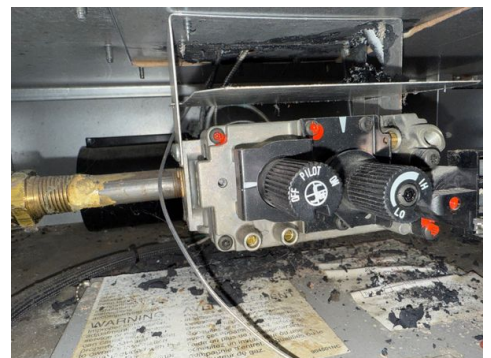
FIREPLACE NOT TESTED PILOT OUT

The gas fireplace could not be tested due to the pilot light being out. You should have a qualified professional test this unit.

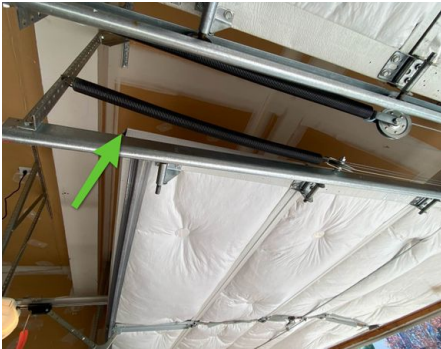
Garage Door Opener: Auto Reverse Functional

Electronic Eyes, Reverse with a (2x4), Emergency Release Present

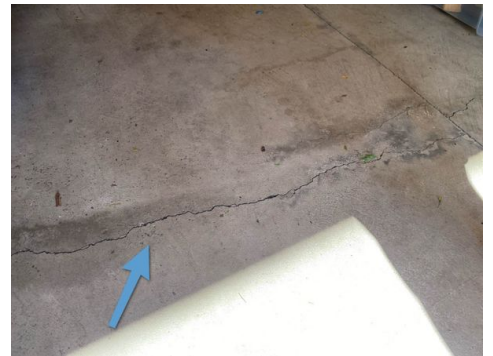
TYPICAL SETTLEMENT CRACKS

Typical settlement cracks were visible in the garage floor. The floor appeared serviceable at the time of this inspection.
