NORTH CAROLINA
Department of Transportation

Implementation of a Dynamic All Red Extension at Signalized Intersections

Carrie L. Simpson, PE

February 12, 2018

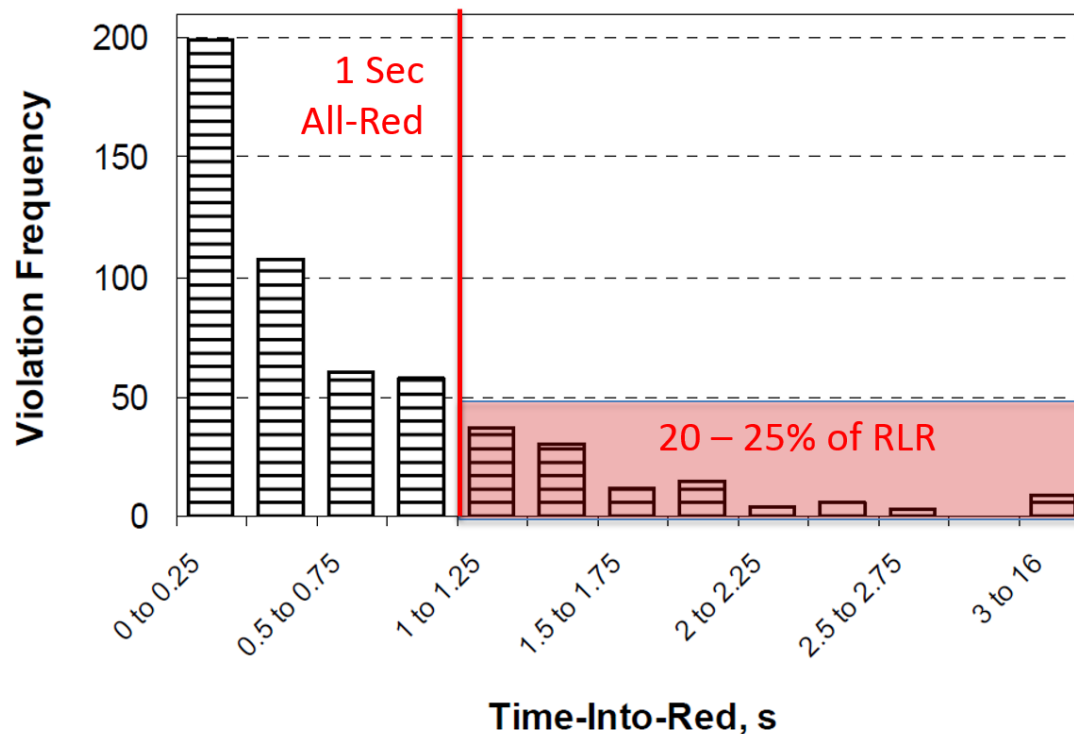
Frequency of Red-Light Violations as a Function of Time-Into-Red

Source: Bonneson & Zimmerman 2004

- All-red clearance intervals are used to help combat red light running crashes by creating a safety cushion for vehicles entering the intersection on red prior to an opposing movement receiving a green indication.
- A one-second all-red clearance interval may only capture ~ 80% of red light violators. The remaining will enter the intersection when the next phase has a green indication.
- Extending clearance timing by a static amount for every cycle may have negative implications to delay, congestion, and driver adaptation.

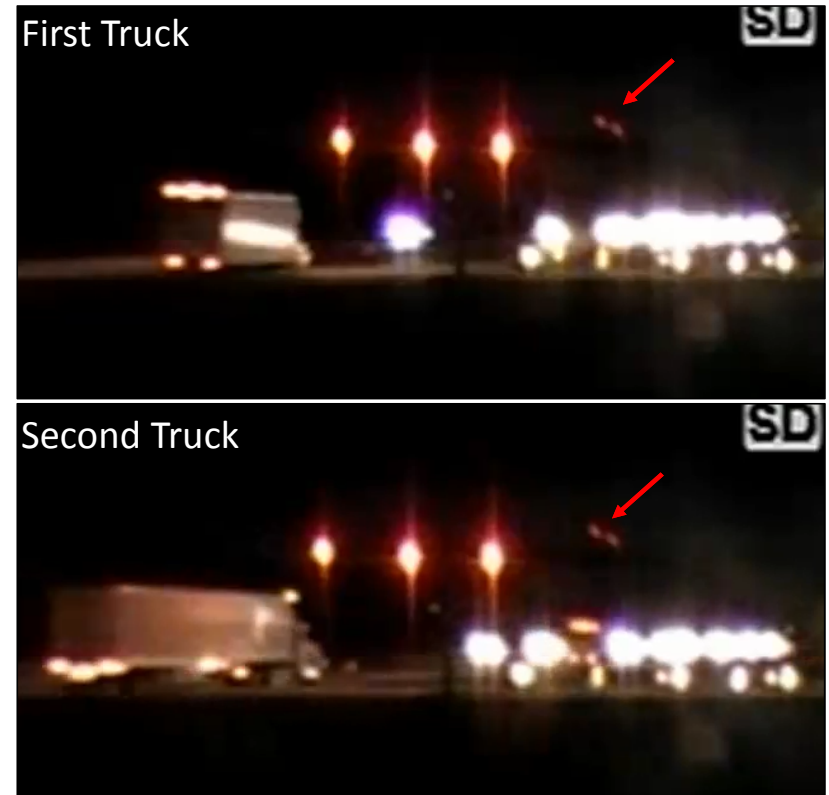
Video captured back-to-back violators after Wake Co. DARE installation. First truck ran red at 1 s and second truck ran red at 3 s. All-red was extended.

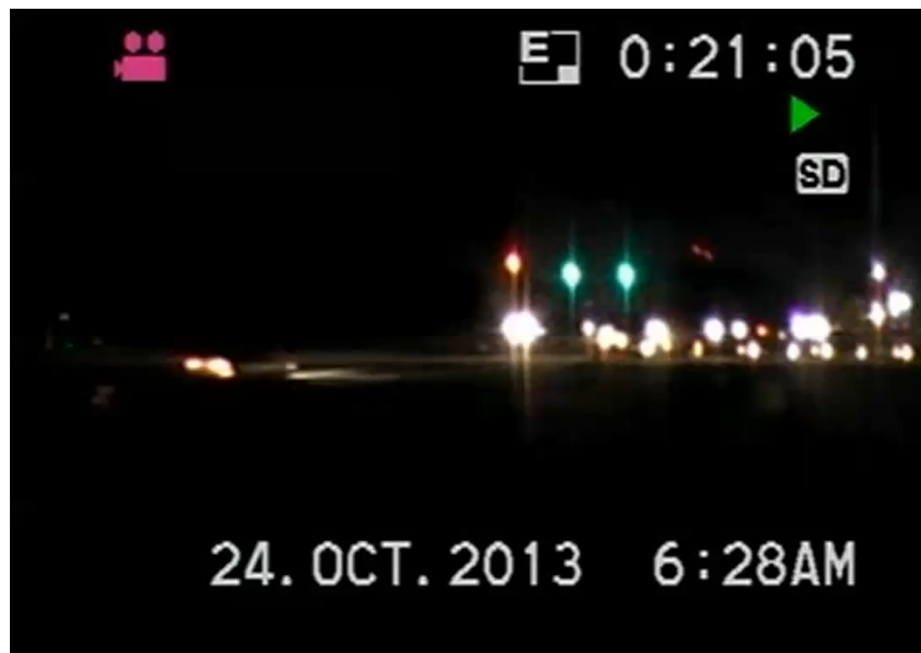
How It Works (Simplistic Version):

Example Site:

- Yellow Interval: 5 seconds
- Default Red Interval: 1 second
- Alarm Time: 5 seconds
- Closest Loop is 240' from Stop Bar
- Vehicle below crosses the loops at 3 seconds into the yellow interval
- 5 second stop time is placed on red interval
 - Vehicle has remaining 2 seconds of yellow, 1 second of default red, and 2 seconds of red extension = 5 seconds from the time they cross the loops.
- Total All-Red Time: 3 sec

The system is termed “dynamic” as the amount of time the red clearance is increased can vary from one cycle to the next. If back to back vehicles violate during the same red clearance interval, the alarm time is reset with each subsequent violation.

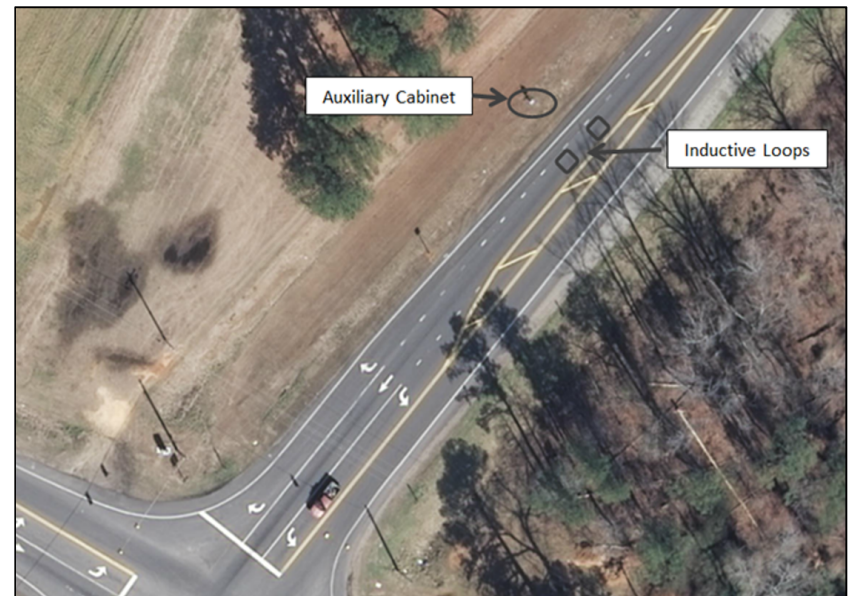
- Oasis/2070 Controller
- Detection method – Two 6' X 6' inductive loops spaced 10' apart
- Northstar Controls Model NQ4 Speed Advisory System
 - Unit is typically placed in separate cabinet next to inductive loops
 - Loop outputs feed into inputs of NQ4 logic unit and determines if preset speed threshold has been violated (threshold varies by location – typically 5 mph below design speed)
 - We tweaked the outputs from our NQ4 detector systems to get the controller to handle the necessary “holds”
 - Duration of alarm output is 5 seconds

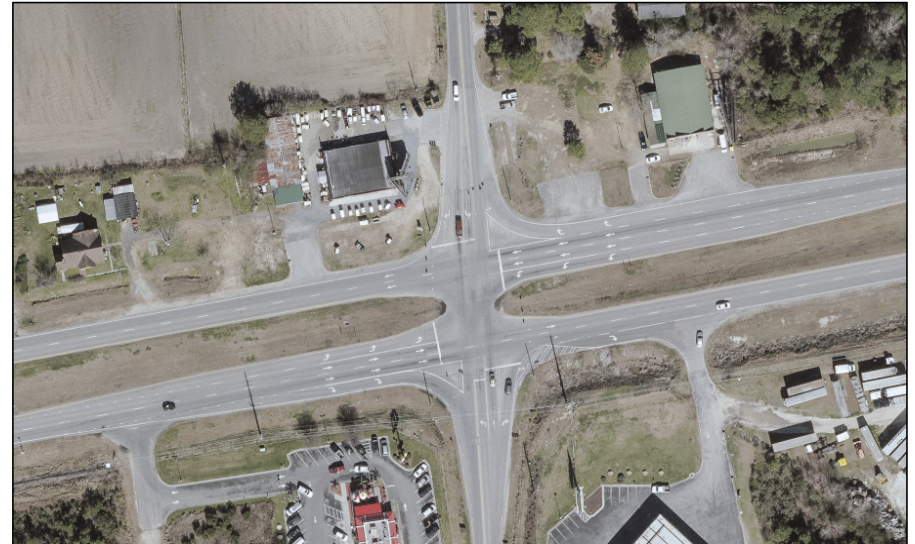
- In the site selection process, we were specifically looking for rural, isolated signals on higher speed facilities with enough reported red light running crashes to allow for post-installation crash analysis evaluation.
- Mainline posted speed limits range from 45 mph to 60 mph.
- 2011 AADT for the mainline approaches range from approx 4,700 to 29,500 vehicles per day.
- The mainline cross sections vary, but a majority are four-lane divided facilities.
- Both mainline approaches were treated at most sites.

County	Treated Approaches	Distance to Loop (ft)	Yellow Interval (sec)	Default Red Interval (sec)	Mainline AADT (vehicles per day)	Mainline Speed Limit (mph)
Pasquotank	US 17 - Both	290	5.5-5.6	1.0-1.1	15,500	60
Surry	US 52 - Westbound	240	5.1	2.0	14,500	55
Pasquotank	US 17 - Both	290	5.5	1.0	8,900	60
Carteret	NC 24 - Both	240	5.3	1.1	16,000	55
Brunswick	US 17 - Both	240	5.2-5.3	1.0-1.2	17,000	55
Wake	US 70 Bus - Eastbound	240	5.2	1.2	29,500	55
Surry	US 601 - Both	155	4.3	1.0	4,700	45
Perquimans	US 17 - Both	290	5.5	2.0	13,500	55

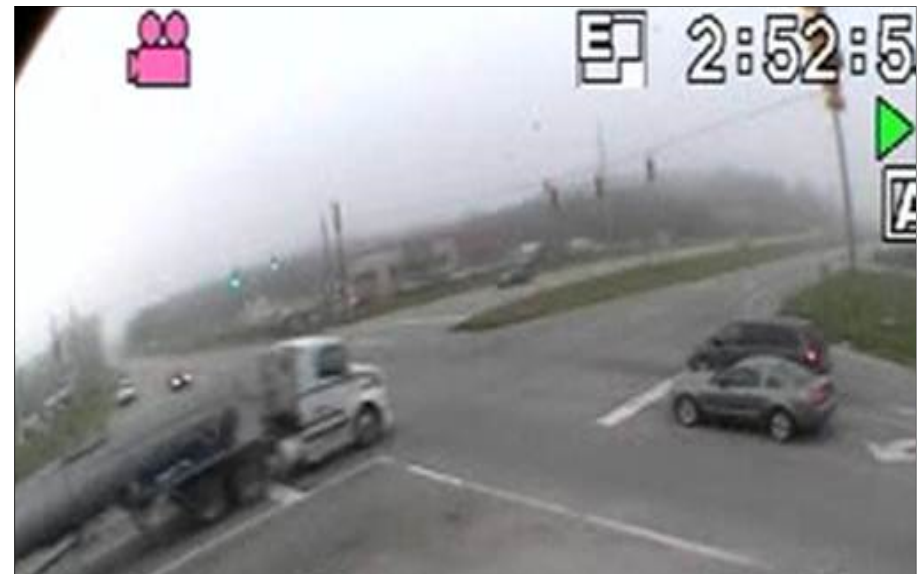
Compliance data collected using cameras mounted to signal poles or other nearby fixed objects.

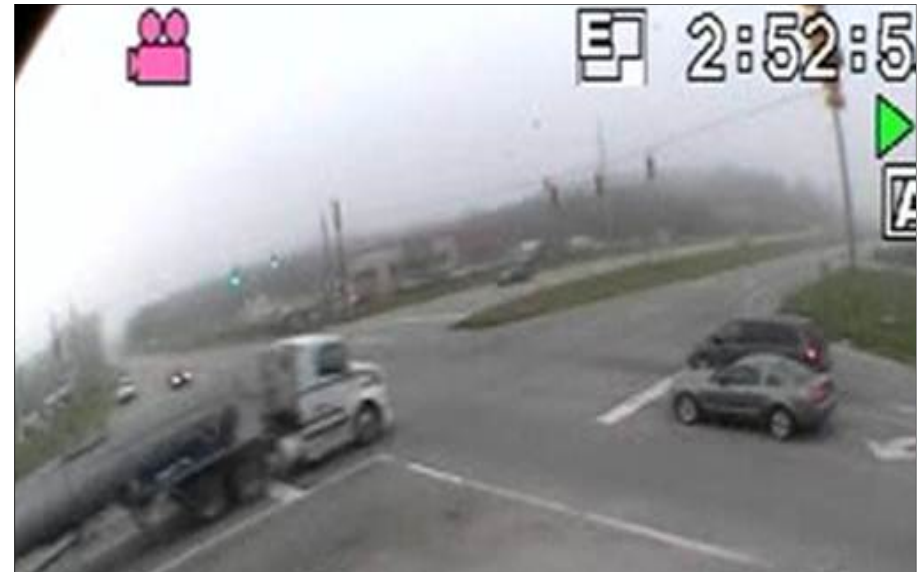
- Analyzed yellow light runners (YLR) and red light runners (RLR).
- For both measures, we were interested in the hourly frequency, the rate per entering through vehicle, and the rate per cycle.
- Data were collected prior to installation and at the 1-month, 3-month, 6-month and 12-month marks after installation.
- Up to 52 hours of before period data and up to 130 hours of after period data were collected at each intersection.

In all, we collected over 1,000 hours of data to determine how the countermeasure may affect vehicle compliance

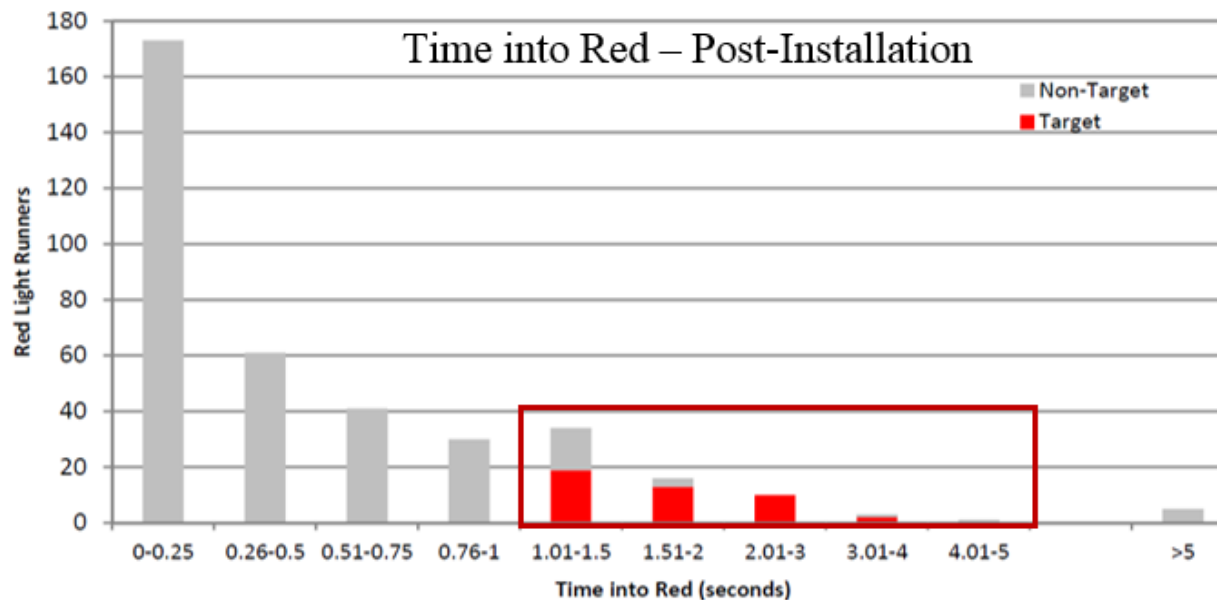
- Approx. 12% of the 374 post-installation RLR captured were targeted by DARE, entering 1-5 s into red, as shown highlighted in red

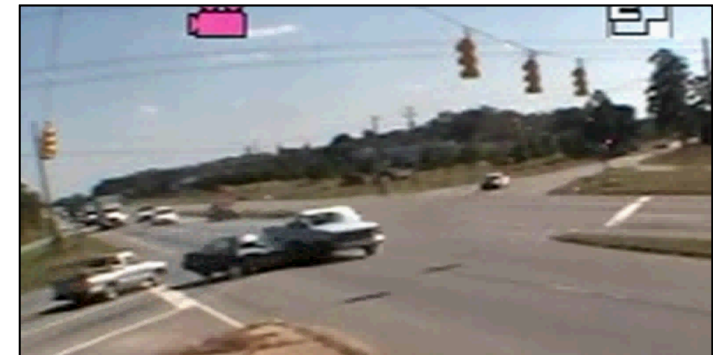
Video captured @ Wake Co. site where a pick-up entered 3 s into red & caused angle crash (no DARE)

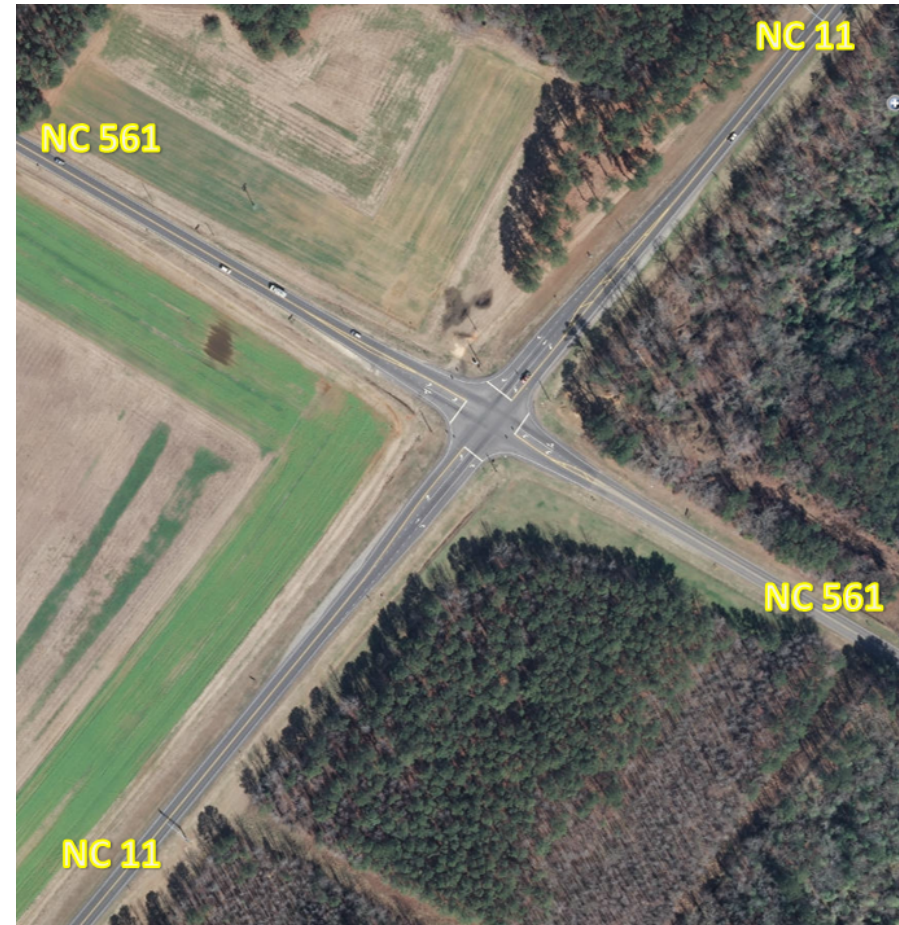
NC 11 @ NC 561, Hertford County – Division 1

- Installation Date: 2/2011
- Treated Approaches: NC 11 – Both
- Treated Road X-Section: 2 Ln
- Major/Minor AADT: 6,600/3,900 (2012)
- Signal: 2 Phase, Fully Actuated, Isolated
- Speed Limit (Major): 45 mph
- Yellow/Red Time: 5.2/3.0
- Alarm Time: 5
- Distance to Loops: 240'/256' (55 mph design)
- Other Existing CM: LVODS, Prepare to Stop LED
- Other New CM: Double Red, Red Rest
- GPS: 36.304214,-77.018872

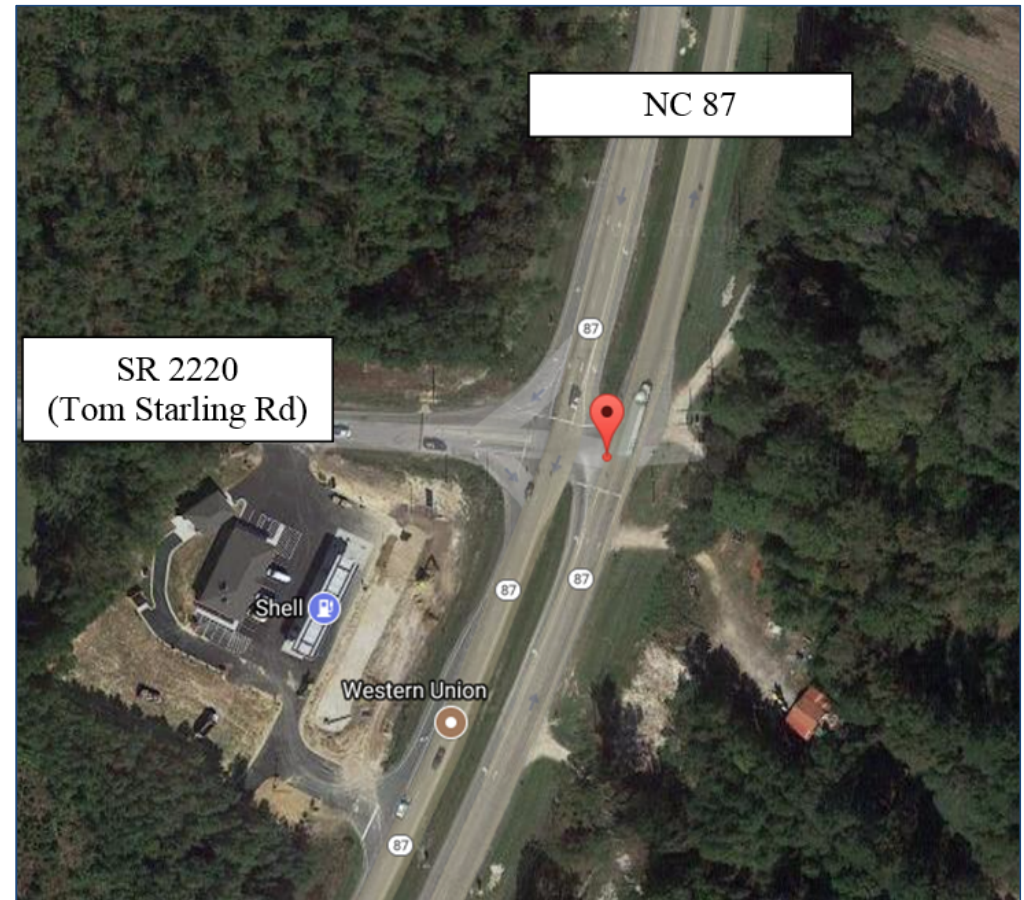
NC 87 @ SR 2220, Cumberland County – Division 6

- Installation Date: 12/2016
- Treated Approaches: NC 87 – Both
- Treated Road X-Section: 4 Ln Divided
- Major/Minor AADT: 13,000/3,200 (2014)
- Signal: 2 Phase, Fully Actuated, Isolated
- Speed Limit (Major): 55 mph
- Yellow/Red Time: 5.7/2.0
- Alarm Time: 5
- Distance to Loops: 240'/256'
- Other New CM: Prepare to Stop LED
- GPS: 34.949627, -78.844661

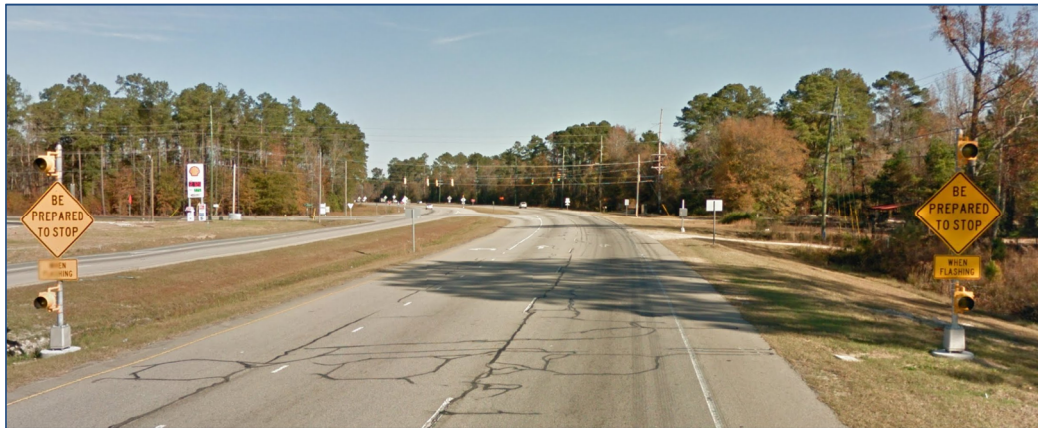
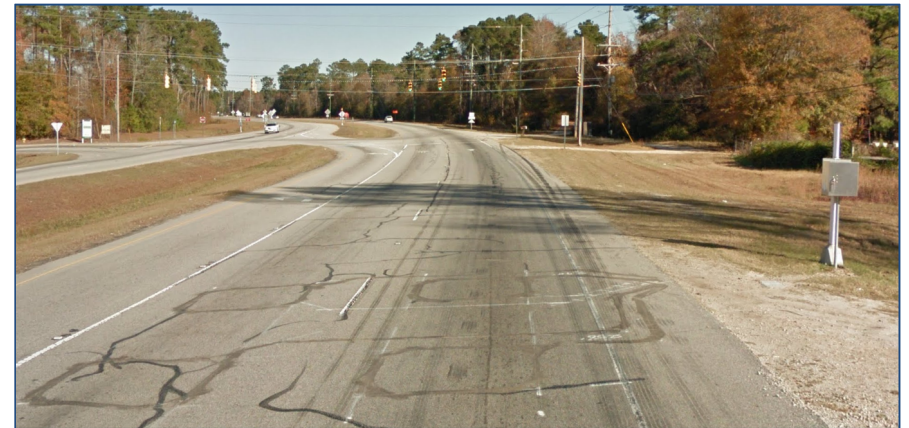
NC 87 @ SR 2220, Cumberland County – Division 6

<u>Treatment Information</u>	Before 3.0 Years	After 0.6 Years	Percent Reduction (-) Percent Increase (+)
Total Crashes	25	4	N/A
Total Severity Index	10.62	2.85	- 73.2 %
Total Crashes Per Year	8.3 CPY	6.7 CPY	- 19.3 %
Target Crashes – NC 87 RLR	7	0	N/A
Target Crash Severity Index	17.11	0.00	- 100.0 %
Target Crashes Per Year	2.3 CPY	0.0 CPY	- 100.0 %
