ROI HOME INSPECTIONS, LLC

## PROPERTY INSPECTION REPORT

4 Mill Brook Ct  
Easton, PA 18045

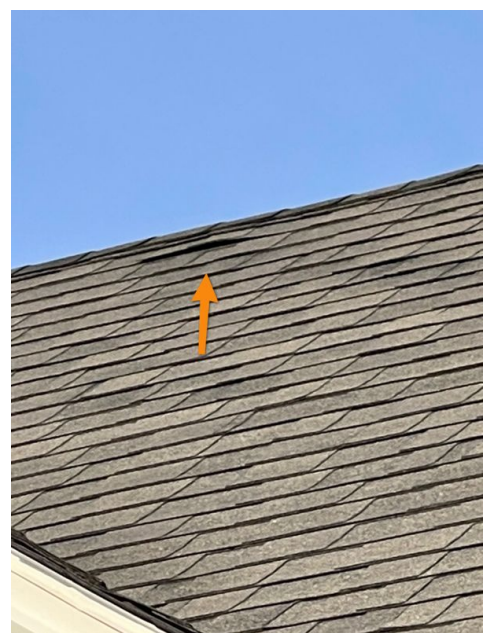
2.2.1 Condition

As your roof ages, the shingles naturally start loosening, and you may see some curling and debris. When curling shingles occur in newer homes, it often means there's a ventilation issue. No matter the age of your roof or your home, curling shingles are a sign that it's time to consider a replacement.

Recommendation

Contact a qualified roofing professional.

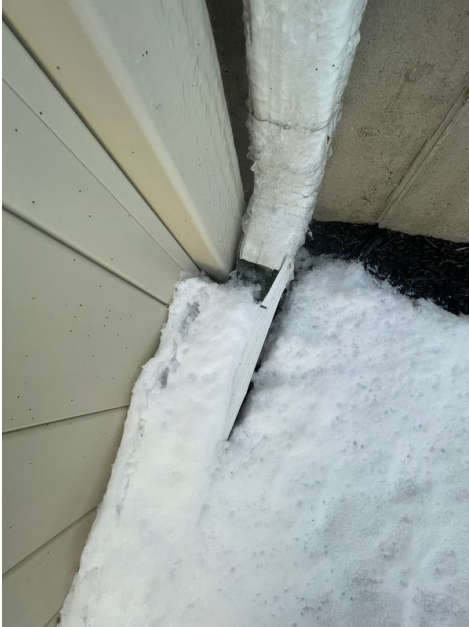
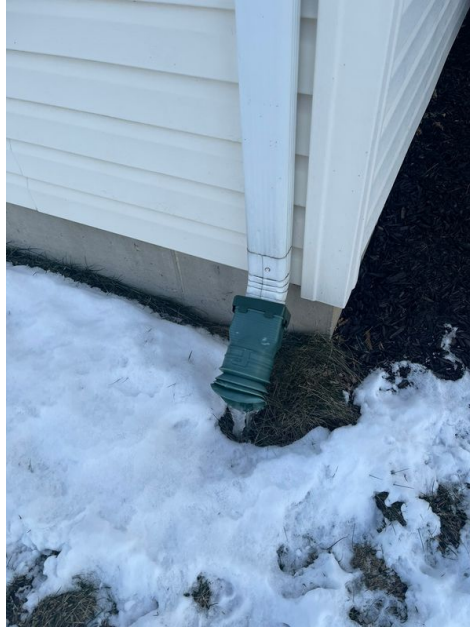
## 2.5.1 Gutters &amp; Downspouts

One or more downspouts drain too close to the home's foundation. This can result in excessive moisture in the soil at the foundation, which can lead to moisture intrusion into the basement and foundation movement. Recommend adding or adjusting downspout extensions to drain at least 4-6 feet from the foundation.

Recommendation

Recommended DIY Project

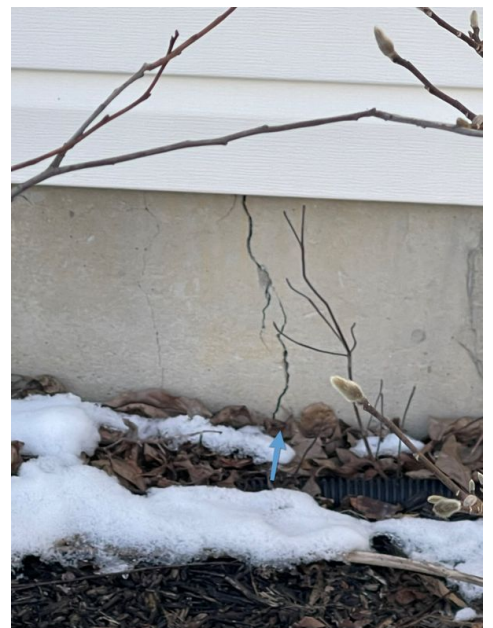
3.4.1 Exterior Foundation Condition

### COMMON CRACKS OBSERVED

Observed common cracks in the concrete foundation. Recommend sealing to prevent potential water intrusion.

Recommendation

Contact a qualified professional.

***Settlement cracks addressed.  
Life Time Warranty Included.***

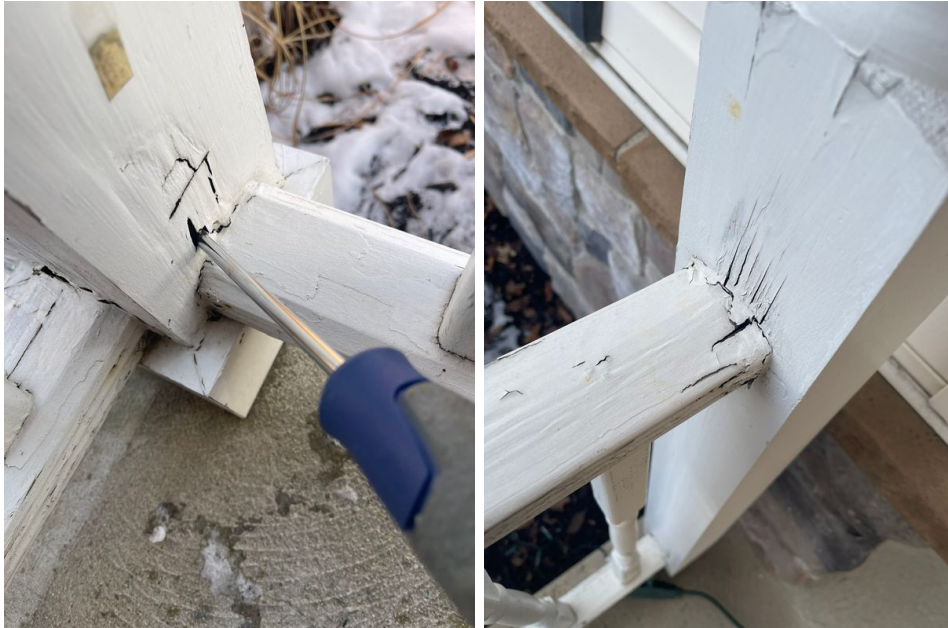
3.6.1 Railings, Handrails & Guardrails

**HANDRAIL IS DAMAGED**

Handrail leading the door is damaged, recommend replacement of board to prevent any further deterioration

Recommendation

Contact a qualified professional.

*porch  
addressed*

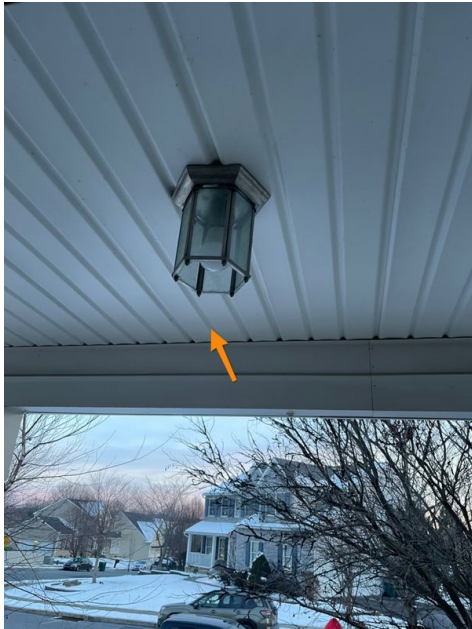
Exterior light did not function during the inspection. This may be due to a spent light bulb. Recommend further evaluation.

Recommendation

Contact a qualified professional.

*porch exterior light  
is lights activated. Works*

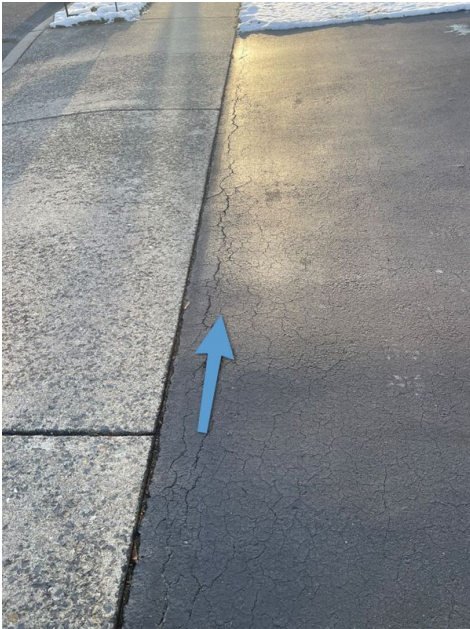
**MINOR CRACKING AT DRIVEWAY**

Observed minor cracking and at driveway. Recommended sealing cracks as needed.

Recommendation

Contact a handyman or DIY project

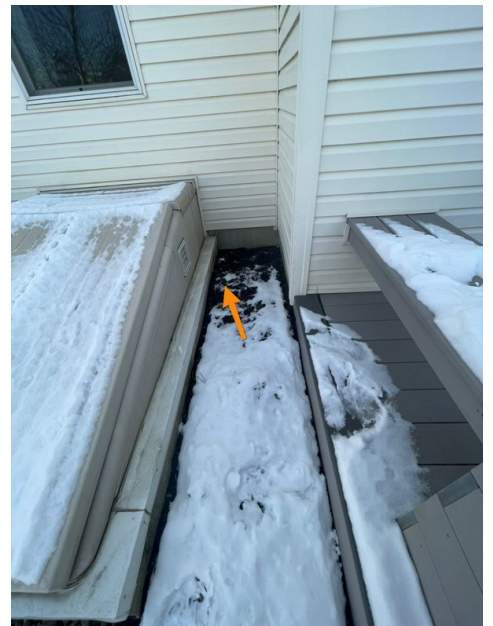
4.3.1 Grading

**LOW SPOTS ALONG THE FOUNDATION**

Recommend adding additional backfill to create the proper slope away from the house to allow for effective drainage.

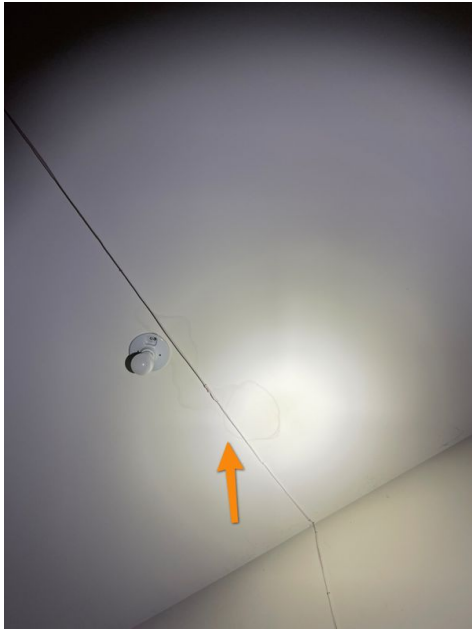
### STAINS- MINOR

There is a stain that requires repair and paint. Source of staining should be determined.

Recommendation

Contact a qualified professional.

*stains addressed*

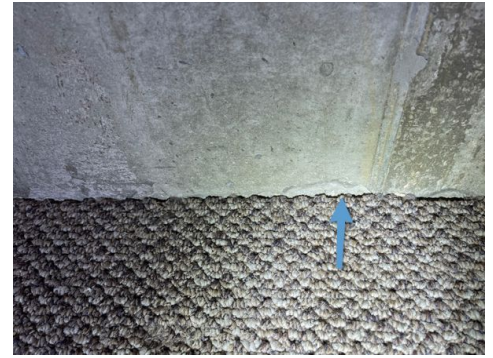
16.2.2 Walls

**EFFLORESCENCE OBSERVED**

Observed efflorescence on the foundation walls. Efflorescence is the white chalky powder that you might find on the surface of a concrete, brick, or stone wall. Efflorescence occurs when water passes through concrete and dries leaving behind mineral deposits found in water. In most cases it is a cosmetic issue, but it can be an indication of moisture intrusion that could lead to structural and indoor air quality issues.

Recommendation

Contact a qualified professional.
