CDA INSPECTION SERVICES

RESIDENTIAL REPORT

5411 Truth Place
Allentown, PA 18106

Creighton Faust
OCTOBER 21, 2024

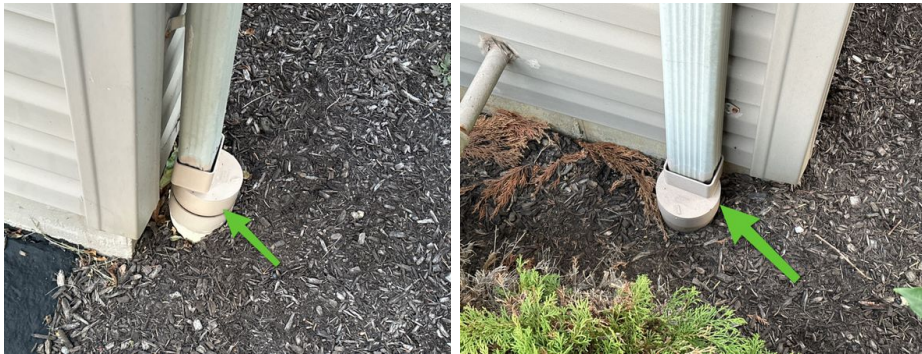
Roof Drainage Systems: Underground Drains

There are underground drains on the property. This type of drainage requires regular maintenance due to clogging or backup of water to the lower structure. It may be difficult to determine the discharge location. You should monitor or install the downspout above grade a safe distance away from the foundation.

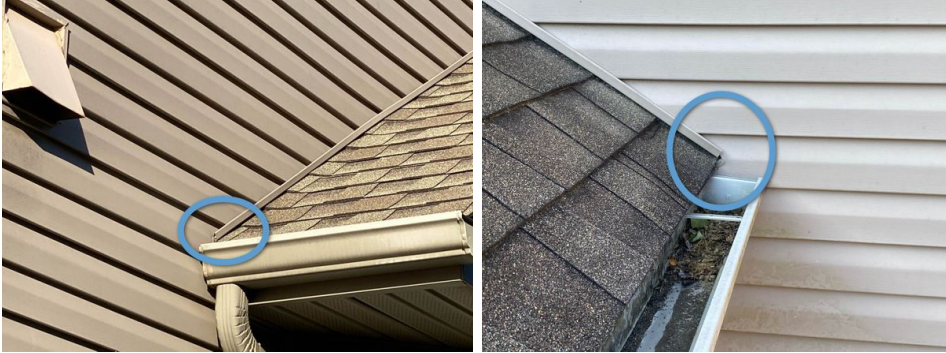
**KICK OUT FLASHING(S) MISSING**

A kick out flashing(s) is missing where the gutter intersects with the siding. This type of flashing is designed to divert roof water run off into the gutter and not overflowing to the lower foundation area. You should consider having this installed.

Contact a qualified professional.

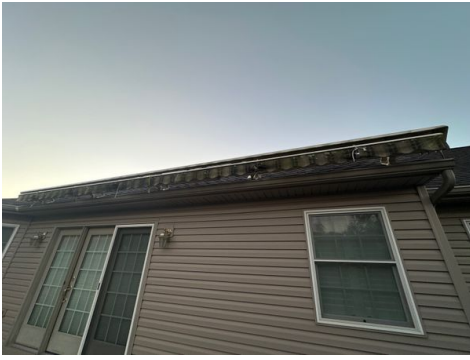
RETRACTABLE AWNING

Retractable awnings are not in the realm of this inspection. During high wind conditions, you should not leave the awning in the open position. Highwinds may cause damage. You should have the homeowner operate the awning for you at your final walk-through.

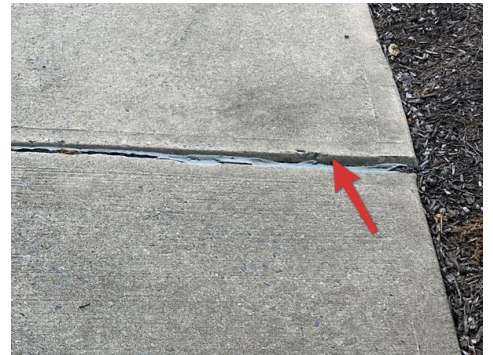
WALKS UNEVEN

The walks are uneven at a few small areas. This is a safety concern-trip hazard, suggest making repairs to create an even and level surface.

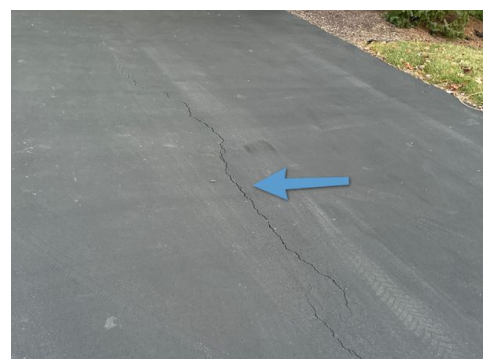
4.2.2 Walkways, Stoops, Steps, Patios & Driveways

DRIVEWAY CRACKING

Cracking was observed. Recommend monitoring and/or have contractor patch/seal.

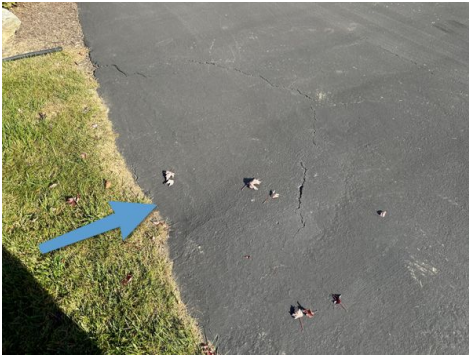
4.2.3 Walkways, Stoops, Steps, Patios & Driveways

The driveway has settled at some areas. This may lead to further damage. You should have the settled areas repaired or replaced.

Contact a qualified professional.

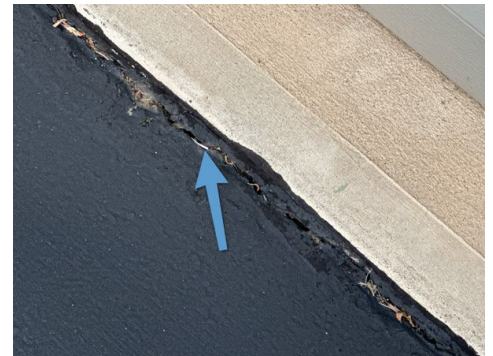
4.2.4 Walkways, Stoops, Steps, Patios & Driveways

SEAL MISSING/DETERIORATED AT GARAGE

The seal at the driveway and garage connection should be replaced to prevent water intrusion and cracking from freeze thaw cycle.

Contact a qualified professional.

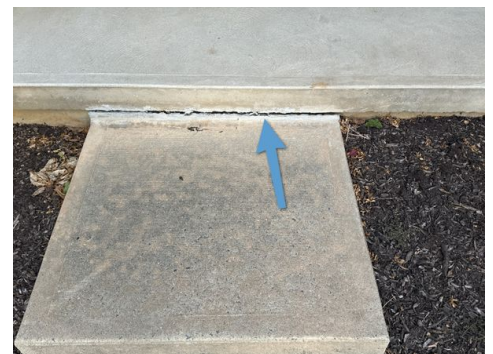
4.2.5 Walkways, Stoops, Steps, Patios & Driveways

There is settlement at the porch, steps, and or stoop. This should be further evaluated and repaired by a qualified professional.

Contact a qualified professional.

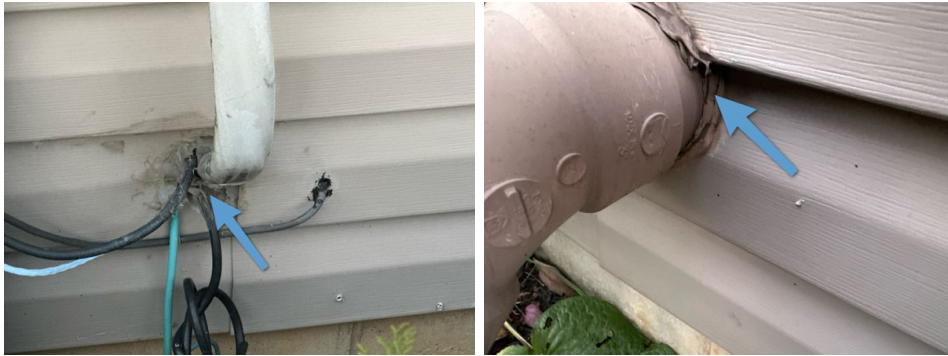
4.4.2 Siding

Caulking is missing where the utility lines or piping enter through the exterior wall. Moisture, pests or insects intrusion is possible. These areas should be caulked with appropriate caulking material.

Contact a qualified professional.

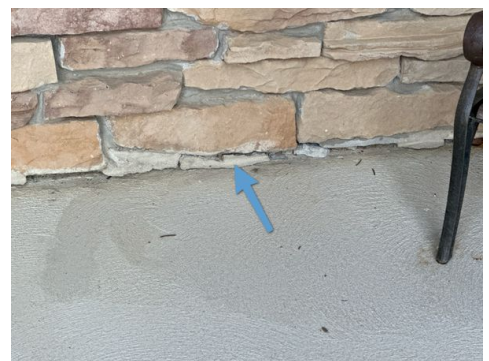
4.4.3 Siding

POINTING/LOOSE MORTAR JOINTS

The masonry mortar joints are deteriorated, loose or missing. Mortar holds the masonry units together and prevents moisture entry. These areas should be further evaluated and repaired by a qualified contractor or mason.

Contact a qualified professional.

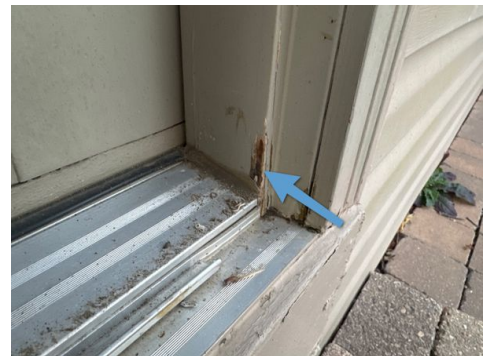
4.5.1 Trim

DETERIORATED PAINT

The paint is deteriorated at various areas of trim. The trim should be re-painted to protect the wood from the exterior extremities.

Contact a qualified professional.

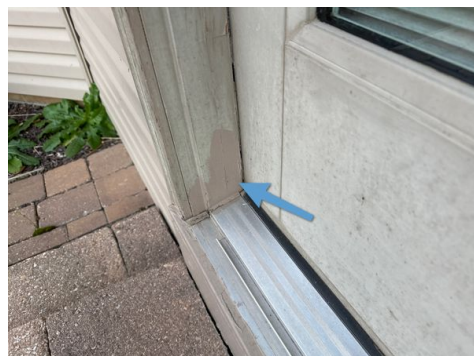
4.5.4 Trim

SIGNS OF PREVIOUS REPAIR

There are signs of previous repair at the exterior trim. Consider asking the current homeowner for more information as to why the repairs were needed.

Contact a qualified professional.

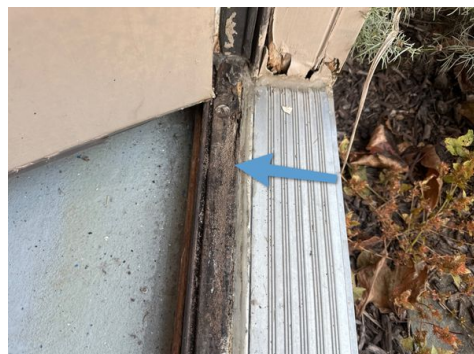
4.6.1 Exterior Doors

DAMAGED THRESHOLD

The threshold is damaged.

Contact a qualified professional.

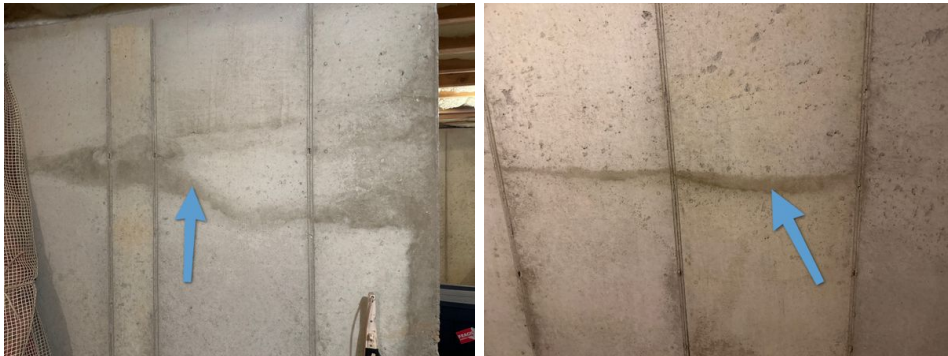
5.2.1 Foundation

Cold pour lines are typically due to the delay between concrete truck delivery. These typically are not harmful to the foundation.

Contact a qualified professional.

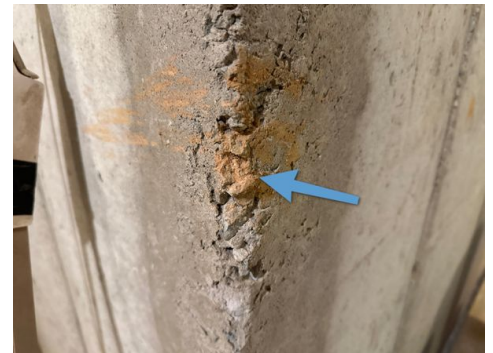
5.2.2 Foundation

There is porous or honey comb areas present. This happens when the different truck loads of concrete are not correctly puddled together during the pouring process. There was no structural concerns at the time of this inspection. The area(s) should be resurfaced repaired/patched by a qualified contractor.

Contact a qualified professional.

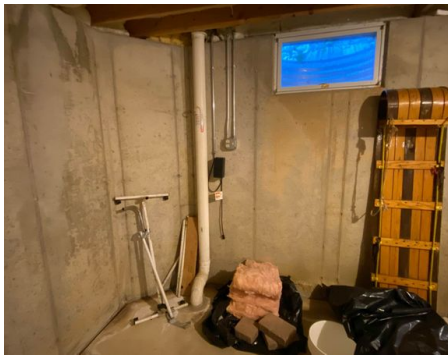
Radon is a naturally occurring radioactive soil gas. This invisible, odorless and tasteless gas is able to travel through the soil and enter buildings. Exposure to radon gas is the leading cause of lung cancer in non-smokers and increases the risk of lung cancer in smokers. You should have your home's indoor air tested at least every two years to determine the amount of radon gas present. If the radon concentration is 4.0 pCi/L or greater, you should have a radon mitigation system installed to reduce the level below 4.0 pCi/L. Go to www.dep.state.pa.us/brp/Radon_Division/Radon_Homepage.htm. You should request a copy of any radon tests performed on this house and retest the house if it has not been tested within the past two years.

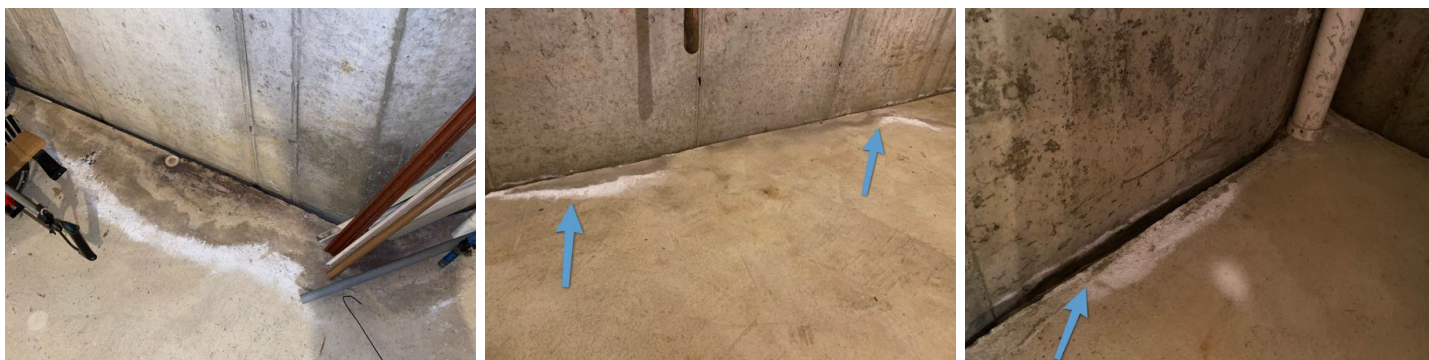
6.7.1 Moisture

EFFLORESCENCE

Efflorescence noted on the wall surface. This a white, powdery deposit that is consistent with moisture intrusion. This can compromise the soil's ability to support the home structure and/or lead to mold growth. Recommend a qualified contractor identify source or moisture and correct.

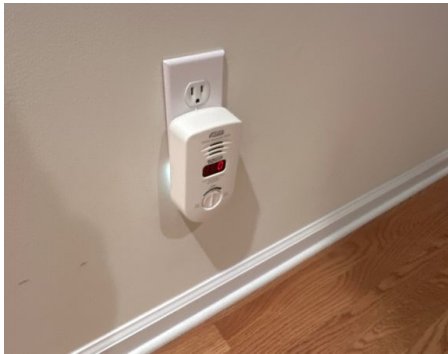
Carbon Monoxide Detectors: Carbon Monoxide Detectors - Plug in Type

Plug-in type carbon monoxide detectors are present. These were not tested. It is not known if these units will be left in the house after settlement. If they are not, you should install carbon monoxide detectors on each level. You should test all carbon monoxide detectors as soon as you occupy the property and monthly thereafter.

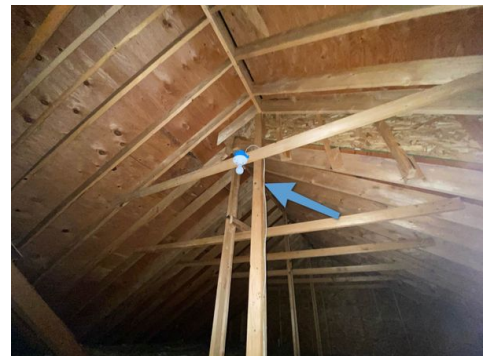
7.6.1 Lighting Fixtures, Switches & Receptacles

LIGHT INOPERABLE

ATTIC

One or more lights are not operating. New light bulb possibly needed.

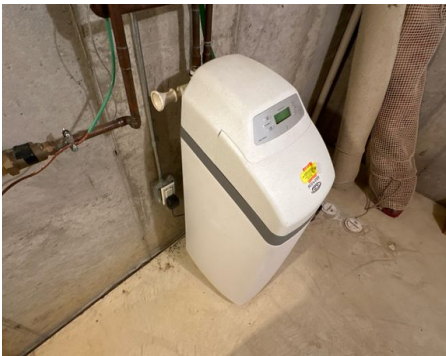
Water Supply, Distribution Systems & Fixtures: Water Treatment Equipment Installed

There is a treatment system installed. These are beyond the scope of this inspection. You should contact the owner for further information or a service company they may use.

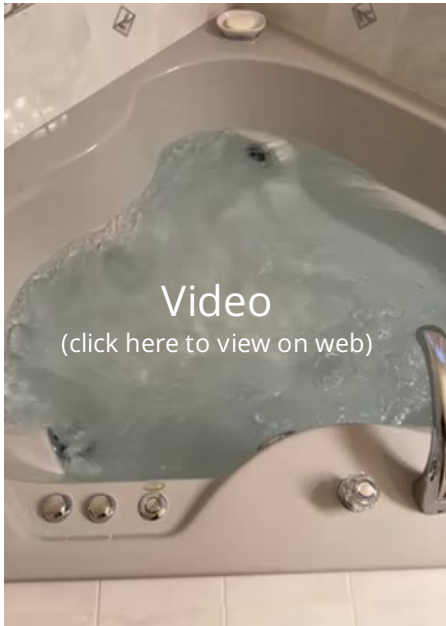
Functional

The Jacuzzi was filled and operated. All areas were functional at the time of this inspection.

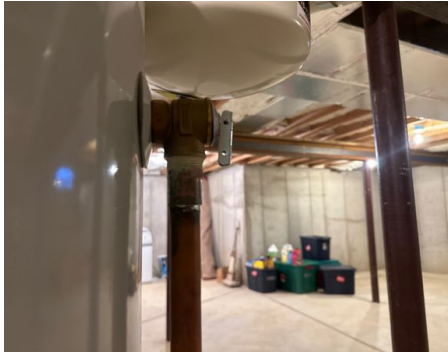
Hot Water Systems: TPR Drain Valve

Present

TPR Valves and Discharge Piping. Temperature/pressure-relief or TPR valves are safety devices installed on water heating appliances, such as boilers and domestic water supply heaters. ... The valve should be connected to a discharge pipe (also called a drain line) that runs down the length of the water heater tank.

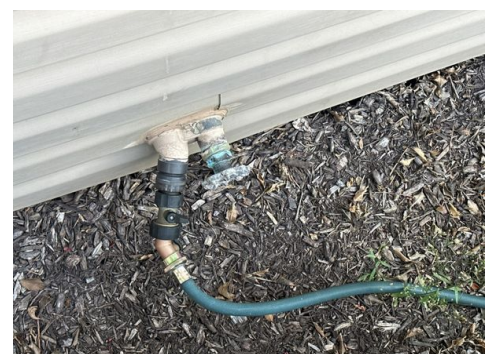
HOSE CONNECTED AND STUCK

The husband cannot be tested do the hose is being installed and stuck on the bib.

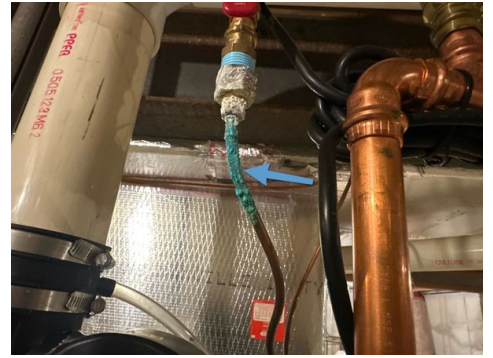
CORRODED VALVES/FITTINGS AND/OR PIPES

Some of the water supply valves, fittings and/or pipes are corroded. Recommend to have a qualified plumber further evaluate and follow their recommendations.

Contact a qualified professional.

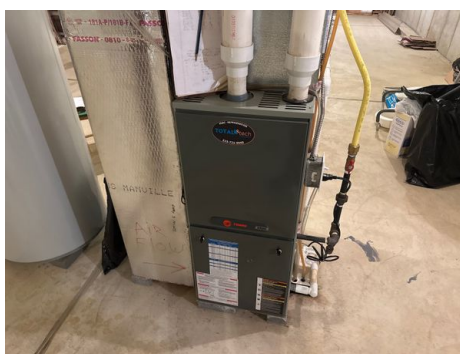
Furnace Equipment: Location
Basement

Furnace Equipment: Fuel Source
Gas

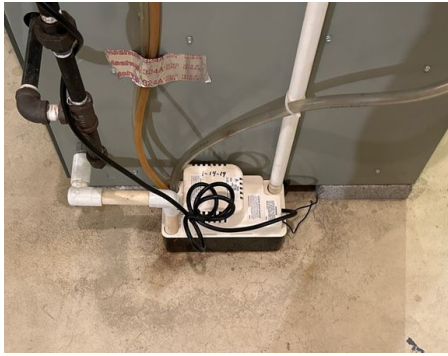
Interior A/C Unit/Handler: Condensate Pump

The indoor unit cooling coil drains into a condensate pump. Testing or evaluation of this is beyond the scope of this inspection. The pump appeared serviceable at the time of this inspection.

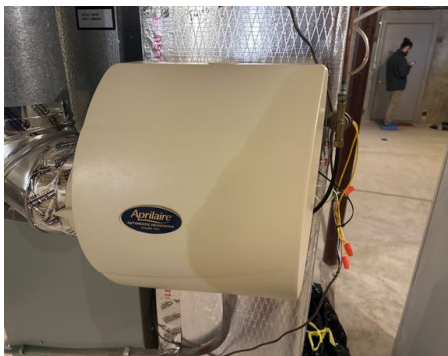
Interior A/C Unit/Handler: Humidifier Present

There is a humidifier installed at the interior unit. These supply moisture to the air. These are beyond the scope of this inspection. You should follow the manufactures instructions for maintenance.

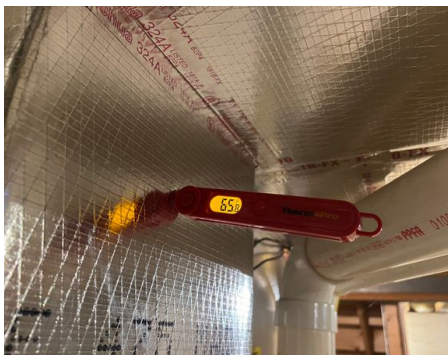
14 to 22 Degrees

The cooling system was operated and found to be functional. The above listed temperature value representing the temperature split across the cooling coil, which is the difference between the supply air temperature and return air temperature. This is typical of a system operating properly. Periodic maintenance including servicing by a professional is recommended to ensure optimal performance.

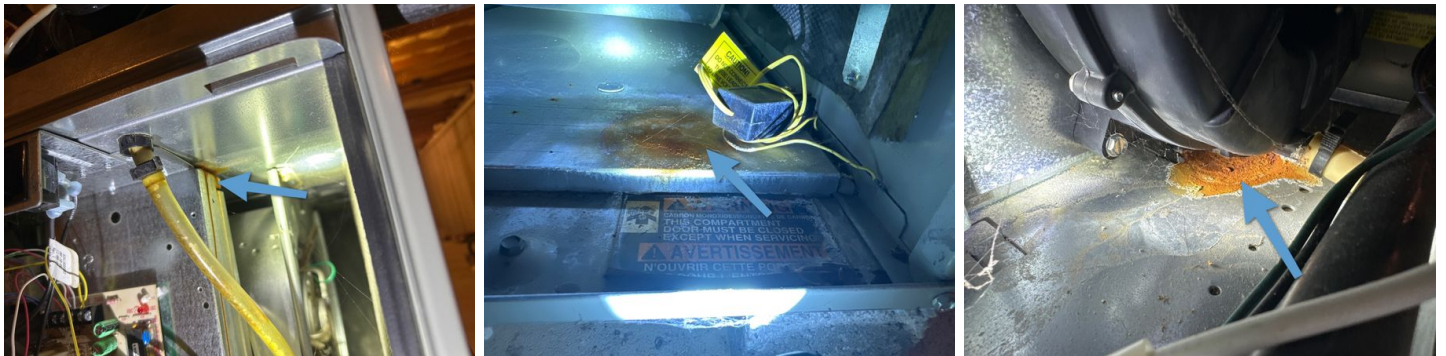
**CORROSION/RUST**

Furnace was corroded or rusted in one or more areas. This could be the result of standing water, leakage from air conditioning condensate, humidifiers, overhead plumbing leaks or improper venting/condensation of exhaust products. This should be further evaluated.

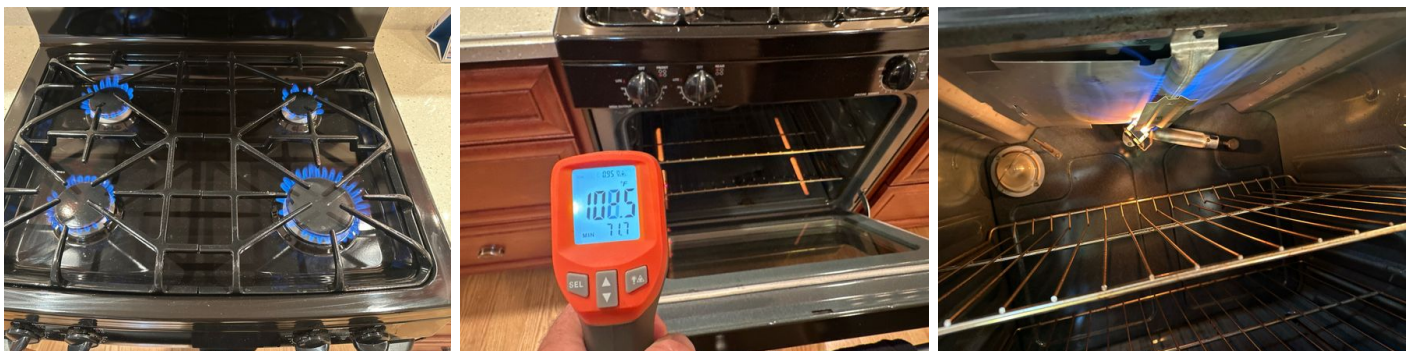
Range/Oven/Wall Oven/Cooktop: Functional
 Functional

The range was operated and was functional at the time of this inspection. The oven was only operated or tested long enough to verify its function. It was not tested to reach any specific temperature.

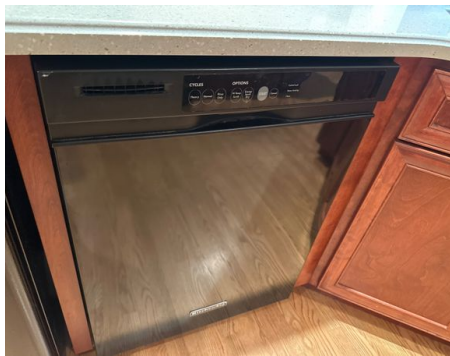
Dishwasher: Functional

The dishwasher was tested in a short cycle and was functional at the time of this inspection.

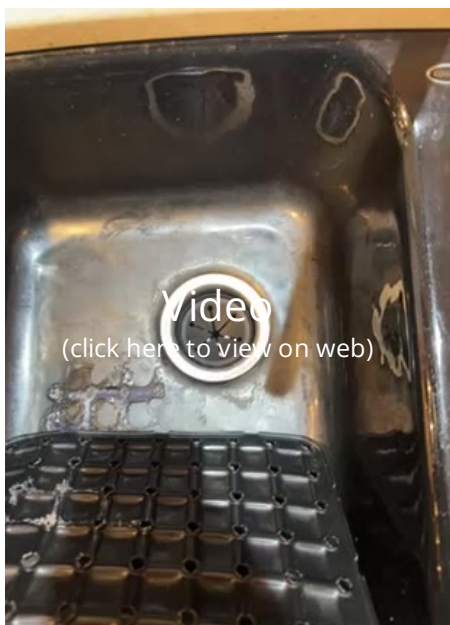
Garbage Disposal: Functional

The disposal was tested and appeared to be functional at the time of this inspection.

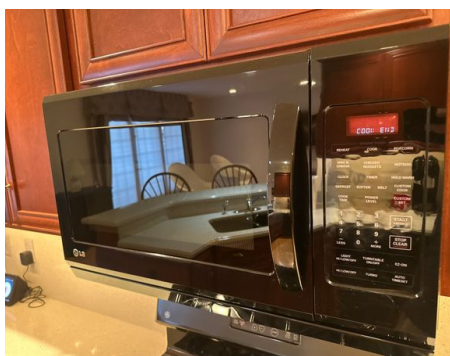
Built-in Microwave: Functional

The microwave was tested and appeared to be in serviceable condition at the time of this inspection.

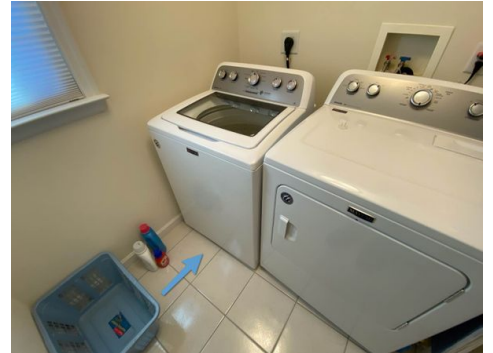
MISSING DRIP PAN

There is no drip pan present. When located on or above finished spaces you should have a drip pan installed beneath the washer to prevent possible moisture damage.

Contact a qualified professional.

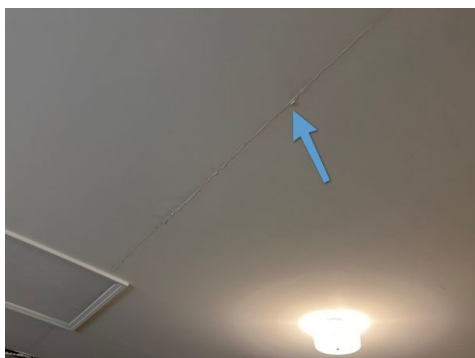
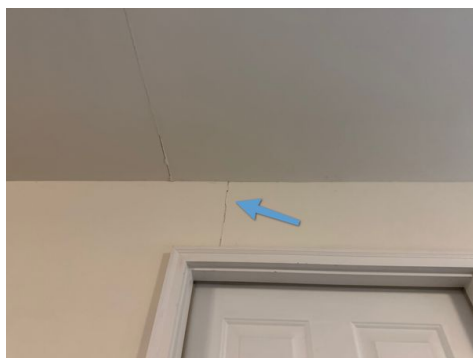
CRACKS & NAIL POPS

There are cracks and nail pops. These are associated with normal settlement of the building. The areas should be repaired.

Contact a qualified professional.

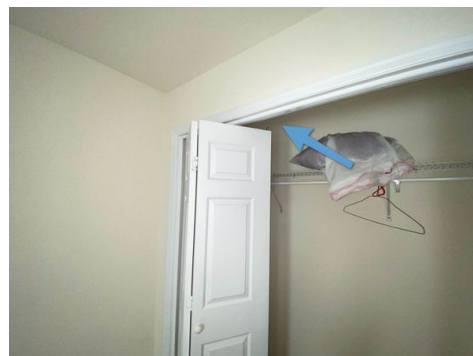
Door was off sliding track. Repair recommended.

Contact a qualified professional.

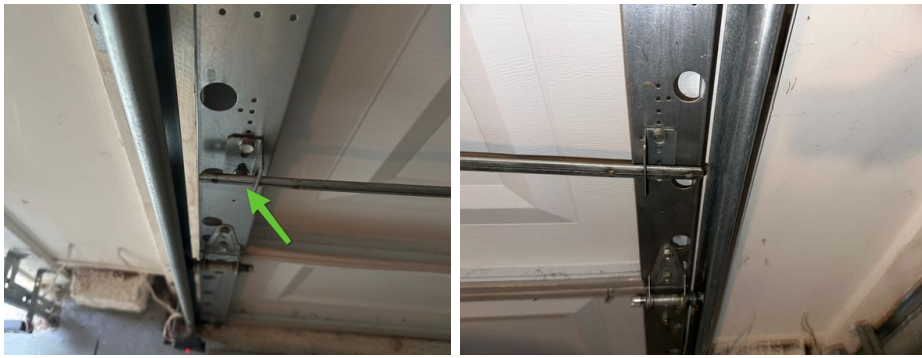
Garage Door: Locks on Door with Opener

Manual locks are installed on the door with automatic opener. Should the lock be engaged and the door opener be activated, it could cause damage to the garage door, it's opener and or other components of this system.

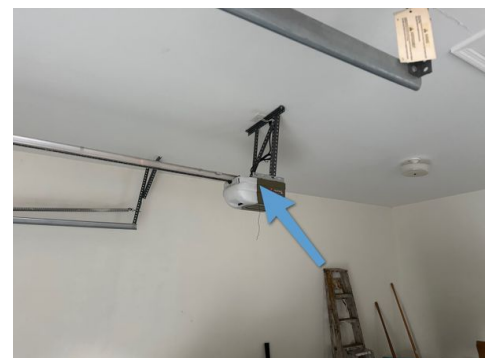
The garage door opener is not functional. This should be repaired by a qualified professional.

Contact a qualified professional.
