## RESIDENTIAL REPORT

3155 Balsam Rd  
CENTER VALLEY, PA 18034

MAY 7, 2024

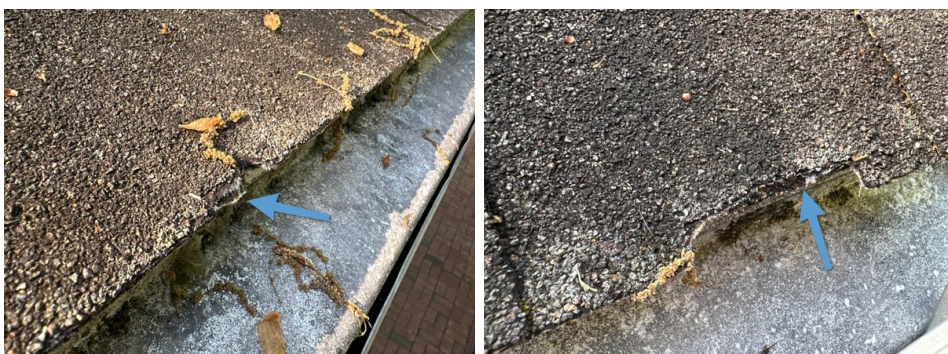
### DAMAGE/DETERIORATION

There is damage and or deterioration present. This has caused wear and some loss of protective granules. You should monitor the areas for any further deterioration and repair or replace as needed.

Contact a qualified professional.

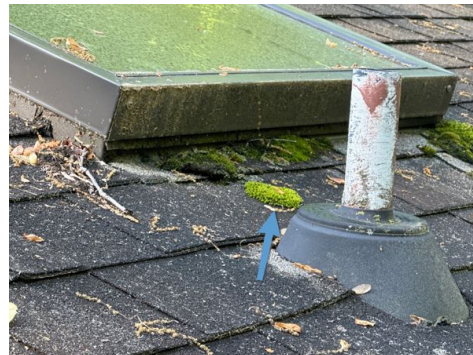
3.2.2 Pitched Roof Asphalt Shingles

The asphalt roofing has moss lichens on the surface. This is mostly cosmetic however this type of moss or fungus will eventually wear on the roofing surface. You should periodically monitor the areas.

Contact a qualified professional.

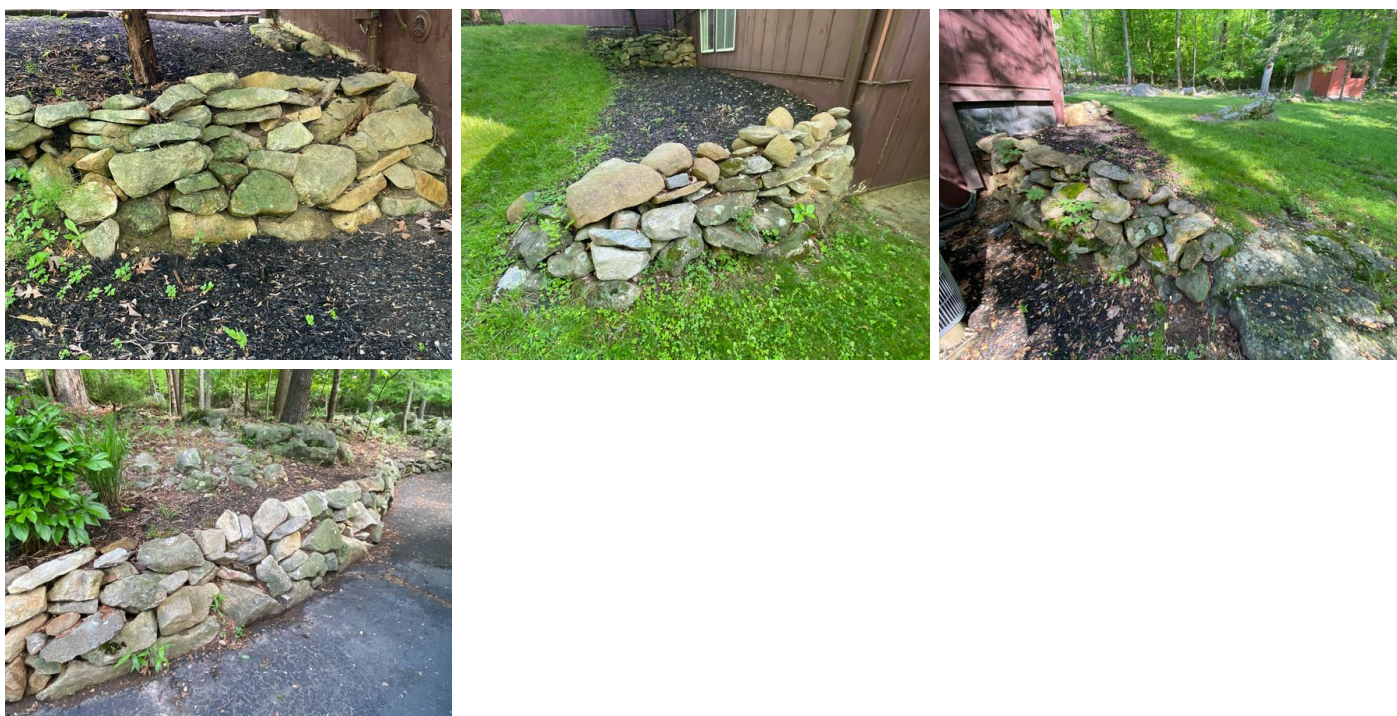
**Retaining Walls: Material**

Stone

There are retaining walls present. These walls should be constructed correctly and stable.

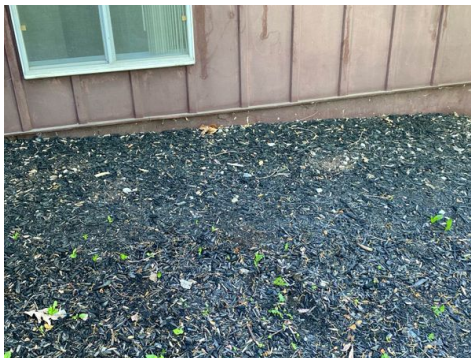
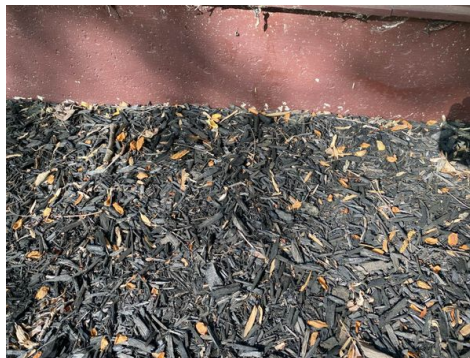
MULTIPLE LOCATIONS

There is mulch or stone around the perimeter at some areas. Due to this type of cover we were unable to view for proper grade height at the time of this inspection.

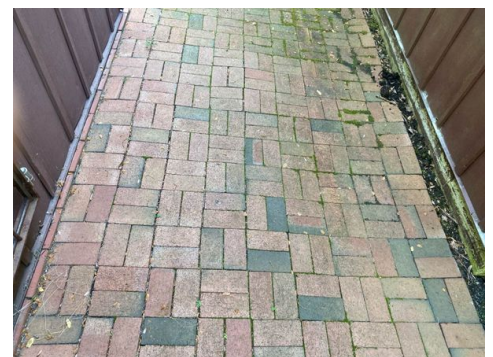
4.2.1 Walkways, Stoops, Steps, Patios & Driveways

### WALKS UNEVEN

The walks are uneven at a few small areas. This is a safety concern-trip hazard, suggest making repairs to create an even and level surface.

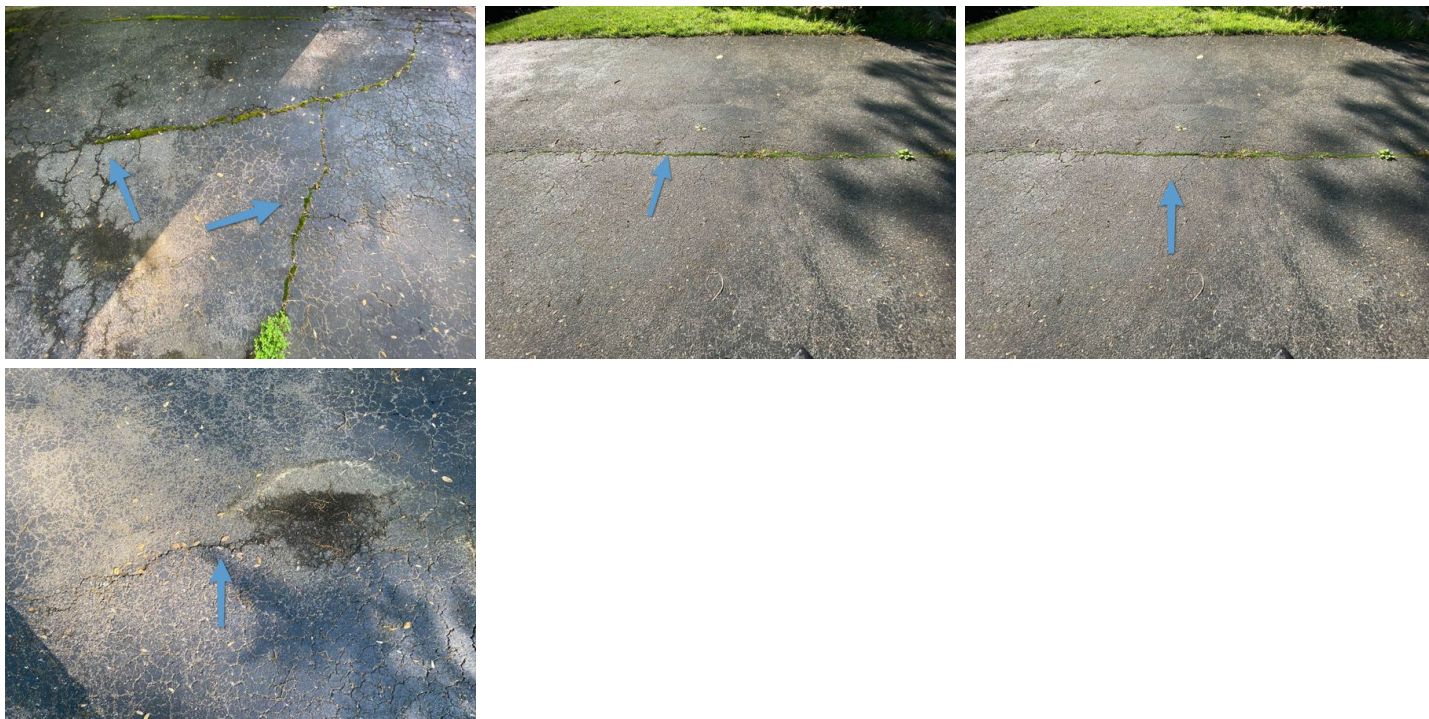
4.2.2 Walkways, Stoops, Steps, Patios & Driveways

### DRIVEWAY CRACKING

Cracking was observed. Recommend monitoring and/or have contractor patch/seal.

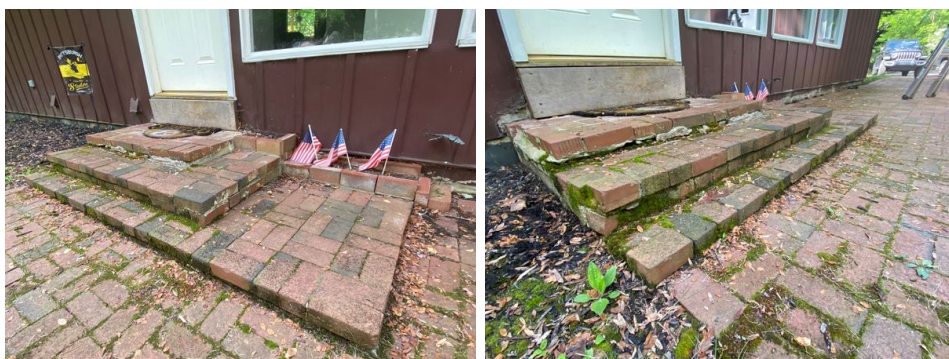
4.2.3 Walkways, Stoops, Steps, Patios & Driveways

Walkways are draining towards the building. This may allow water to enter the basement area. You should have a qualified contractor further evaluate and repair or replace the concrete. Note: At the very least you should seal between the walkway and foundation with an appropriate sealing material.

Contact a qualified professional.

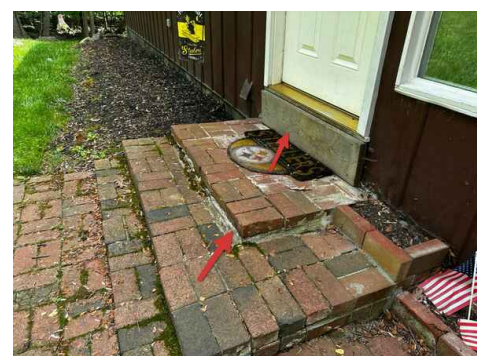
4.2.4 Walkways, Stoops, Steps, Patios & Driveways

Riser height is uneven. This is considered a trip hazard.

Contact a qualified professional.

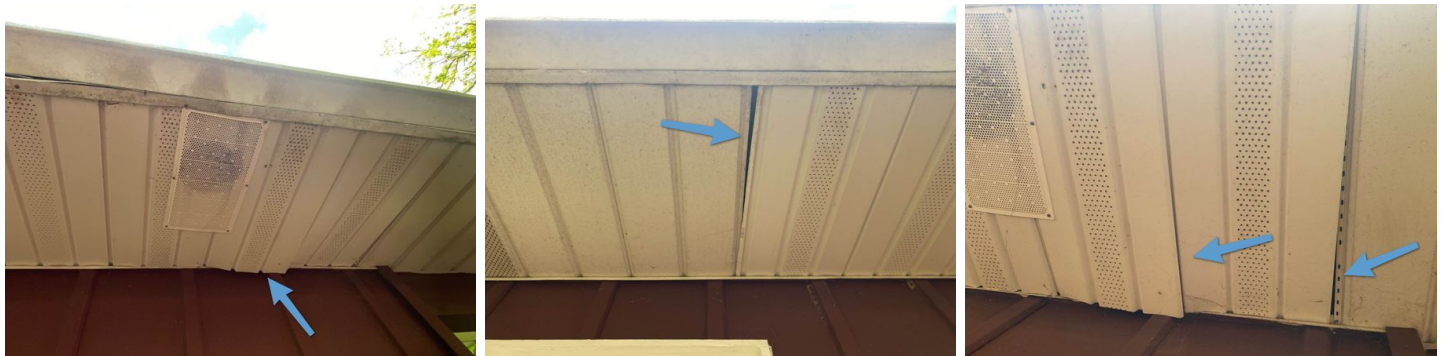
4.3.1 Soffit & Facia

**LOOSE/DAMAGED OR MISSING SOFFIT**

The soffit is loose, damaged or missing. Consider repair to prevent pest intrusion or further damage.

Contact a qualified professional.

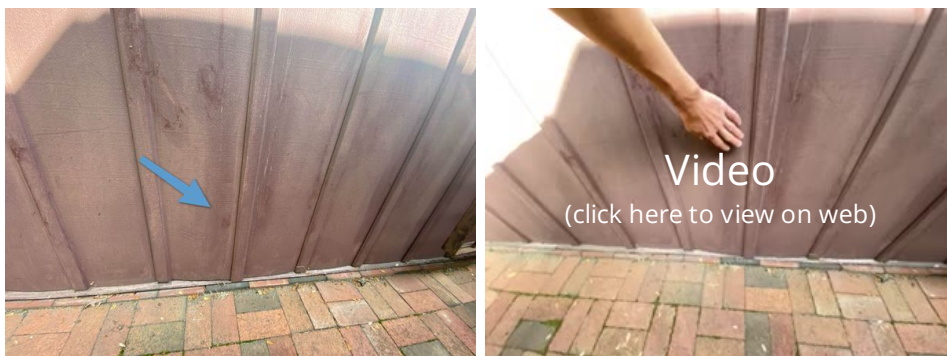
4.4.1 Siding

**LOOSE SIDING**

The siding is loose at various areas. Loose siding can allow moisture or insects to enter. The siding provides important weather protection. The siding should be repaired or replaced.

Contact a qualified professional.

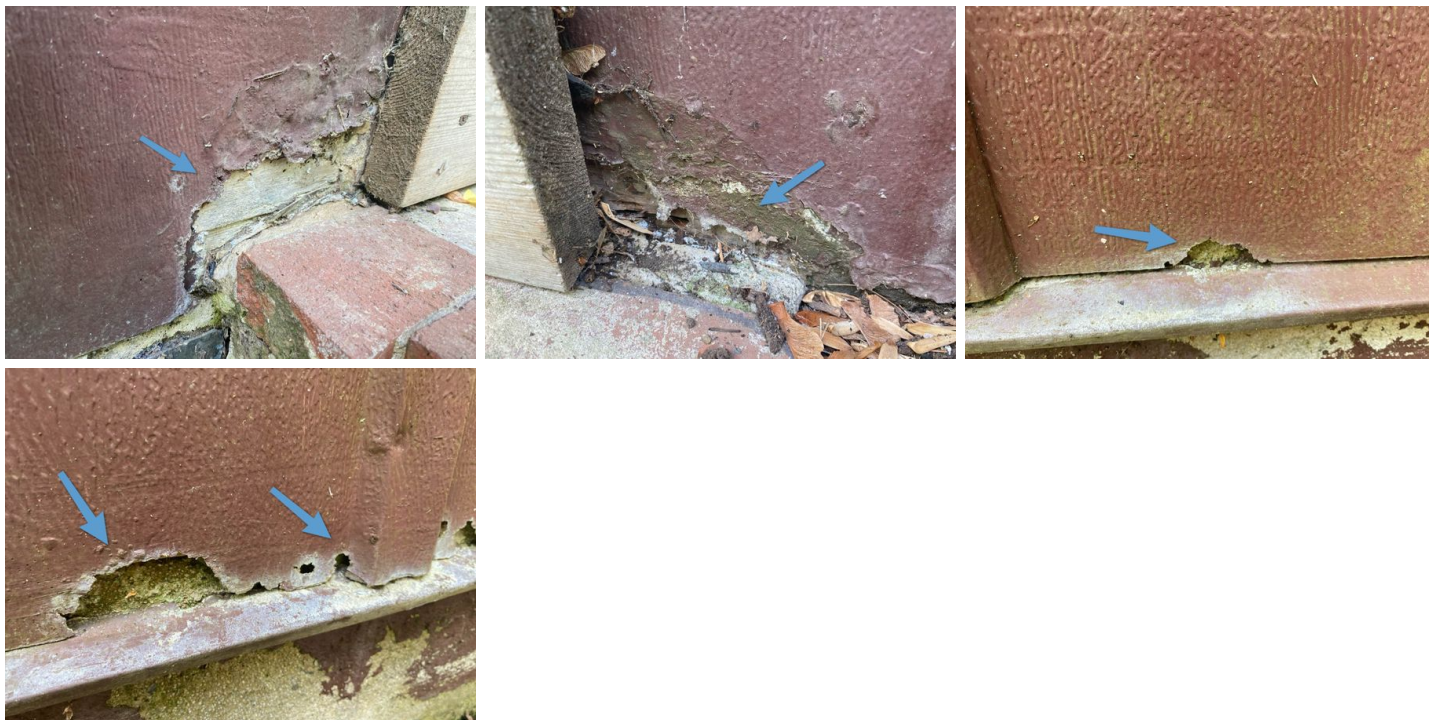
4.4.2 Siding

**DAMAGED AND/OR DETERIORATED SIDING**

The siding is damaged and/or deteriorated at areas. Siding is the protection for the building and any damage or deterioration could allow moisture and weather intrusion, causing further damage and expense. The siding material should be repaired or replaced as needed to make a weather-tight envelope for the building.

Contact a qualified professional.

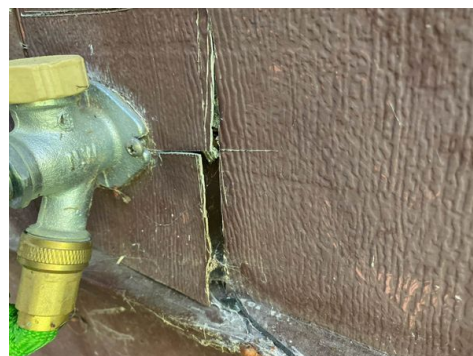
4.4.3 Siding

**CRACKING**

HOSE BIB FRONT RIGHT

Siding showed cracking in one or more places. This is a result of temperature changes, and typical as homes age. Recommend sealing and monitoring.

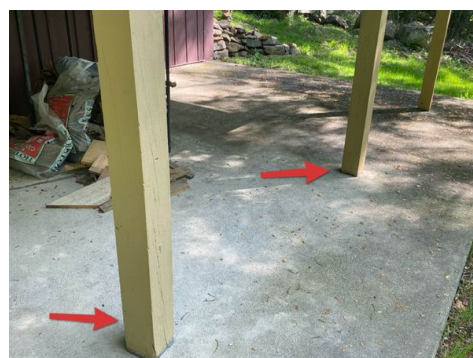
The deck posts are resting on the patio. Decks should sit on concrete footers. These footers should be 36" deep to penetrate below the permafrost line. Recommend to have a qualified contractor further evaluate and follow their recommendations.

Contact a qualified professional.

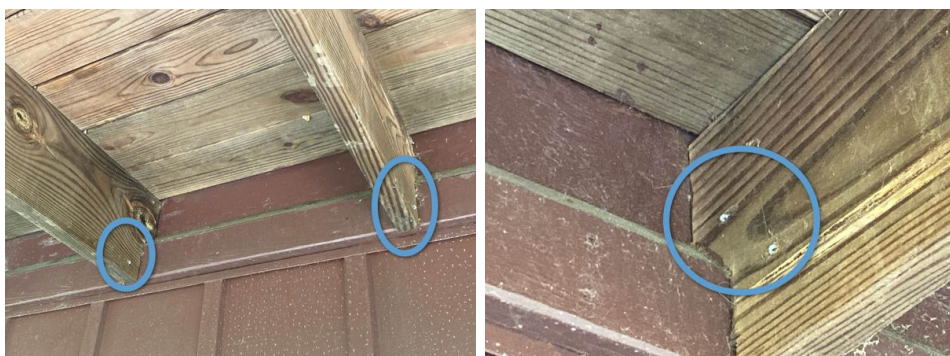
4.8.2 Decks, Balconies, Porches & Steps

**SCREWS USED AT JOISTS**

Contact a qualified professional.

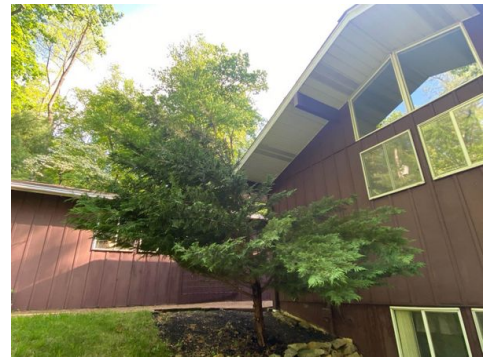
4.10.1 Vegetation, Grading & Drainage

The trees or bushes are close or touching the dwelling. This can retain moisture at the siding areas which may allow for mold/mildew. You should trim these areas back to allow for proper air flow.

Contact a qualified professional.

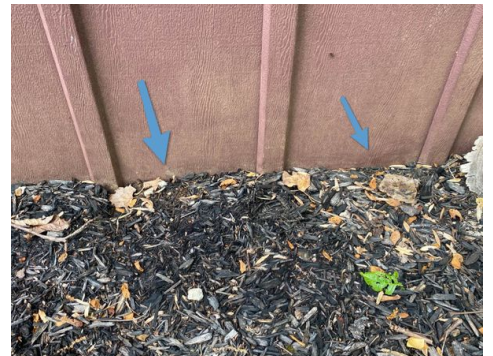
4.10.2 Vegetation, Grading & Drainage

The grading is high at areas. This can allow moisture or insect penetration. The ground should be at least 2 to 3 inches below the siding or top of the foundation.

Contact a qualified professional.

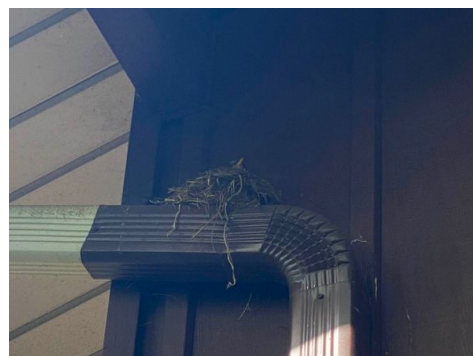
4.11.1 Pest Indications

There is birds nesting. We recommended calling a qualified pest control company to mitigate.

Contact a qualified professional.

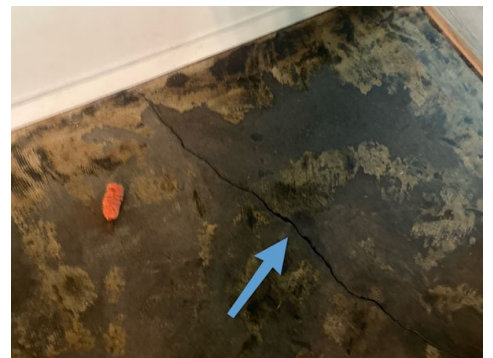
### TYPICAL SETTLEMENT CRACKING

There is typical settlement cracking in the basement concrete floor.

Contact a qualified professional.

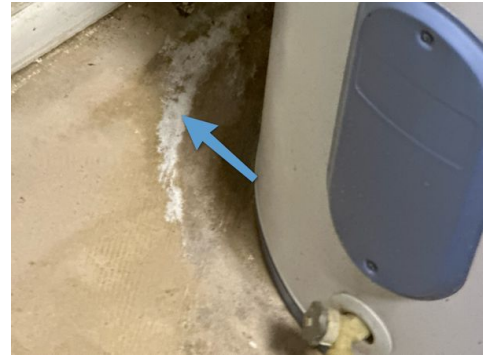
### 6.6.1 Moisture

#### **EFFLORESCENCE**

Efflorescence noted on the wall surface. This a white, powdery deposit that is consistent with moisture intrusion. This can compromise the soil's ability to support the home structure and/or lead to mold growth. Recommend a qualified contractor identify source or moisture and correct.

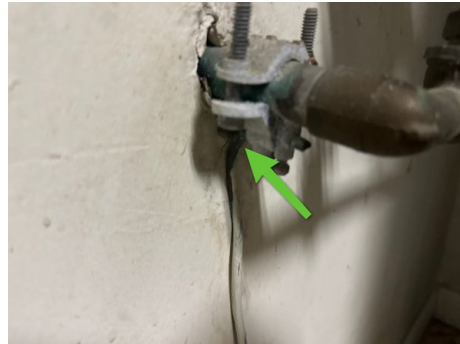
### Grounding & Bonding: Service Grounding Location

Street Side of Plumbing Meter

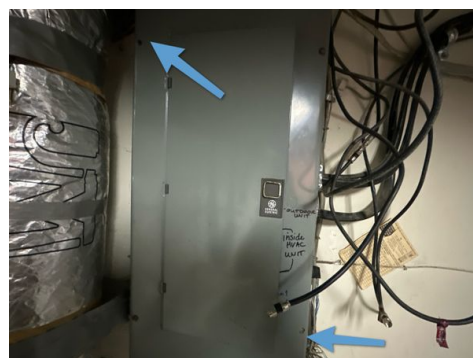
### 7.4.1 Main & Subpanels & Main Overcurrent Device

#### MISSING SCREWS

There are screws missing at the panel cover. The screws should be replaced.

Contact a qualified professional.

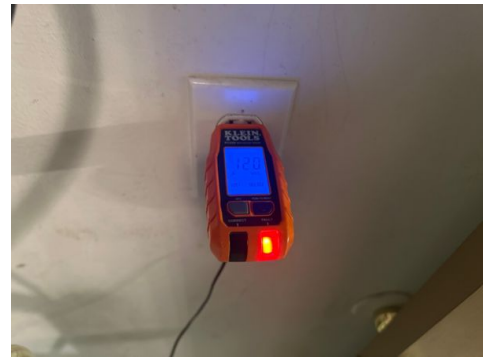
7.6.1 Lighting Fixtures, Switches & Receptacles

**UNGROUND RECEPTACLE**

LAUNDRY

One or more receptacles are ungrounded. To eliminate safety hazards, all receptacles should be grounded.

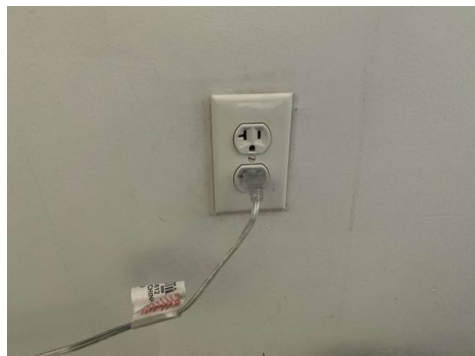
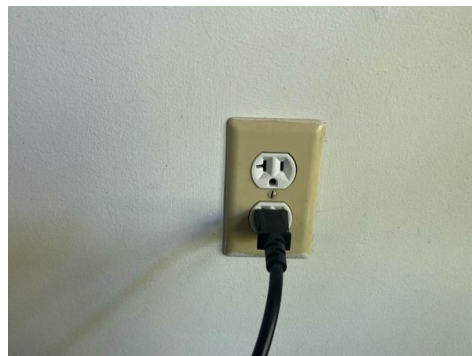
7.6.2 Lighting Fixtures, Switches & Receptacles

**LOOSE RECEPTACLES AND OR JUNCTION BOX**

There are loose outlets and or junction boxes present. This could cause a short circuit. These outlets should be repaired or replaced.

Contact a qualified professional.

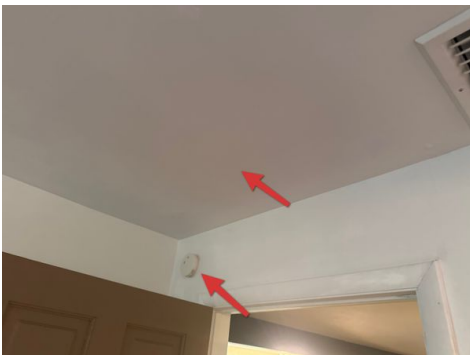
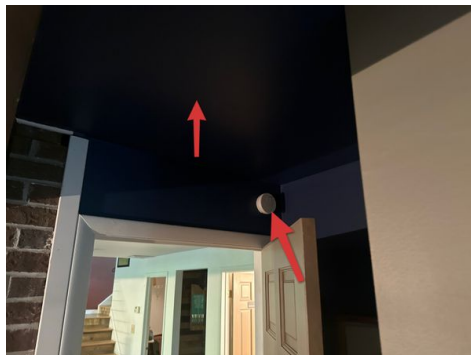
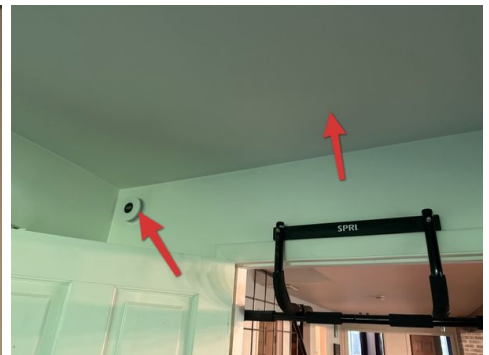
7.8.1 Smoke Detectors

**INAPPROPRIATE LOCATION**

Smoke detector effectiveness may be compromised due to location. Recommend relocating according to manufacturers instructions. Note: Alarms should not be positioned over bedroom doorways. The alarm should be installed at the ceiling area at least 12" away from the wall.

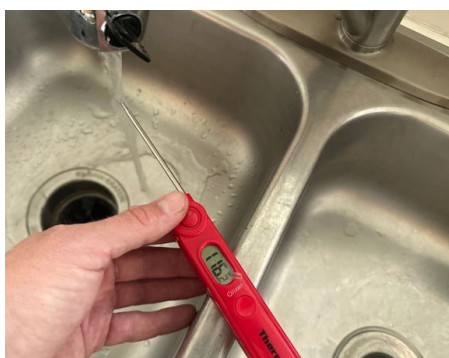
## Hot Water Systems: Functional

The water heating system was tested at various areas. The hot water heating system was functional at the time of this inspection.

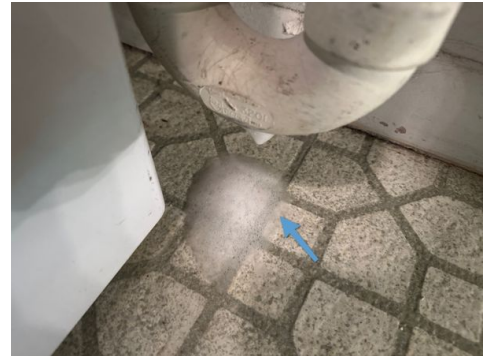
##### LAUNDRY TRAP

A drain, waste and/or vent pipe showed signs of a leak. Recommend contacting a qualified plumber for further evaluation.

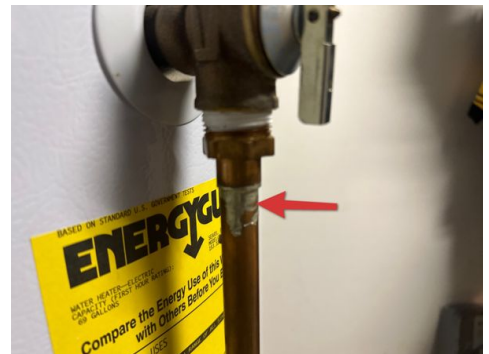
Safety Defects

Recommendation

Contact a qualified professional.

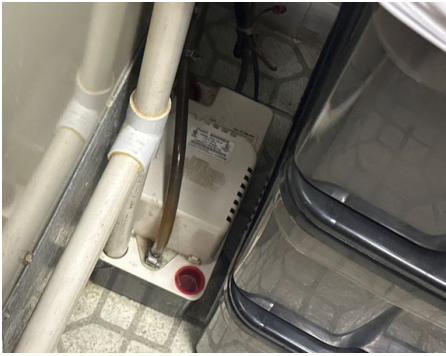
### Interior A/C Unit/Handler: Condensate Pump

The indoor unit cooling coil drains into a condensate pump. Testing or evaluation of this is beyond the scope of this inspection. The pump appeared serviceable at the time of this inspection.

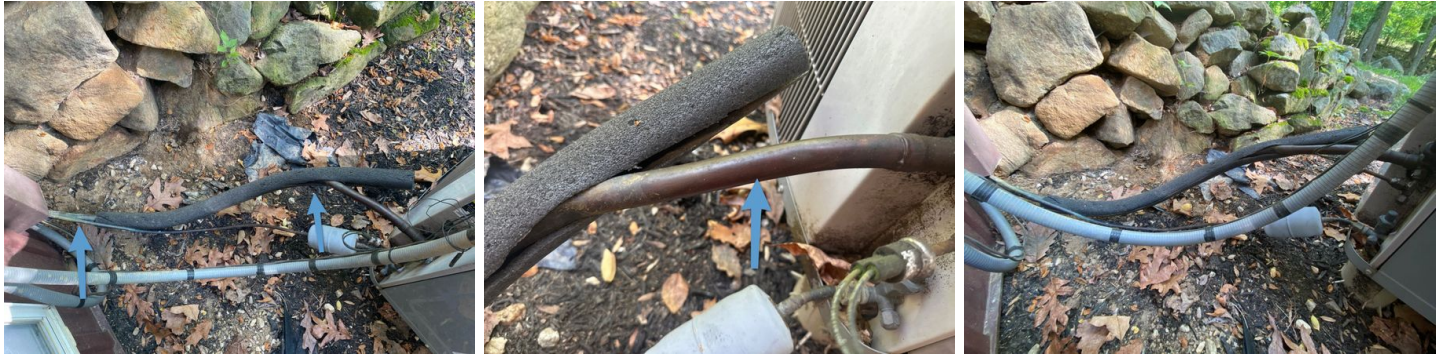
**DAMAGED OR MISSING REFRIGERANT LINE INSULATION**

The refrigerant line insulation jacket is damaged or missing. This may cause a reduction in operational efficiency. The insulation jacket should be repaired or replaced.

Recommendation

Contact a qualified professional.

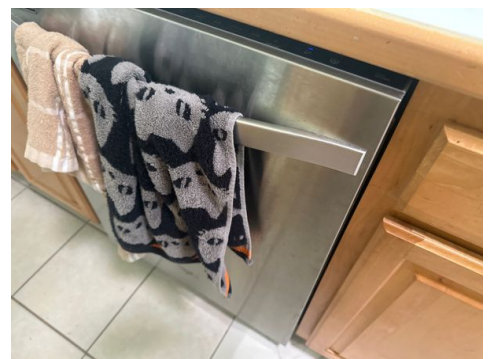
The dishwasher door falls open. This can be a safety concern. This should be further evaluated for repair or replacement.

Recommendation

Contact a qualified professional.

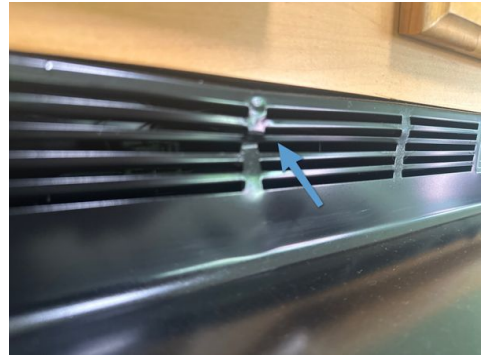
12.5.1 Kitchen Exhaust

**LOOSE/DAMAGED HARDWARE**

Loose and or damaged hardware is present..

Recommendation

Contact a qualified professional.

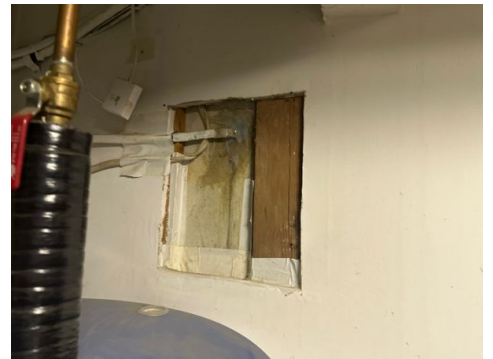
### 13.3.1 Walls

#### DAMAGED WALLS

There is damage present. The damaged area(s) should be repaired.

Recommendation

Contact a qualified professional.

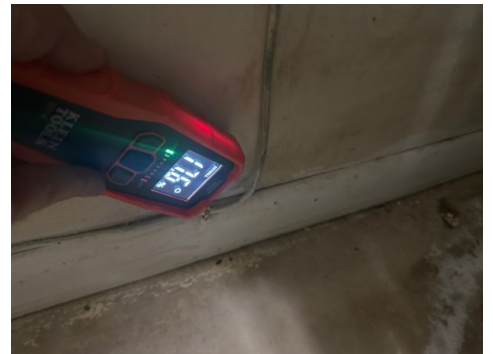
### 13.3.2 Walls

#### STAINS WERE TESTED AND DRY

There were stains that were tested and appeared to be dry at the time of this inspection. This appears to be from a previous water leak that was not active. You should monitor the area(s).

Recommendation

Contact a qualified professional.

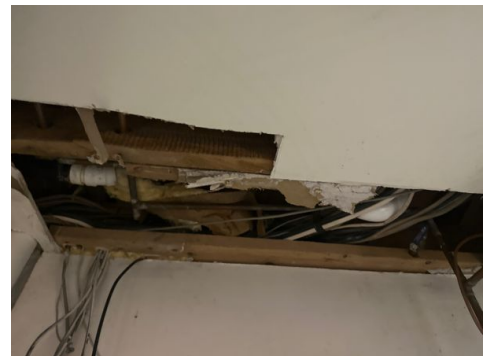
### 13.4.1 Ceilings

#### DAMAGED CEILING

There are areas of the ceiling which are damaged. It is unknown as to why this is present. Recommend to have a qualified contractor further evaluate and repair.

Recommendation

Contact a qualified professional.

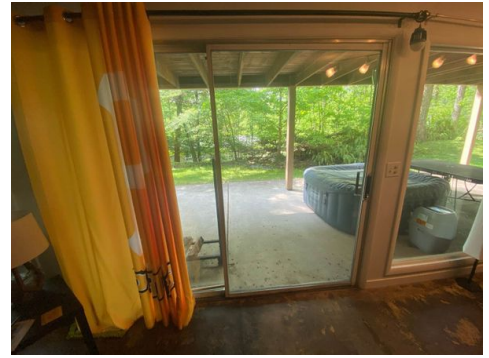
13.6.1 Doors

One or more doors take excessive force to operate. Repair by a qualified professional is recommended.

Recommendation

Contact a qualified professional.

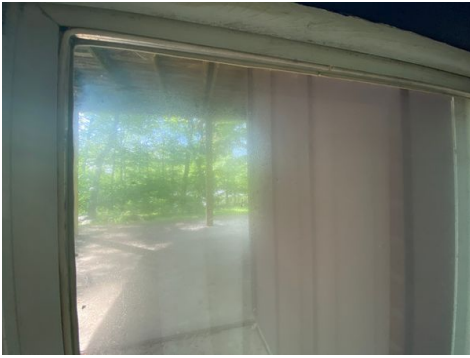
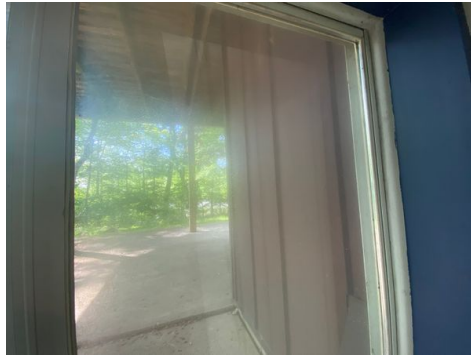
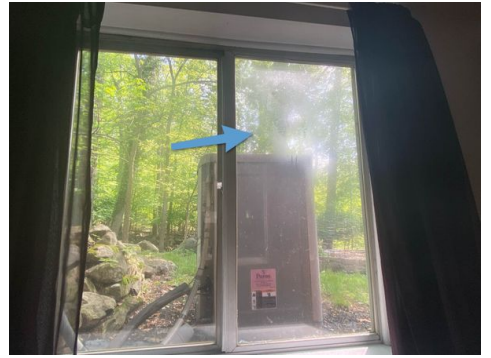
13.7.1 Windows

MULTIPLE LOCATIONS

Observed condensation between the window panes, which indicates a failed seal. Recommend further evaluation by a qualified contractor for repair or replacement.

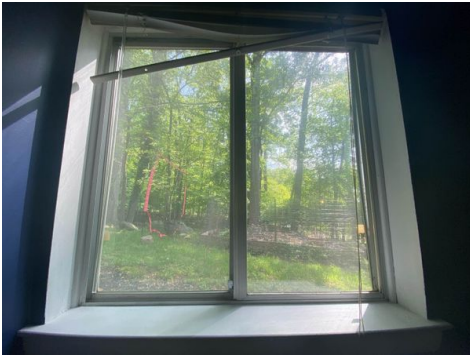
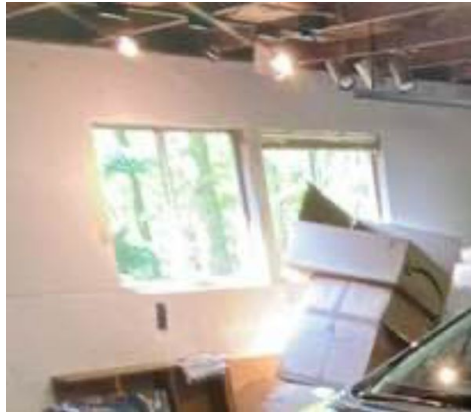
One or more windows take excessive force to operate. Repair by a qualified professional is recommended.

Recommendation

Contact a qualified professional.

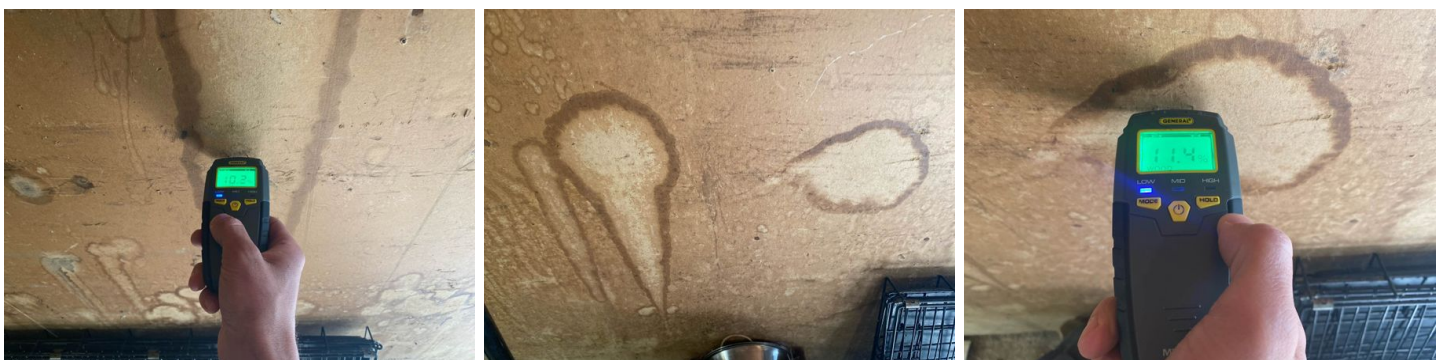
### STAINS TESTED AND DRY

There were stains that were tested and appeared to be dry at the time of this inspection. This appears to be from a previous water leak that was not active. You should monitor the area(s).

Recommendation

Contact a qualified professional.

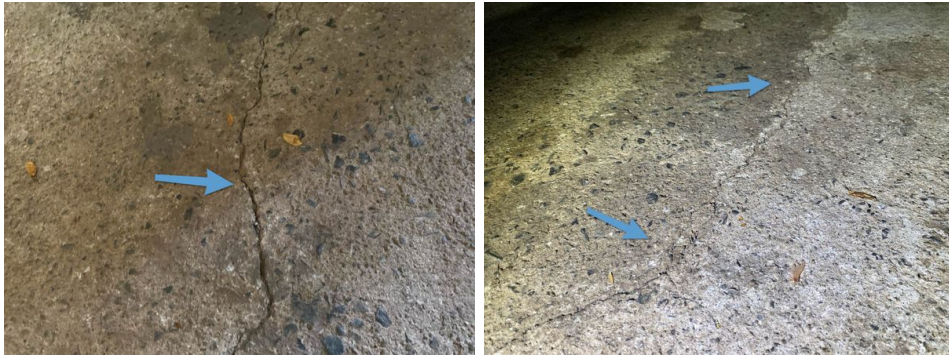
16.3.1 Floor

### TYPICAL SETTLEMENT CRACKS

Typical settlement cracks were visible in the garage floor. The floor appeared serviceable at the time of this inspection.
