RESIDENTIAL REPORT

3525 Regent Ct
Allentown, PA 18103

Creighton Faust
SEPTEMBER 20, 2023

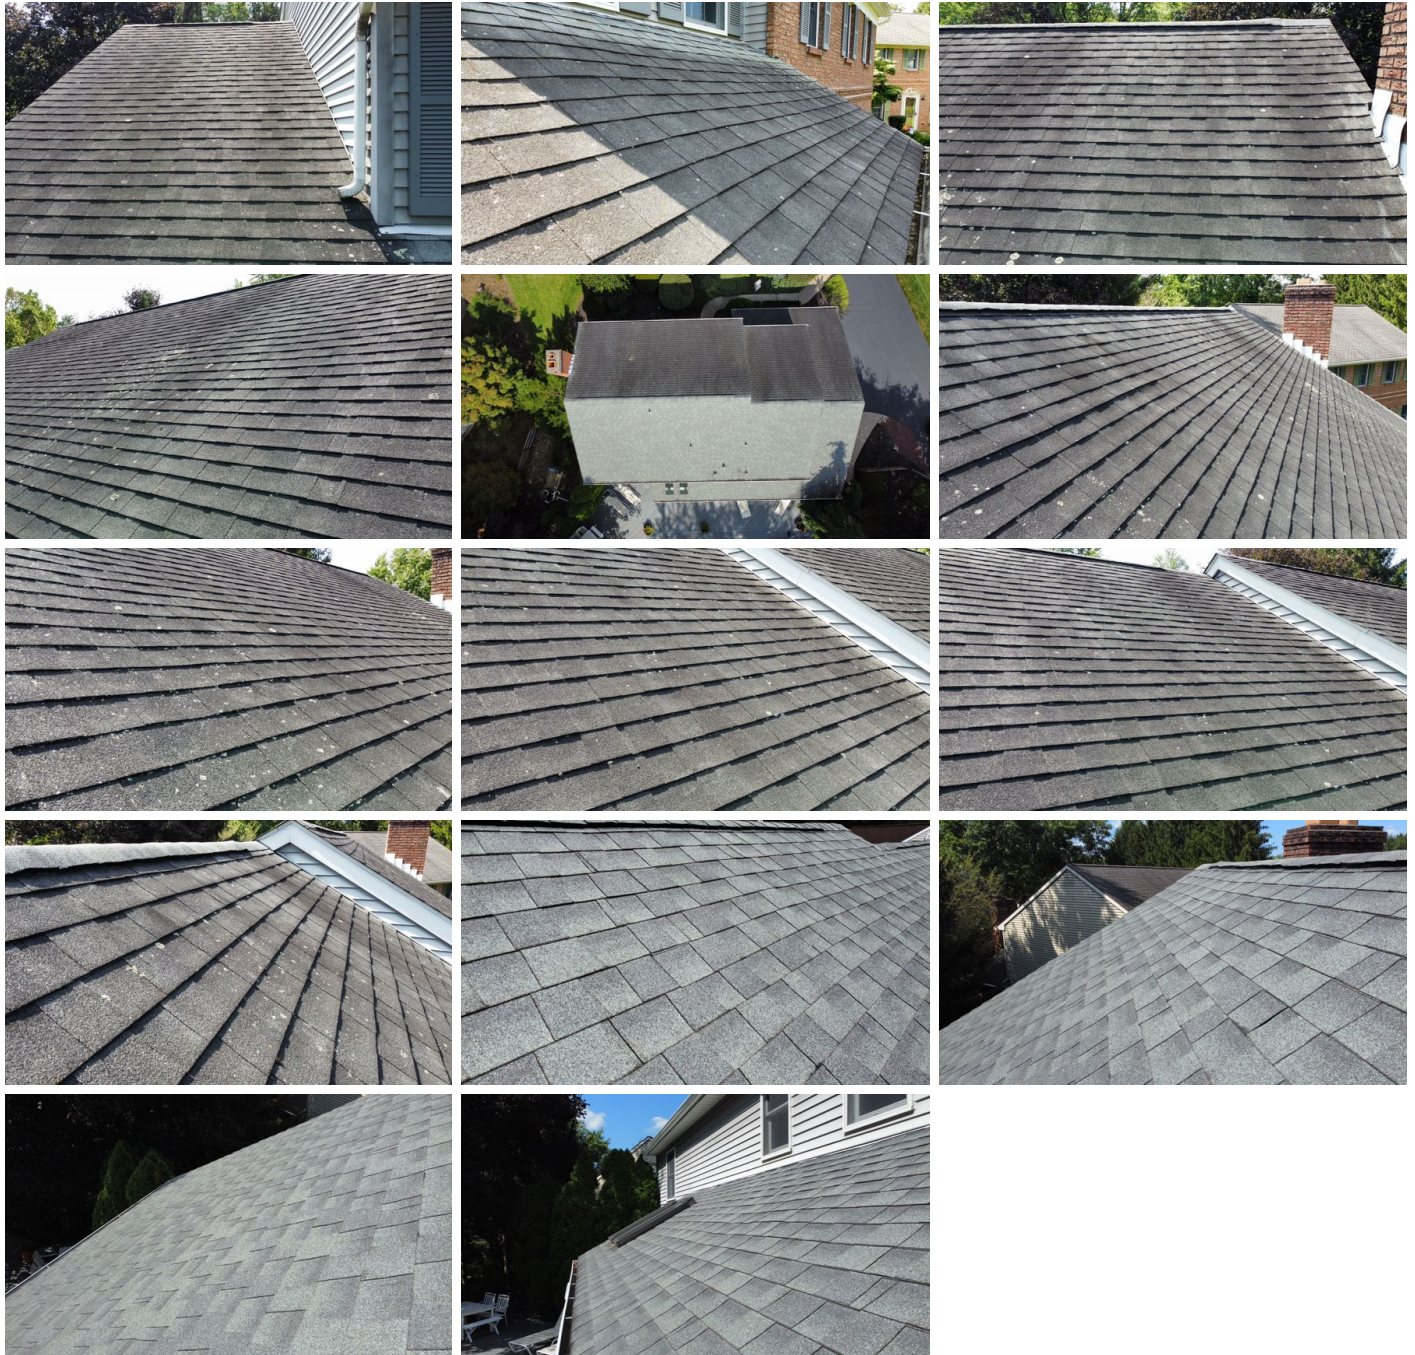
Roof Drainage Systems: Upper Roof Discharges onto Lower Roof

The upper downspouts are discharging onto the lower roof. This may cause premature wear to the roofing material. You may consider extending the downspouts to the lower gutter.

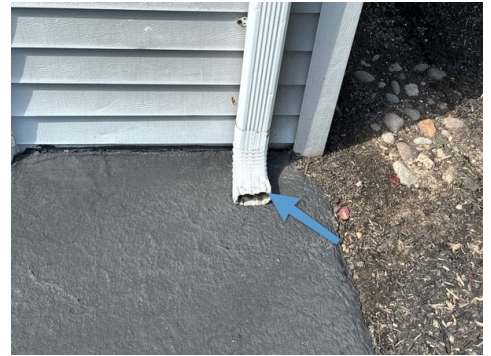
DOWNSPOUTS DRAIN NEAR HOUSE

One or more downspouts drain too close to the home's foundation. This can result in excessive moisture in the soil at the foundation, which can lead to foundation/structural movement. You should install downspout extensions to drain at least 6 feet from the foundation.

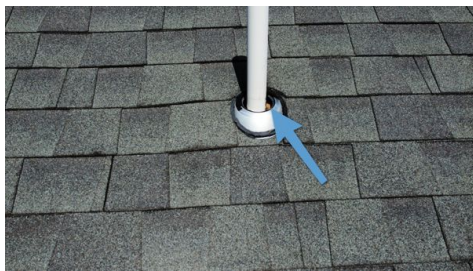
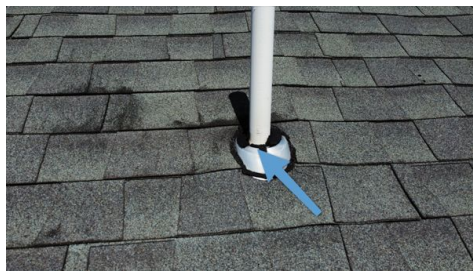
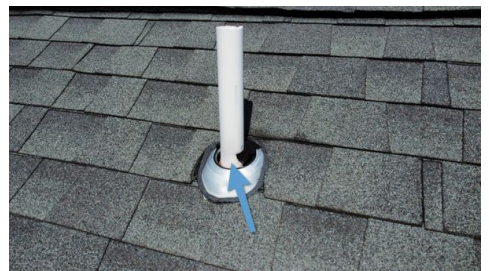
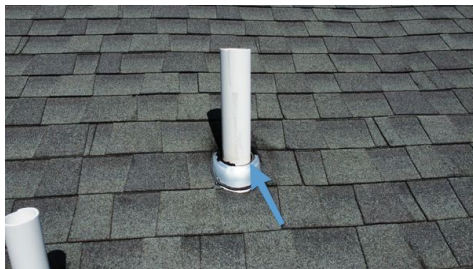
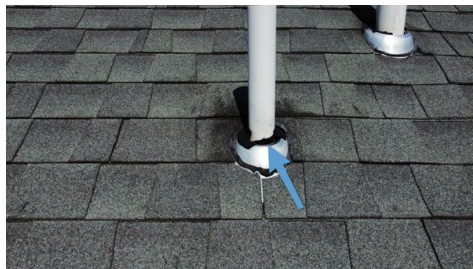
VENT COLLAR FLASHINGS SEPARATED/DAMAGED

The vent collar flashings are separated or worn and may be leaking. This could lead to further damage. You should have the flashings repaired or replaced.

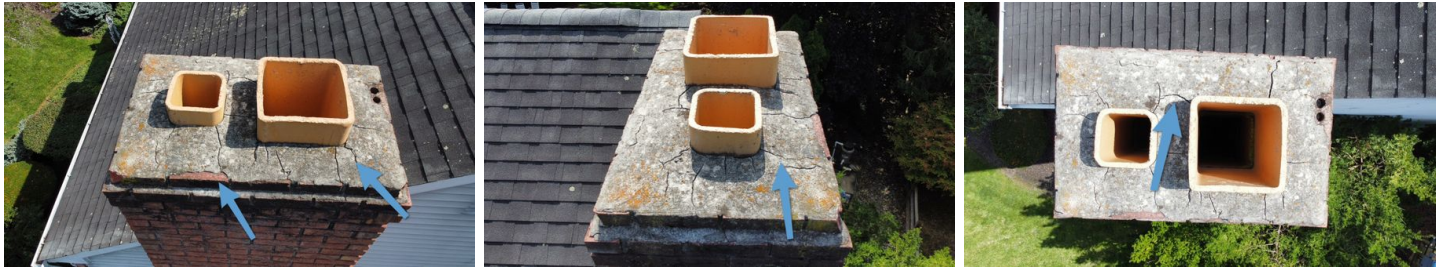
CHIMNEY CROWN CRACKED OR DETERIORATED

The masonry cap or crown is cracked or deteriorated. This can allow water to penetrate and damage the structure. The cap should be repaired or replaced as needed.

Contact a qualified professional.

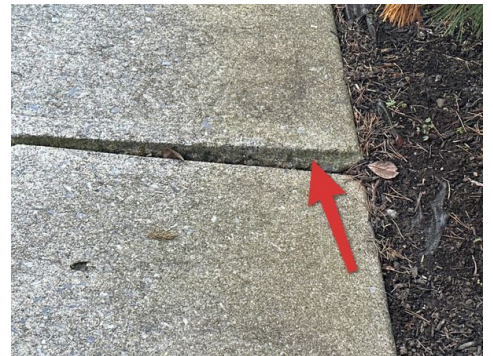
WALKS UNEVEN

The walks are uneven at a few small areas. This is a safety concern-trip hazard, suggest making repairs to create an even and level surface.

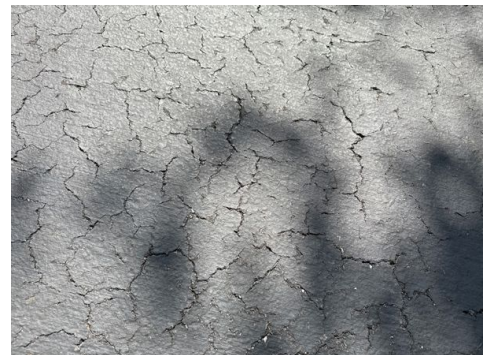
4.1.2 Walkways, Stoops, Steps, Patios & Driveways

DRIVEWAY CRACKING

Cracking was observed. Recommend monitoring and/or have contractor patch/seal.

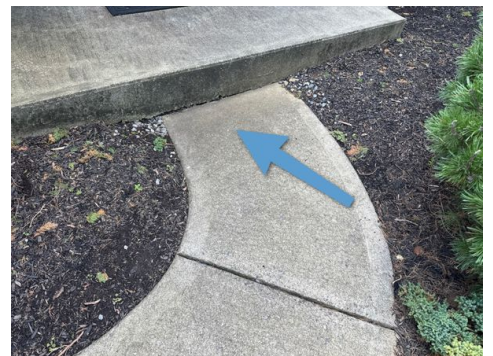
4.1.3 Walkways, Stoops, Steps, Patios & Driveways

Walkways are draining towards the building. This may allow water to enter the basement area. You should have a qualified contractor further evaluate and repair or replace the concrete. Note: At the very least you should seal between the walkway and foundation with an appropriate sealing material.

Contact a qualified professional.

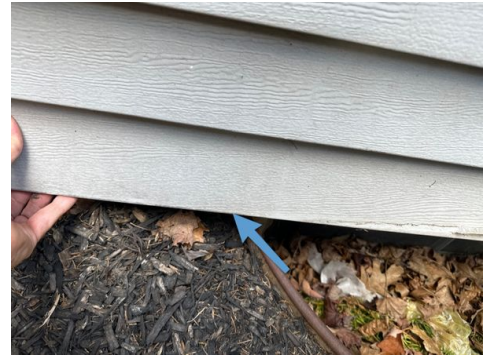
4.3.1 Siding

LOOSE SIDING

The siding is loose at various areas. Loose siding can allow moisture or insects to enter. The siding provides important weather protection. The siding should be repaired or replaced.

Contact a qualified professional.

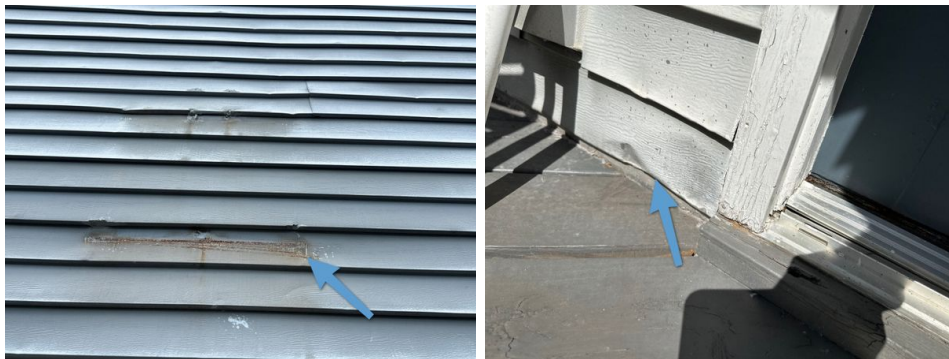
4.3.2 Siding

DAMAGED AND/OR DETERIORATED SIDING

The siding is damaged and/or deteriorated at areas. Siding is the protection for the building and any damage or deterioration could allow moisture and weather intrusion, causing further damage and expense. The siding material should be repaired or replaced as needed to make a weather-tight envelope for the building.

Contact a qualified professional.

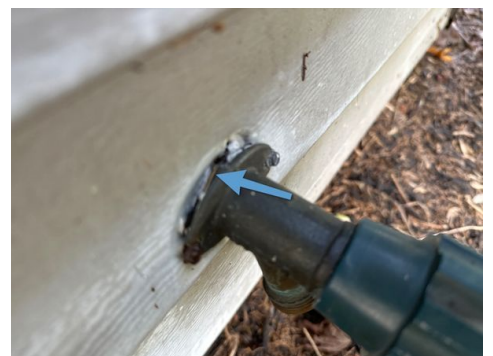
4.3.3 Siding

Caulking is missing where the utility lines or piping enter through the exterior wall. Moisture, pests or insects intrusion is possible. These areas should be caulked with appropriate caulking material.

Contact a qualified professional.

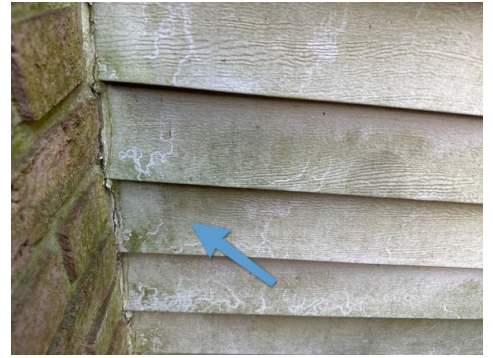
4.3.5 Siding

MILDEW/ALGAE

There are signs of a green bio-growth and/or mildew on the siding. This is a cosmetic issue and is not uncommon especially on shaded portions of the home. Recommend that said areas be washed or cleaned on a regular basis.

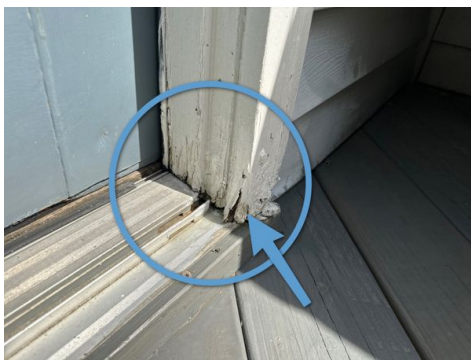
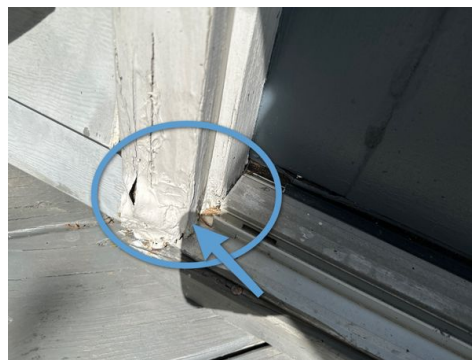
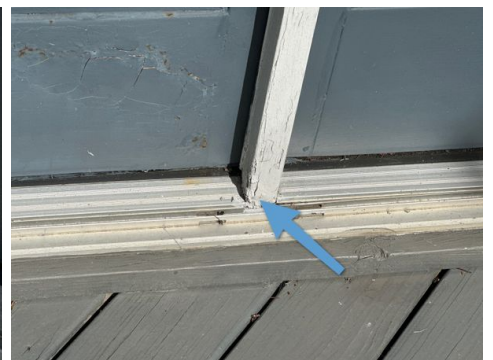
ROTTED TRIM

The trim is rotted. This can allow moisture to further penetrate and damage the substrate or building materials. The trim should be repaired or replaced.

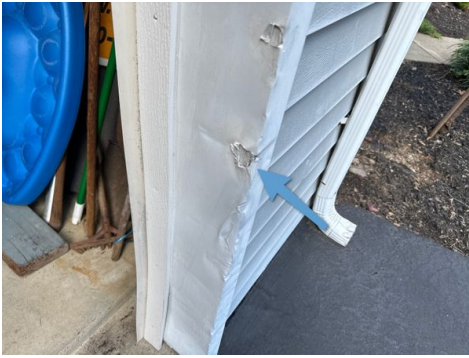
DENTED GARAGE TRIM

The trim is dented or damaged at the garage. You may consider repair or replacement.

Contact a qualified professional.

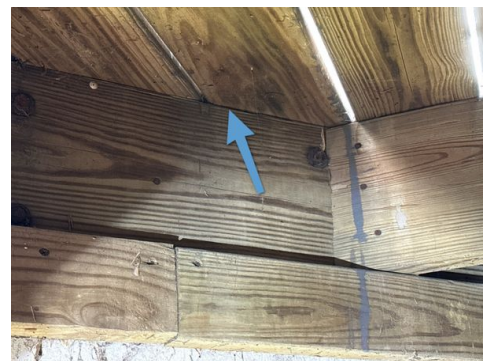
LEDGER FLASHING MISSING

There does not appear to be adequate ledger flashing at the ledger board connection to the building. Flashing is necessary to prevent moisture penetration into the structure and or the ledger board rotting at the building connection. Proper flashing should be installed at the ledger board.

Contact a qualified professional.

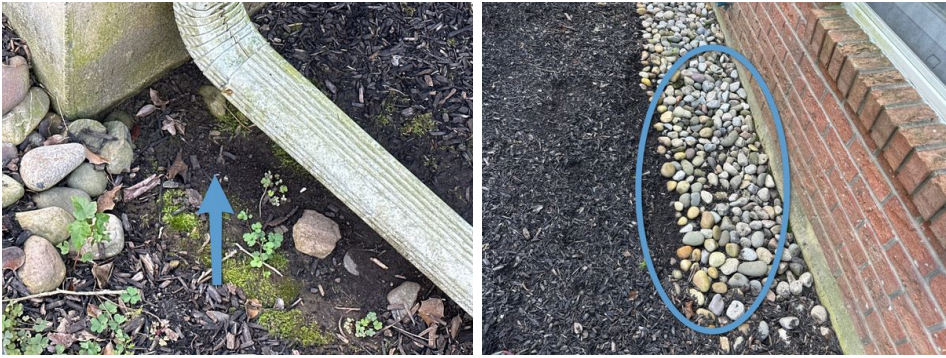
LOW GRADE

Grading is sloping towards the home in some areas. This could lead to water intrusion and foundation issues. You should consider contacting a qualified landscaper to regrade so water flows away from the foundation.

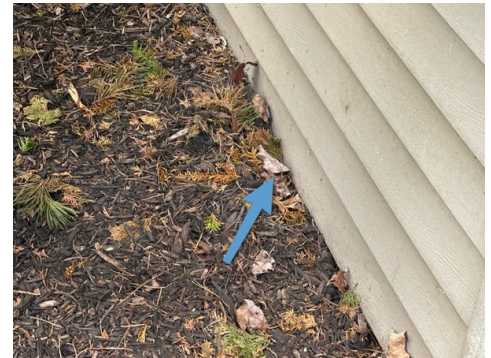
The grading is high at areas. This can allow moisture or insect penetration. The ground should be at least 2 to 3 inches below the siding or top of the foundation.

Contact a qualified professional.

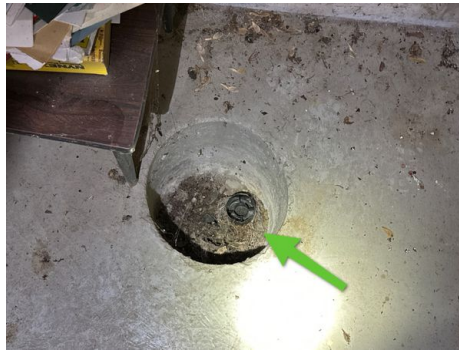
Sump Pump(s): Sump Location

Sump Pit without Pump

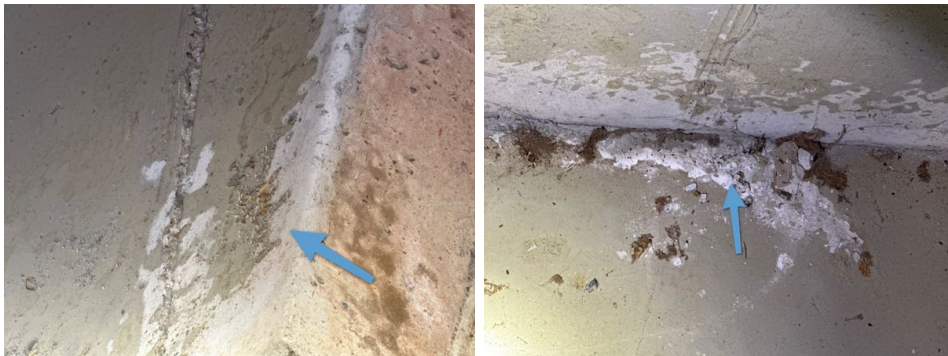
EFFLORESCENCE

Efflorescence noted on the wall surface. This a white, powdery deposit that is consistent with moisture intrusion. This can compromise the soil's ability to support the home structure and/or lead to mold growth. Recommend a qualified contractor identify source or moisture and correct.

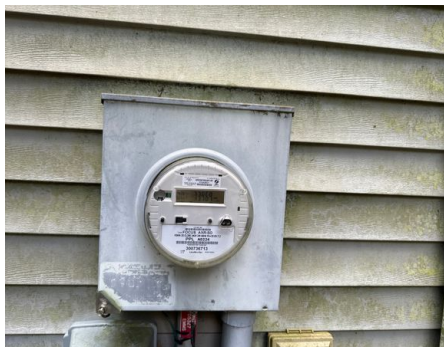
Service Entrance Conductors:
Service Entrance
Underground

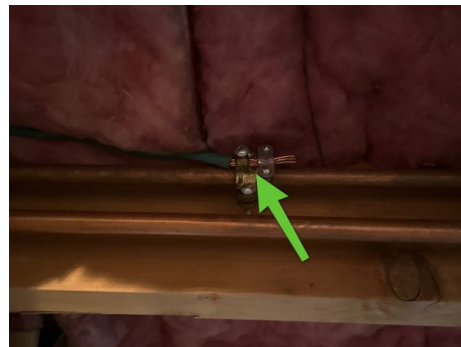
Grounding & Bonding: Service
Grounding Location
Plumbing supply line

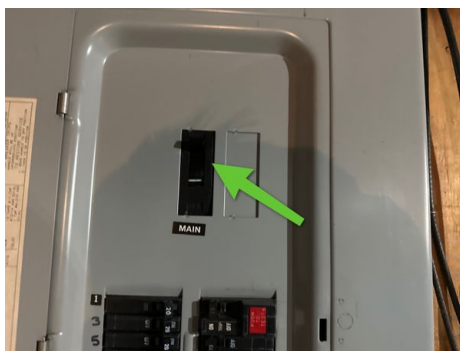
Main & Subpanels & Main
Overcurrent Device: Main
Disconnect Location
Inside the Main Panel

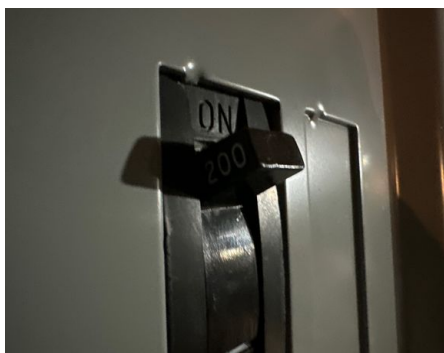
Main & Subpanels & Main
Overcurrent Device: Panel Type
Circuit Breaker

Main & Subpanels & Main
Overcurrent Device: Panel
Capacity
200 AMP

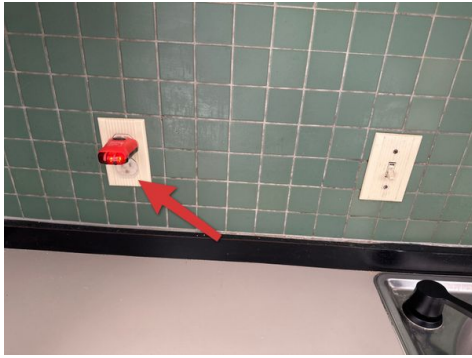
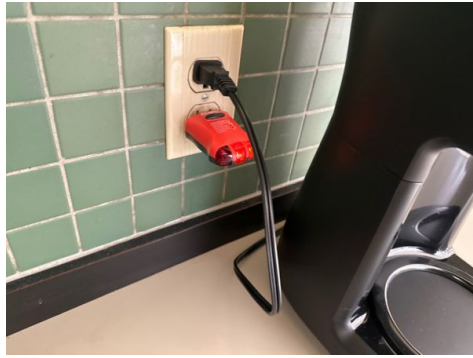
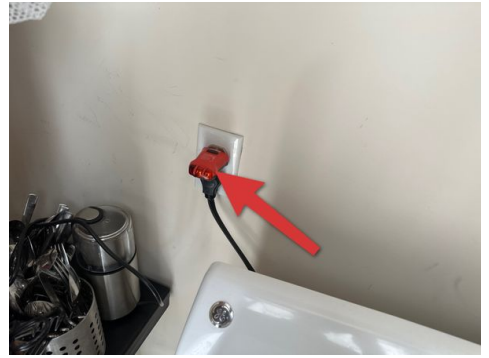
GFCI OUTLET(S) MISSING

GFCI outlet(s) missing at recommended area(s). You should have GFCI outlets installed to avoid possible injury.

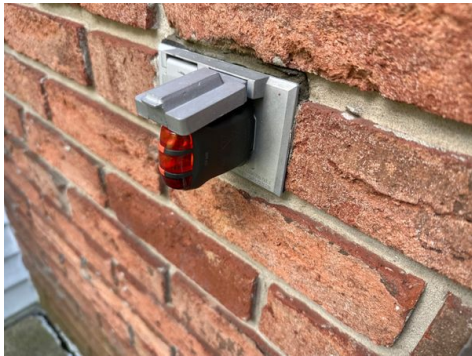
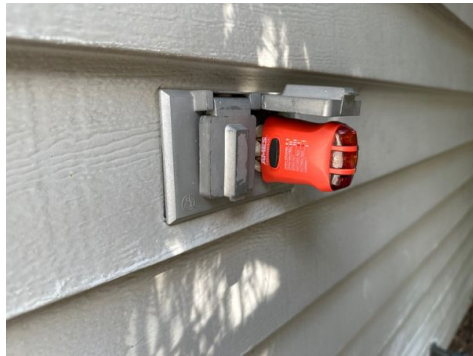
7.6.2 GFCI/AFCI

RECEPTACLES NOT WEATHERPROOF WHEN IN USE

The exterior covers may not be fully weather proof when in use or missing covers. You should have the covers updated to the current standard.

Contact a qualified professional.

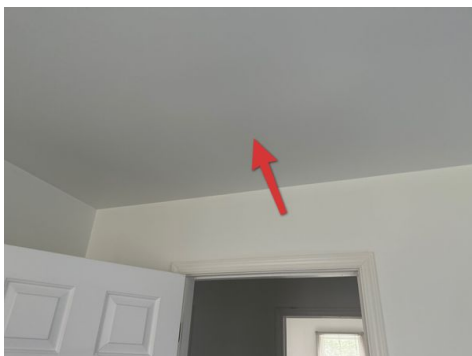
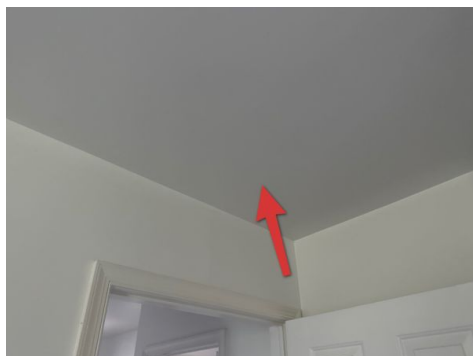
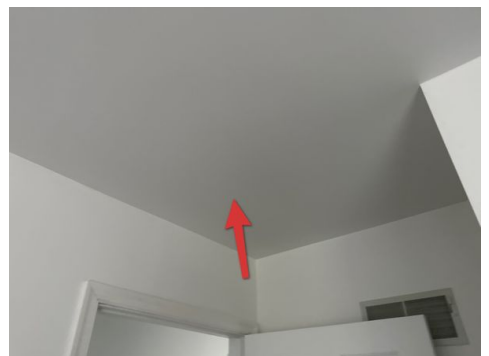
7.7.1 Smoke Detectors

MISSING SMOKE DETECTORS

Some smoke detectors were missing at the time of this inspection. This is a safety concern. Smoke alarms should be installed at all appropriate locations according to current safety standards.

Contact a qualified professional.

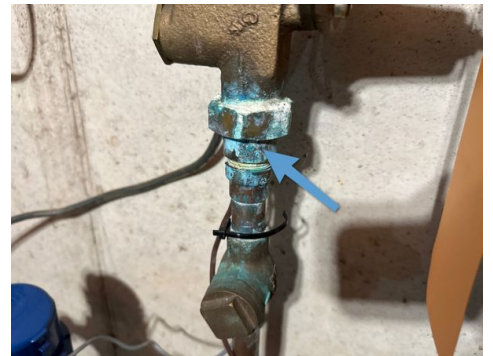
8.2.1 Water Supply, Distribution Systems & Fixtures

CORRODED VALVES/FITTINGS AND/OR PIPES

Some of the water supply valves, fittings and/or pipes are corroded. Recommend to have a qualified plumber further evaluate and follow their recommendations.

Contact a qualified professional.

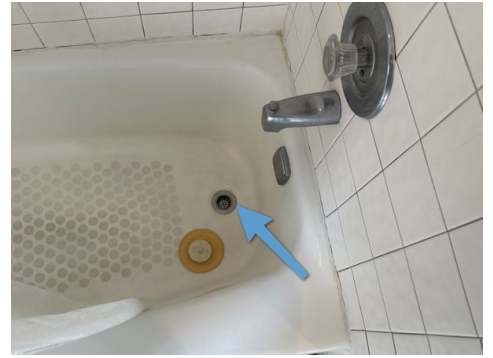
POPUP TUB DRAIN NOT WORKING/MISSING

The tub drain popup is not working or is missing. This should be repaired or replaced.

Contact a qualified professional.

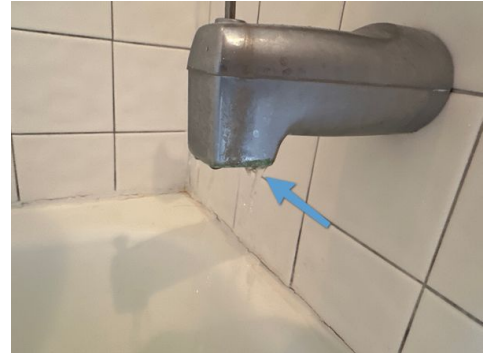
8.4.3 Sinks/Tubs/showers/Toilets

TUB DIVERTER LEAKS

The diverter at the tub is allowing water to flow through the spout instead of directing it to the shower head. The diverter should be repaired or replaced for proper or designated flow location.

Contact a qualified professional.

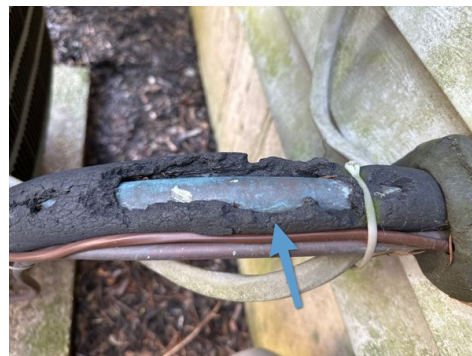
DAMAGED OR MISSING REFRIGERANT LINE INSULATION

The refrigerant line insulation jacket is damaged or missing. This may cause a reduction in operational efficiency. The insulation jacket should be repaired or replaced.

Contact a qualified professional.

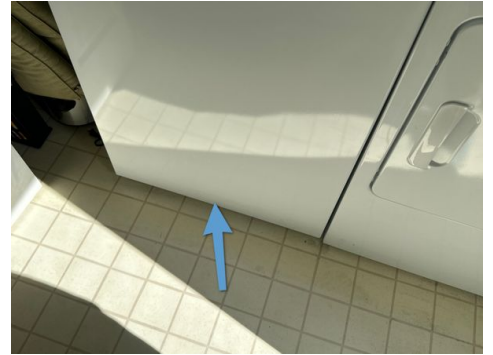
**MISSING DRIP PAN**

There is no drip pan present. When located on or above finished spaces you should have a drip pan installed beneath the washer to prevent possible moisture damage.

Contact a qualified professional.

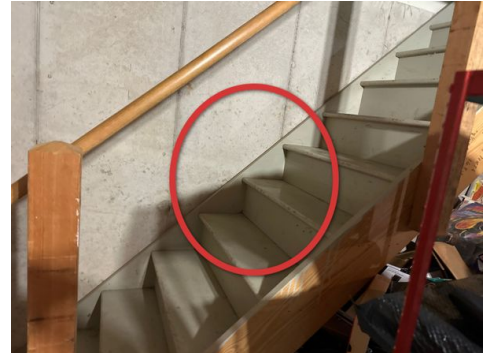
11.1.2 Steps, Stairways & Railings

OPEN BELOW HANDRAIL/GUARDRAIL

Contact a qualified professional.

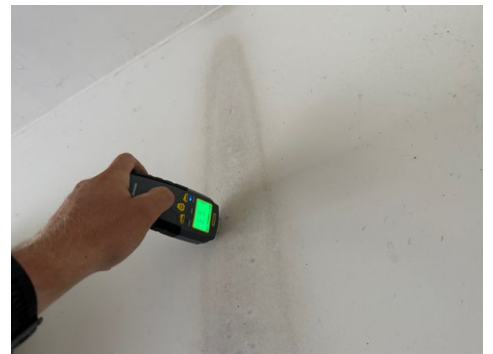
11.2.1 Walls

STAINS WERE TESTED AND DRY

There were stains that were tested and appeared to be dry at the time of this inspection. This appears to be from a previous water leak that was not active. You should monitor the area(s).

Contact a qualified professional.

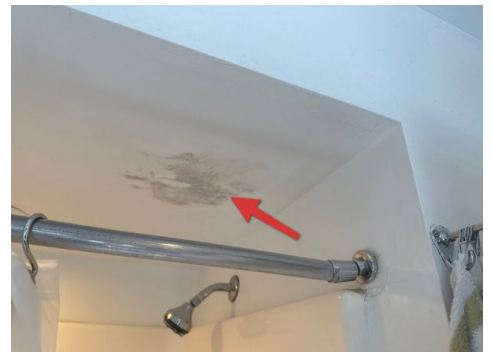
PRIMARY BATHROOM SHOWER

There are possible signs of fungi growth on ceiling. It is unknown if this is a safety hazard. Recommend a qualified mold inspector evaluate.

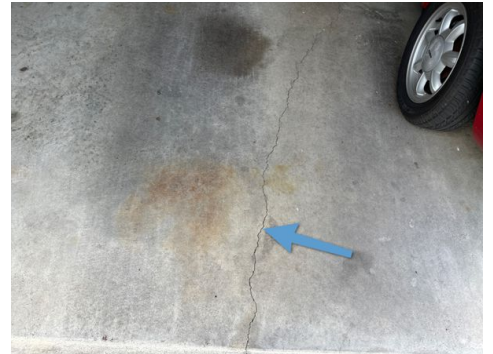
TYPICAL SETTLEMENT CRACKS

Typical settlement cracks were visible in the garage floor. The floor appeared serviceable at the time of this inspection.

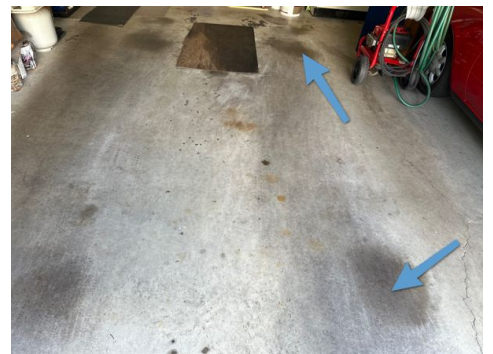
STAINING

Garage floor shows visible staining from oil/grease. You should clean the areas with a degreaser or cleaning solution.

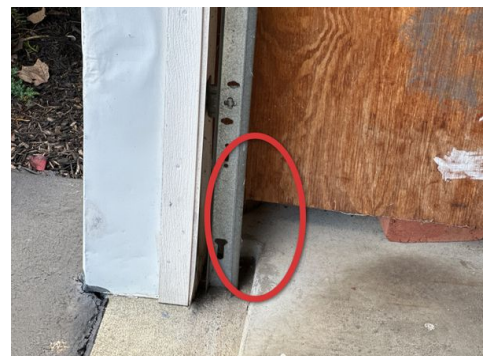
MISSING SENSORS

Contact a qualified professional.

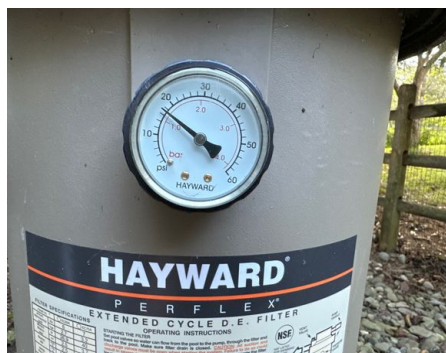
Filter/Pressure Gauge & Bleeder Valve: Pressure Gauge Functional

The pressure gauge was present and functional.

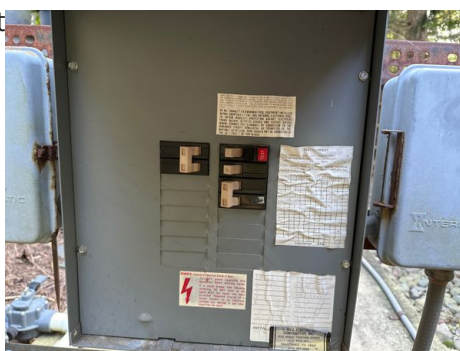
Electrical: Breaker Location
Exterior at Equipment

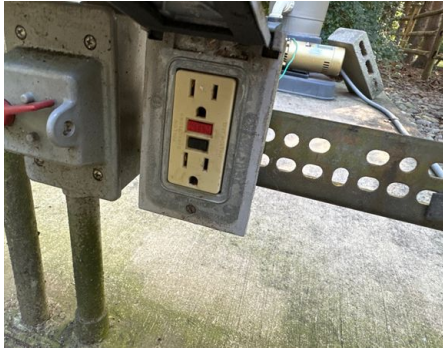
Electrical: Wire Type
Plastic Conduit

Electrical: GFCI Outlets Present/Functional At Pool Equipment

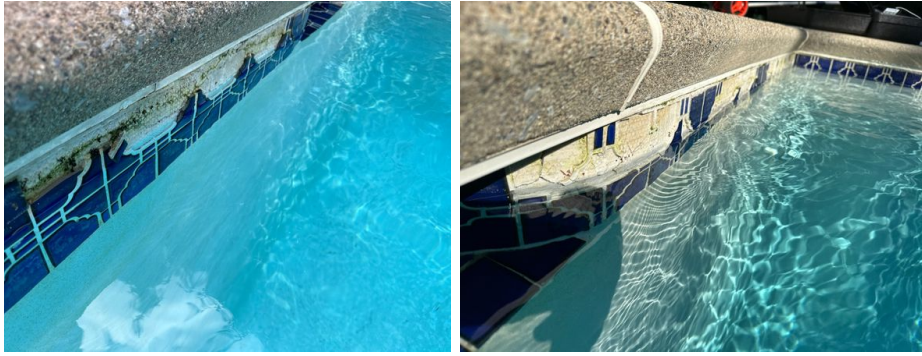
Deck/Coping: Tile Condition

Multiple Missing Tiles

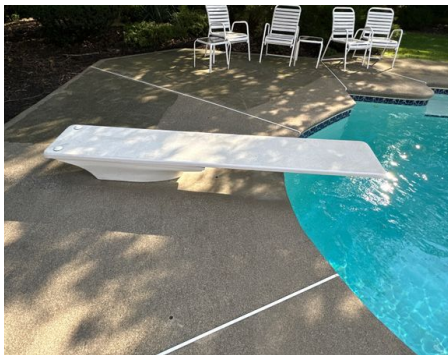
**Ladder/Rails & Diving/Sliding Boards: Diving & Sliding Boards**

Diving Board Present

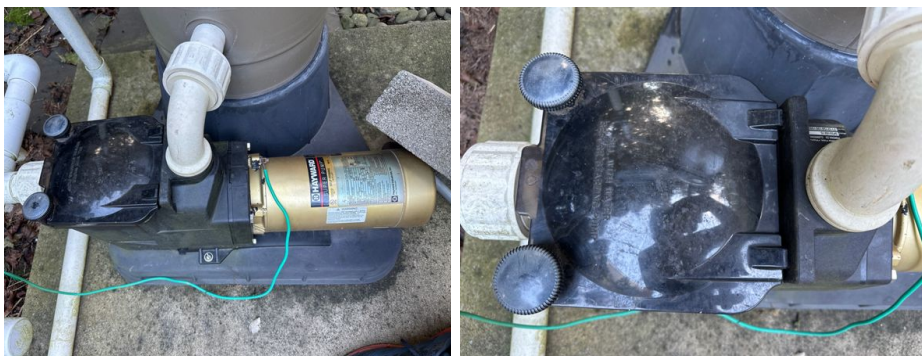
Pool Pumps: Pump(s) Present and Functional

The pool pump(s) was present and functional at the time of this inspection.

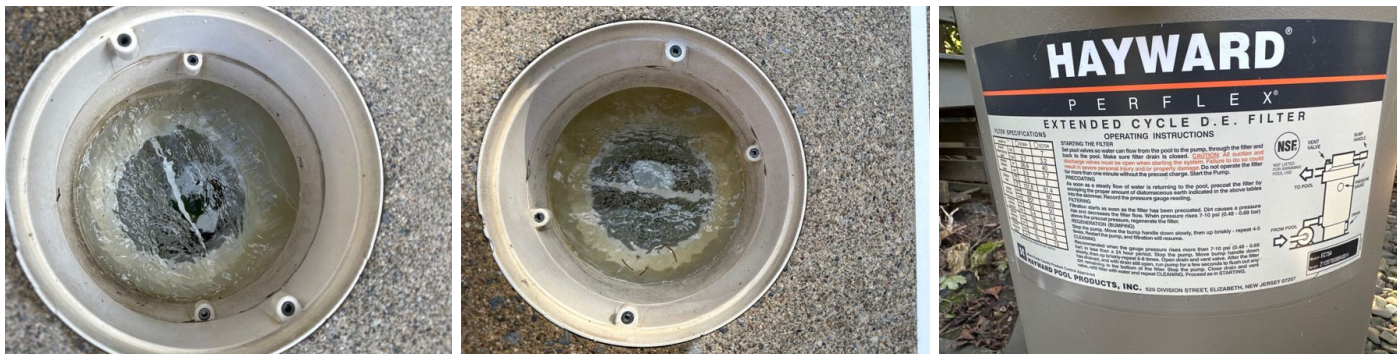
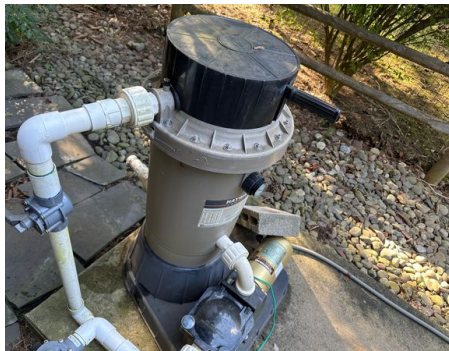
Filter/Pressure Gauge & Bleeder Valve: Filter Type

Diatomaceous Earth Filter, Skimmer Baskets

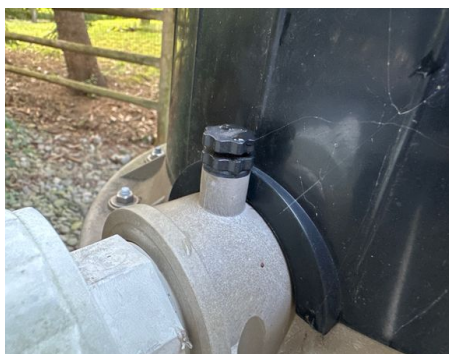
Filter/Pressure Gauge & Bleeder Valve: Bleeder Valve Present

The bleeder valve was present and appeared to be functional at the time of this inspection.

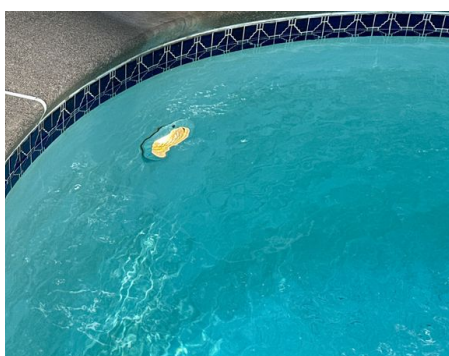
Electrical: Underwater Light/Present/Functional

The underwater light was tested and appeared to be functional at the time of this inspection.

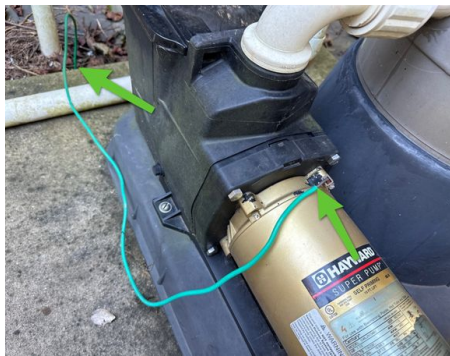
Electrical: Grounding/Bonding Present

The pool equipment appeared to be correctly grounded/bonded at the time of this inspection.

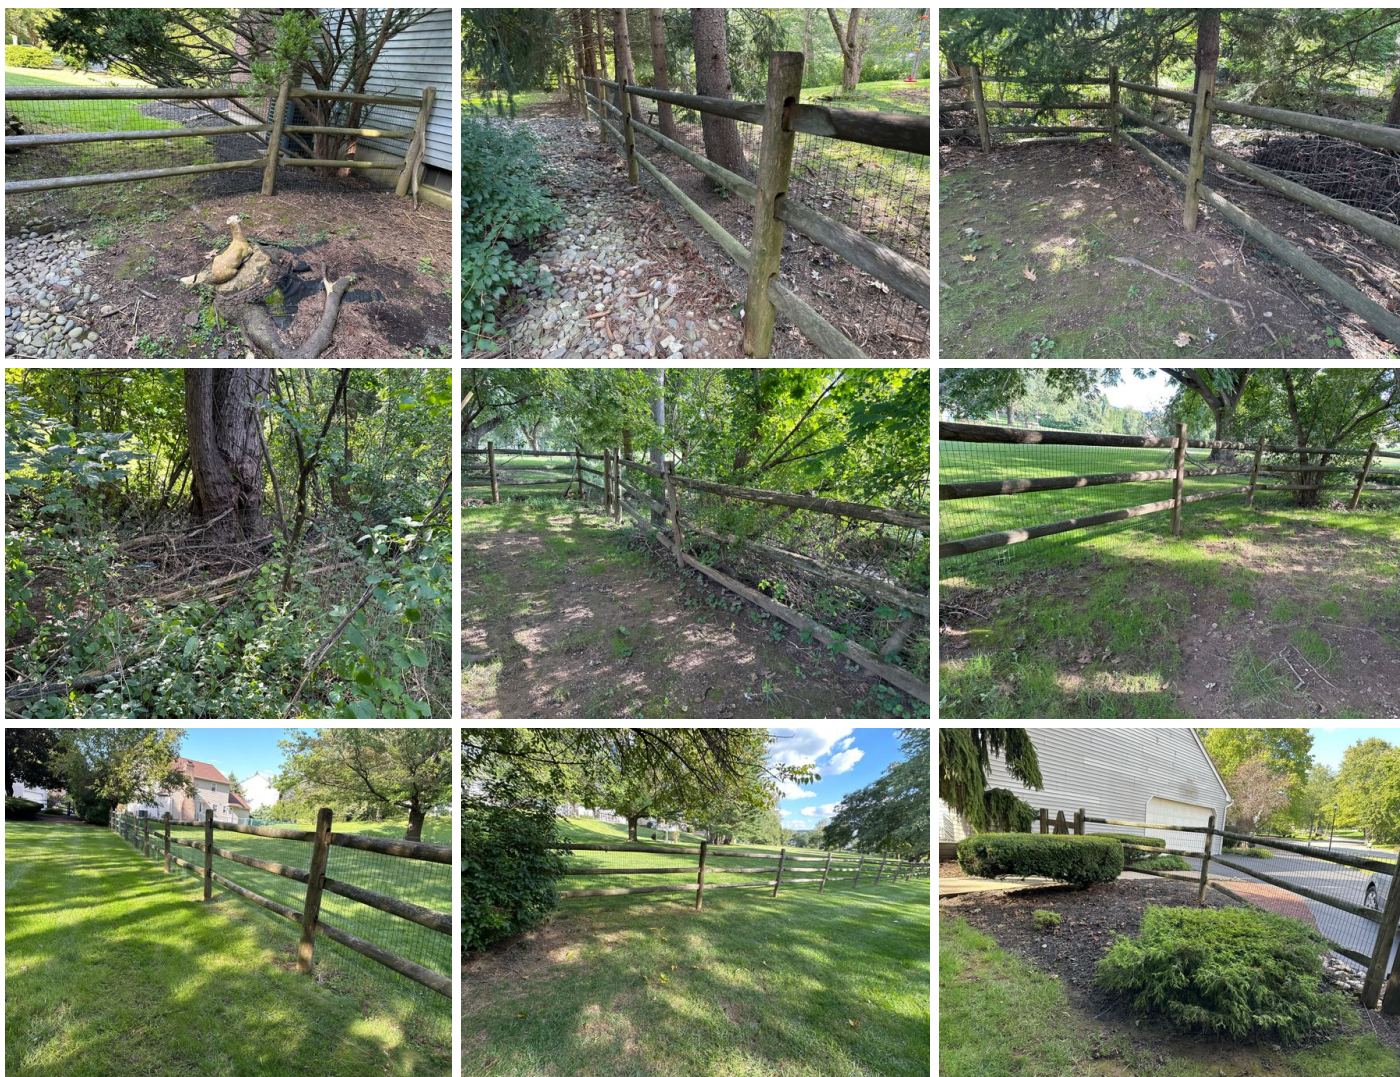
Enclosure: Barrier Fence

Present

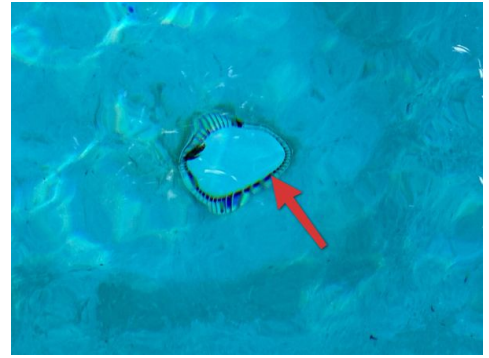
The pool is a single drain pool. Modern pools require multiple drains so that entrapment is less likely. This cover should I add a minimum be upgraded to a Virginia Baker cover. This helps reduce the chance of entrapment however, someone’s hair could still get entangled in it.

Contact a qualified professional.

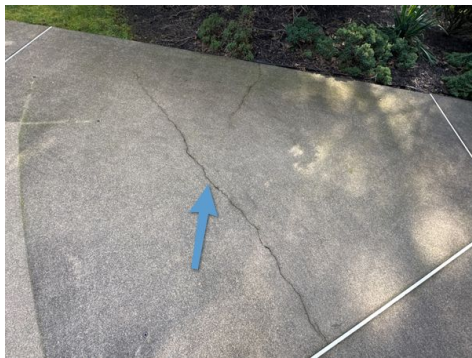
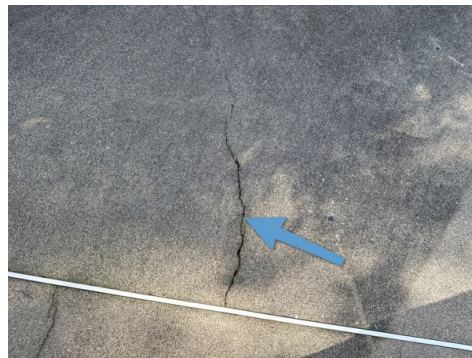
CONCRETE APRON/SIDEWALK CRACKS

There are cracks in the concrete apron or sidewalk. These should be sealed with the appropriate material.

Contact a qualified professional.

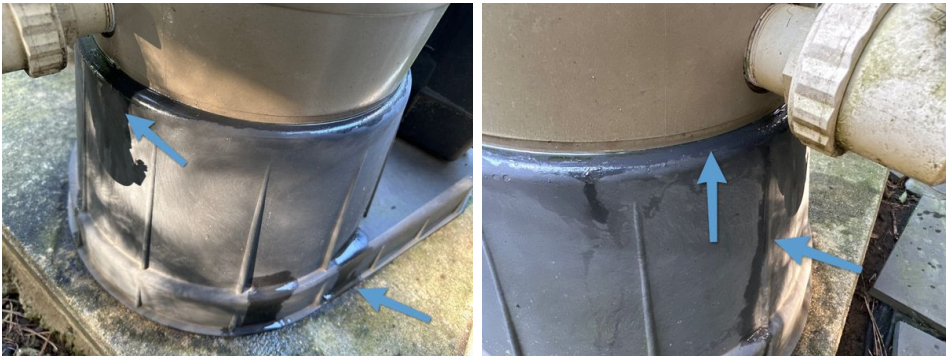
FILTER LEAKING

There was active leakage at the filter. This can hamper the pool pressure. This should be further evaluated for repair or replacement.

Contact a qualified professional.

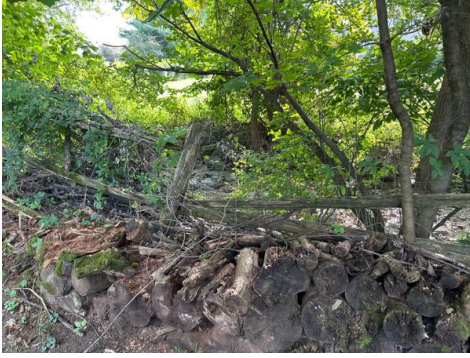
FENCE DAMAGED

Damage is present at the fence. Repair is recommended.

Contact a qualified professional.

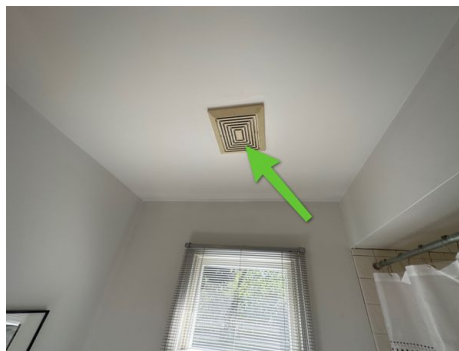
**Bath Exhaust Systems: Exhaust
Fans**

Present and Functional

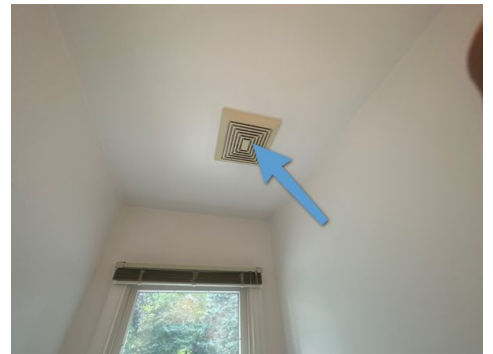
Fan in bathroom not operational at the time of inspection. Repair or replacement recommended.
