THE PENTAGON BUILDING PERFORMANCE REPORT

January 2003

American Society of Civil Engineers

SEI
Structural Engineering Institute
of the American Society of Civil Engineers

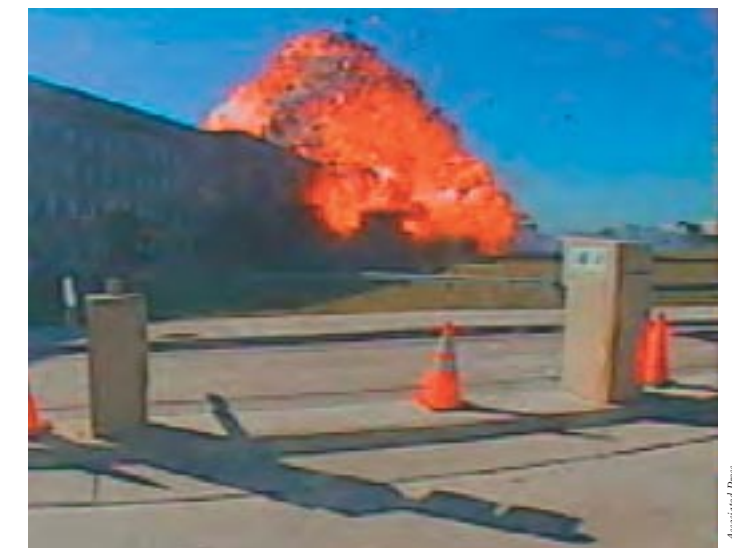
Figure 1.2 Aircraft impact

At 9:38 A.M. on September 11 an airliner was flown into the first story of the Pentagon. The impact occurred in the renovated portion of the building approximately 140 ft to the south of the boundary between the renovated section and the next section scheduled to be renovated. (Figure 1.2, a photograph taken by a security camera, shows the plane impacting the building at ground level.) The aircraft sliced through the building into the section not yet renovated. The impact and the fire initiated by the fuel in the airplane that immediately spread widely in the structure took the lives of all 64 people aboard the aircraft and 125 occupants of the Pentagon.

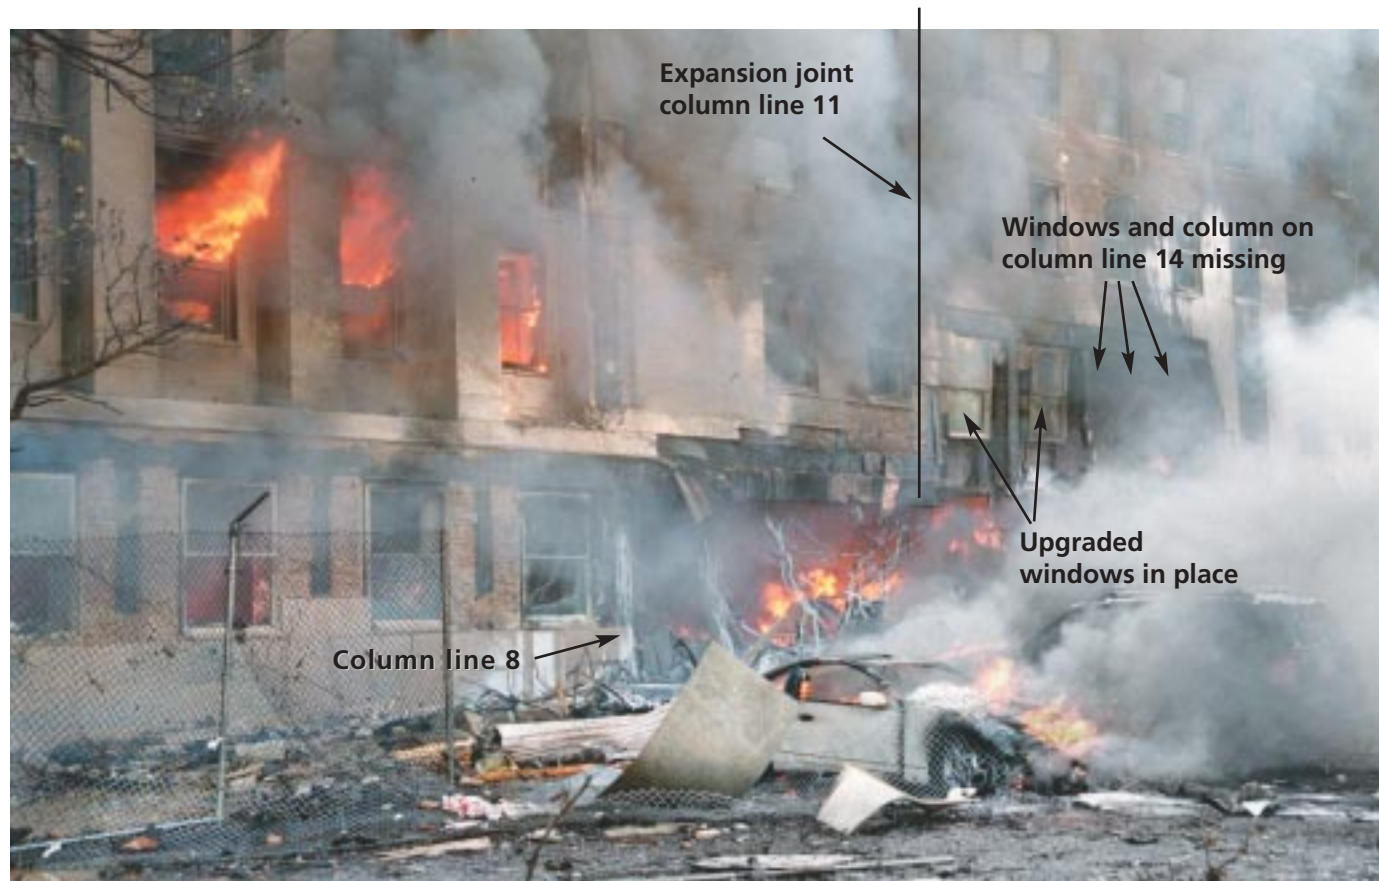
Figure 3.8 Northern portion of impact area before collapse

A photograph (figure 3.8) taken by the Associated Press before the building to the south of the expansion joint collapsed provides useful information that the BPS team could not observe at the site. This photograph shows that the portion of the building that subsequently collapsed was displaced vertically by approximately 18 in. to 2 ft relative to the building north of the expansion joint. The facade was missing on the first floor as far north as column line 8 (the expansion joint is at column line 11), and on the second floor, the facade was missing between column lines 11 and 15. However, windows and their reinforcing frames were still in place between column lines 11 and 13 on the second floor.

The photograph also shows that the only column missing on the second floor in the west exterior wall of the building was at column line 14. The spandrel beam for the third floor and all third-floor exterior columns appears to be intact.

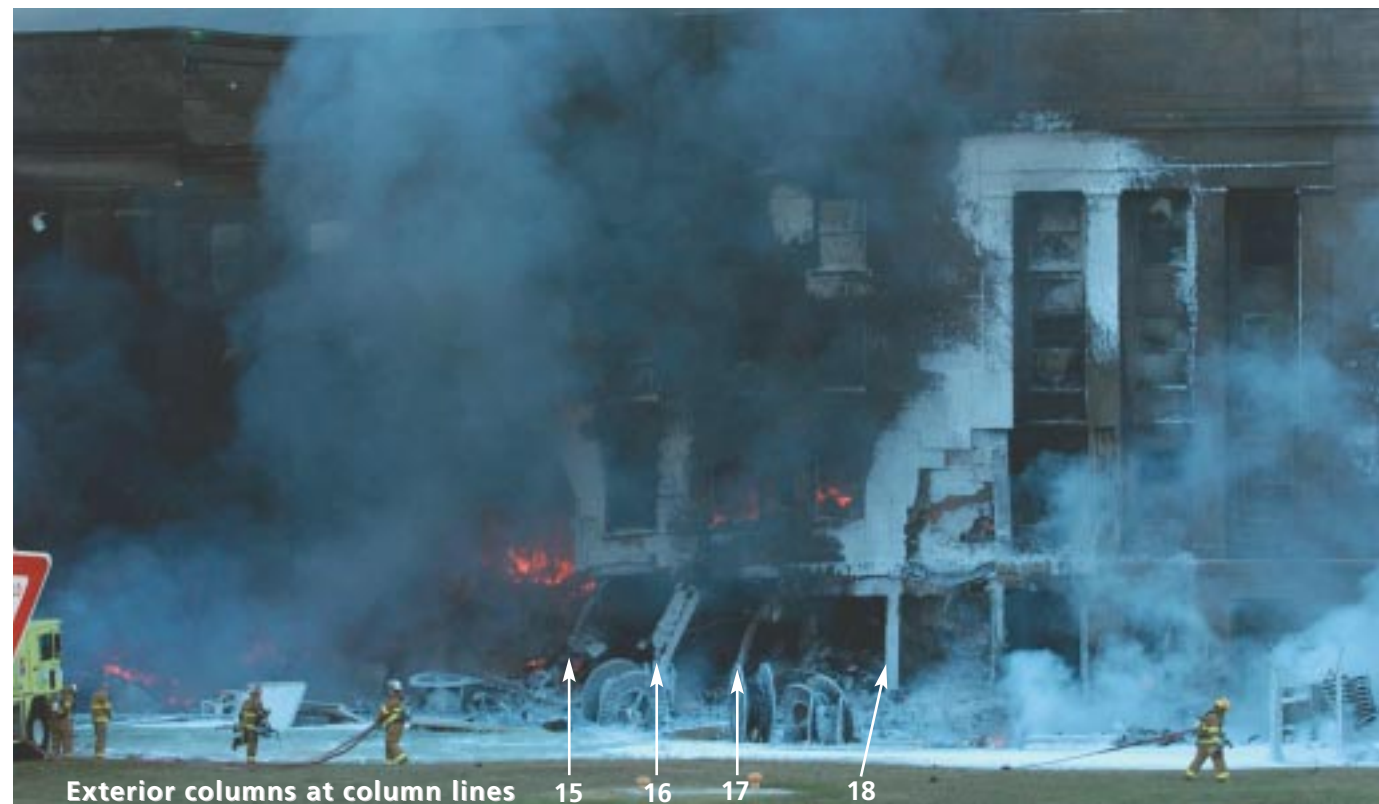
Figure 3.9 Southern portion of impact area before collapse

A second photograph (figure 3.9) taken before the collapse reveals that first-floor exterior columns on column lines 15, 16, and 17 were severely distorted but still attached at least at their top ends to the second-floor framing. The vertical displacement noted previously also is evident in this photograph.

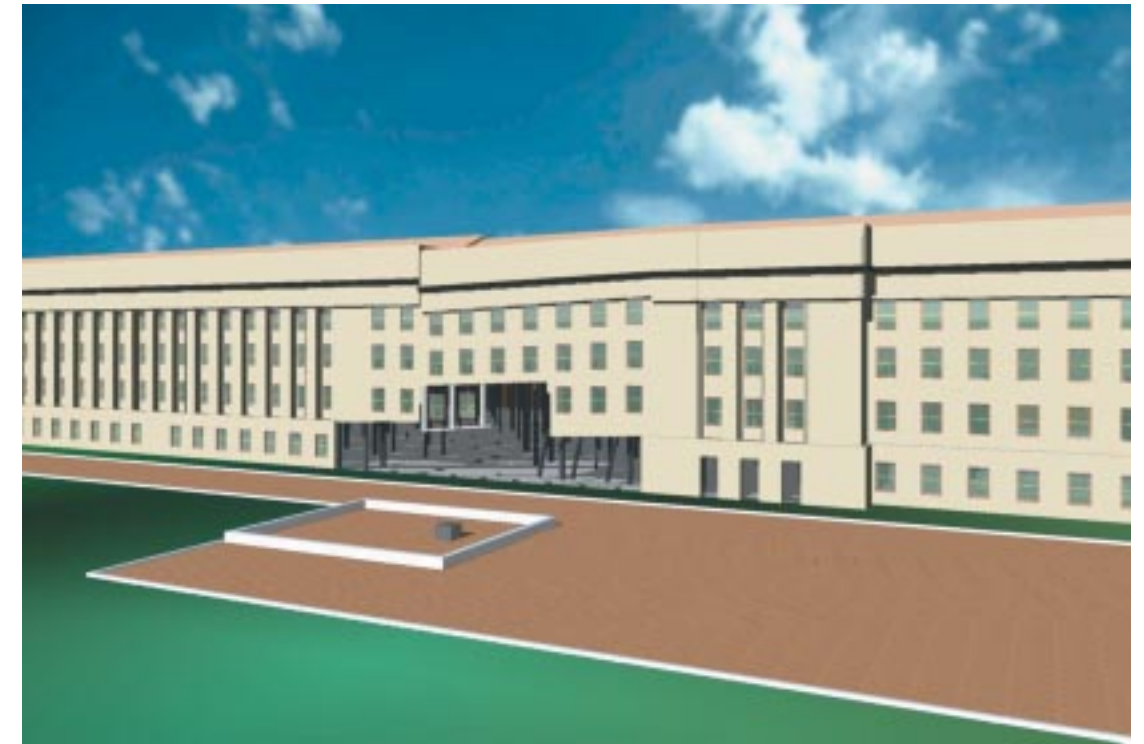
Figure 3.10 Impact location before collapse

The precollapse state of the structure is illustrated for clarity in figure 3.10.

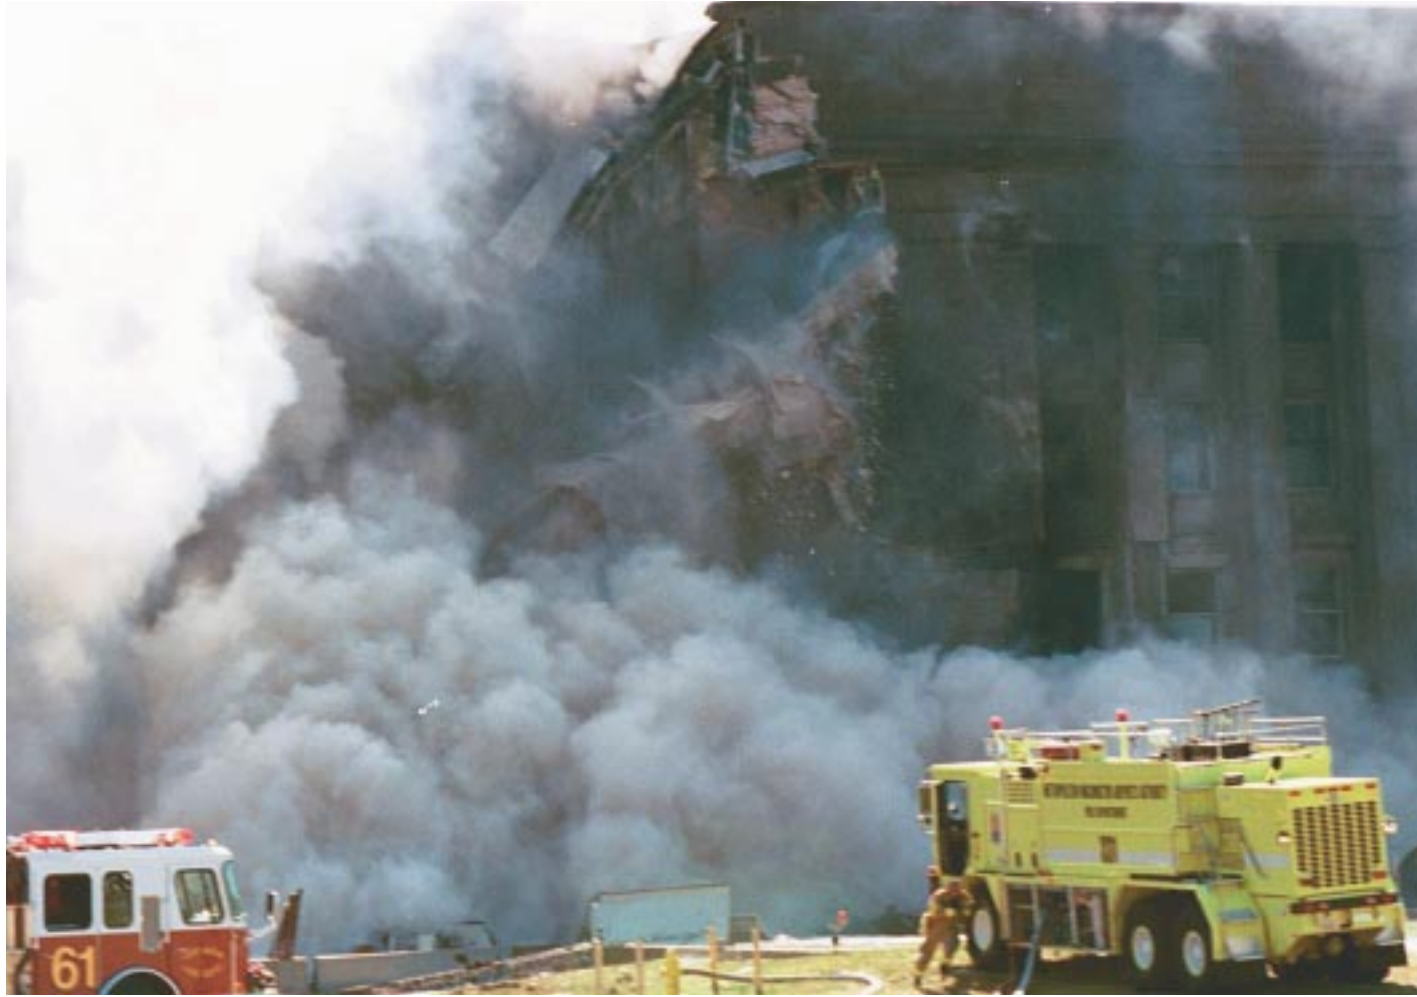
Figure 3.11 is a photograph taken at the moment of collapse, approximately 20 minutes after the aircraft struck the west wall of the Pentagon. The collapse extended to approximately column line 18 on the west face of the building.

Figure 3.11 Portion of Ring E at moment of collapse

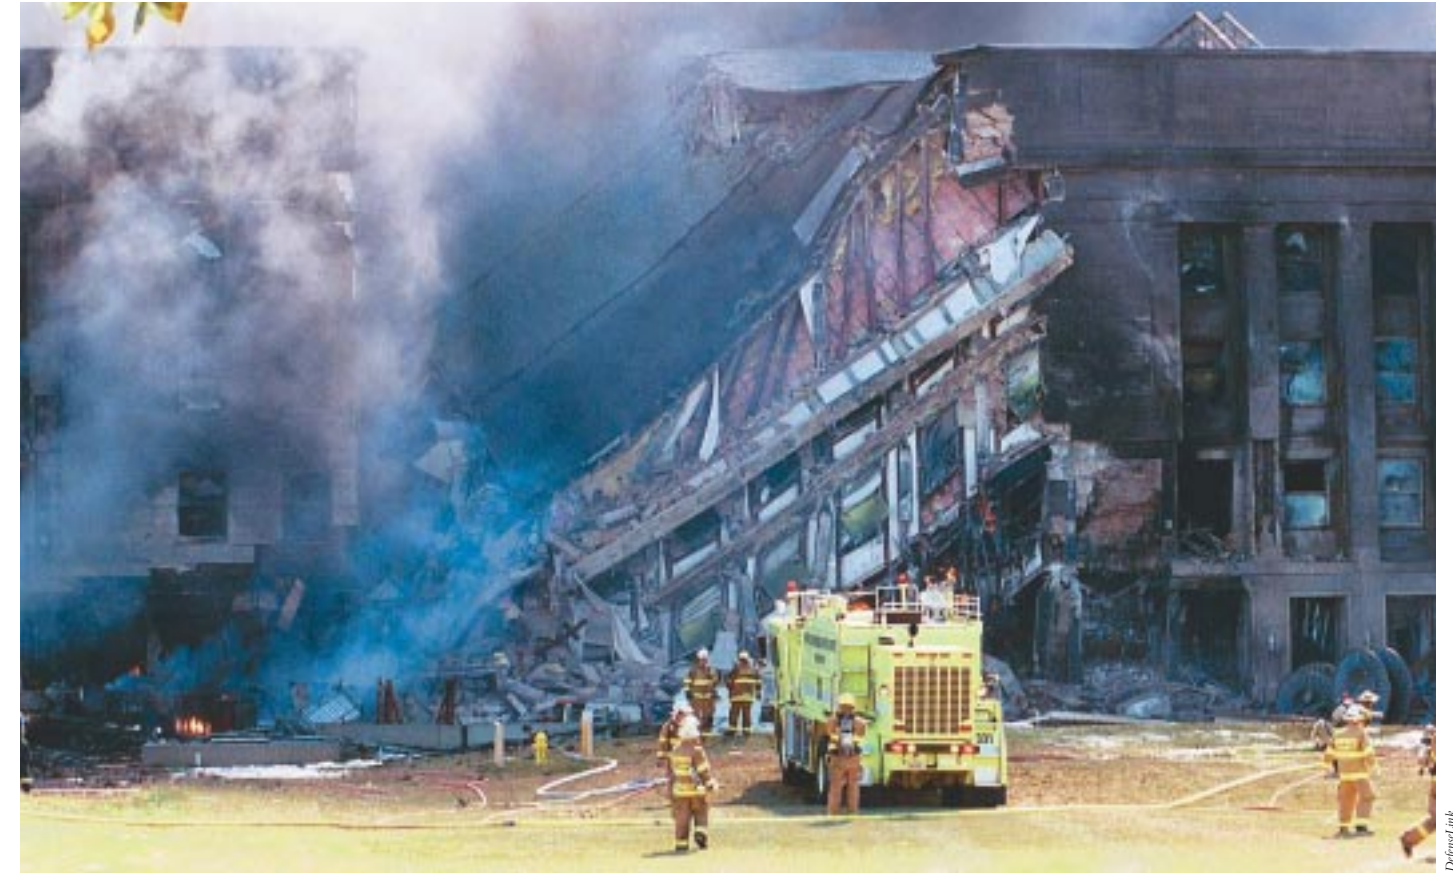
Figure 3.12—a photograph taken after the fire was extinguished, but before significant debris was removed from the collapse area or shoring was installed—shows the condition of the building after the collapse. The collapsed portion of Ring E extends from an expansion joint on column line 11 to approximately column line 18 on the west facade.

Figure 3.12 Ring E after collapse

The structure was able to maintain this deformed shape for approximately 20 minutes, at which point all five levels of Ring E collapsed from column line 11 to approximately column line 18 (figure 3.12).

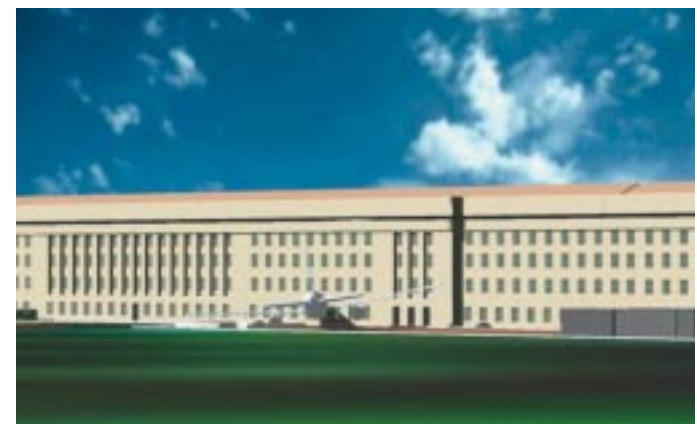
Figure 3.16 Aircraft at impact with the Pentagon

ground at nearly the same instant that the nose of the aircraft struck the west wall of the Pentagon (figure 3.15). Impact of the fuselage was at column line 14, at or slightly below the second-floor slab. The left wing passed below the second-floor slab, and the right wing crossed at a shallow angle from below the second-floor slab to above the second-floor slab (figure 3.16)

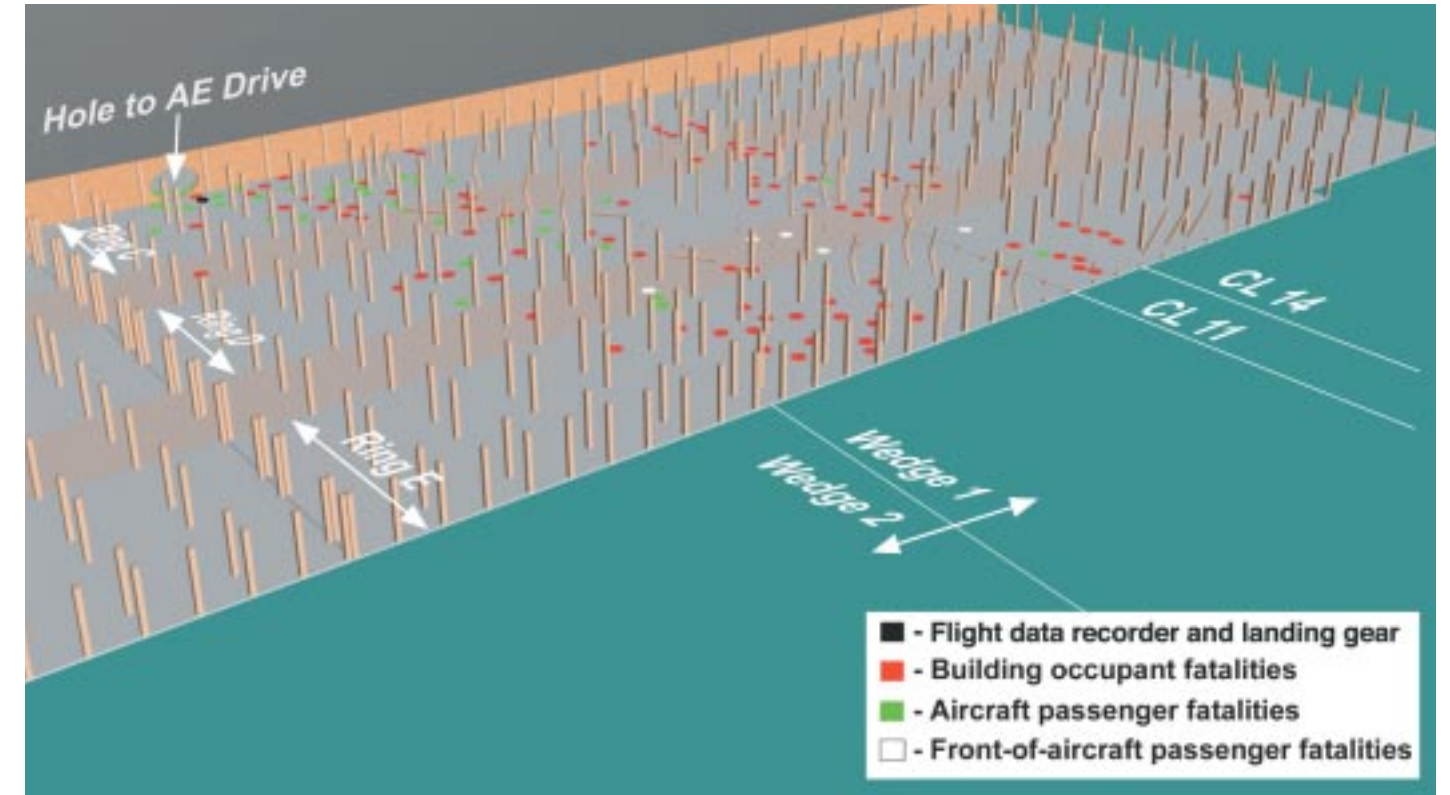
Figure 3.17 Fatalities found in first story

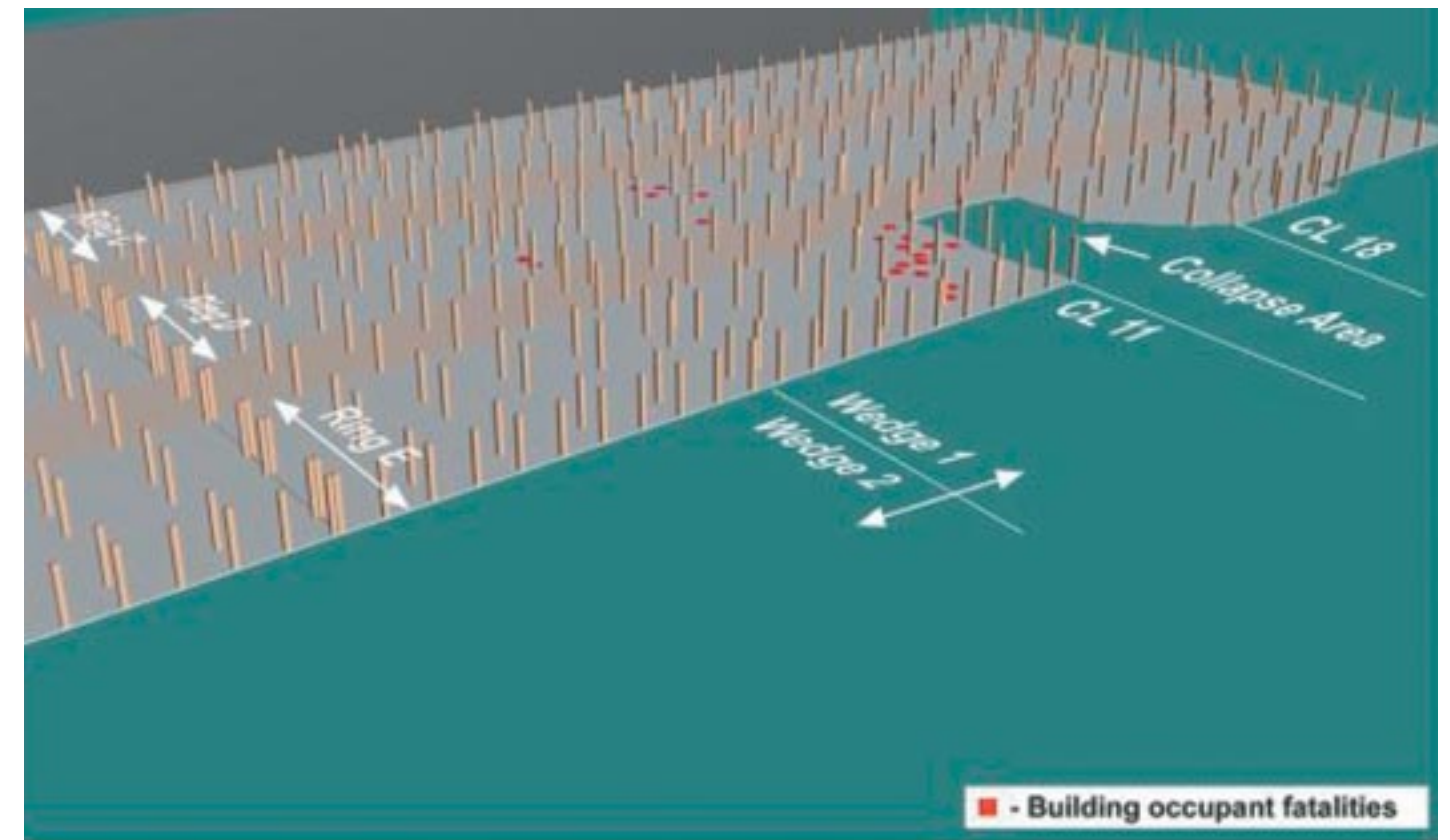
No fatalities from the aircraft were found on the second floor (figure 3.18). The figure shows no fatalities in the collapsed area above the first floor. In fact, it is likely that there were upper-floor fatalities in this area, but their remains were found on the first-floor level after the building collapsed.

Figure 3.18 Fatalities found in second story

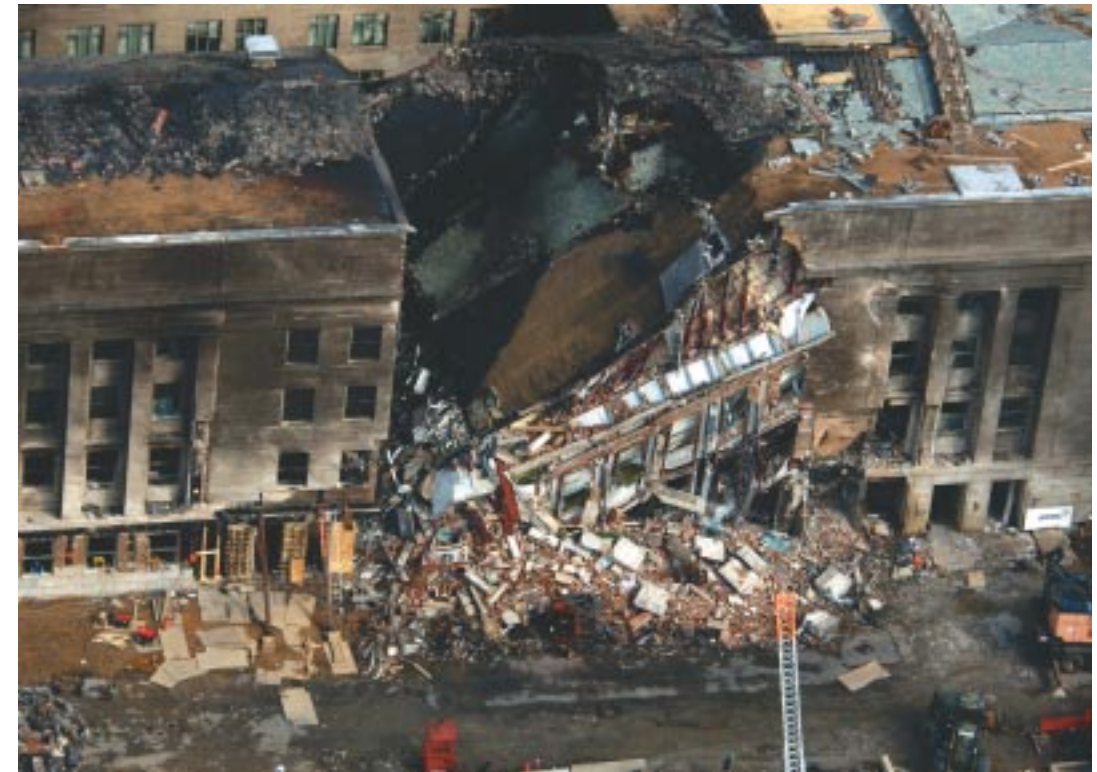
Figure 5.3 Aerial view of collapsed portion of Ring E

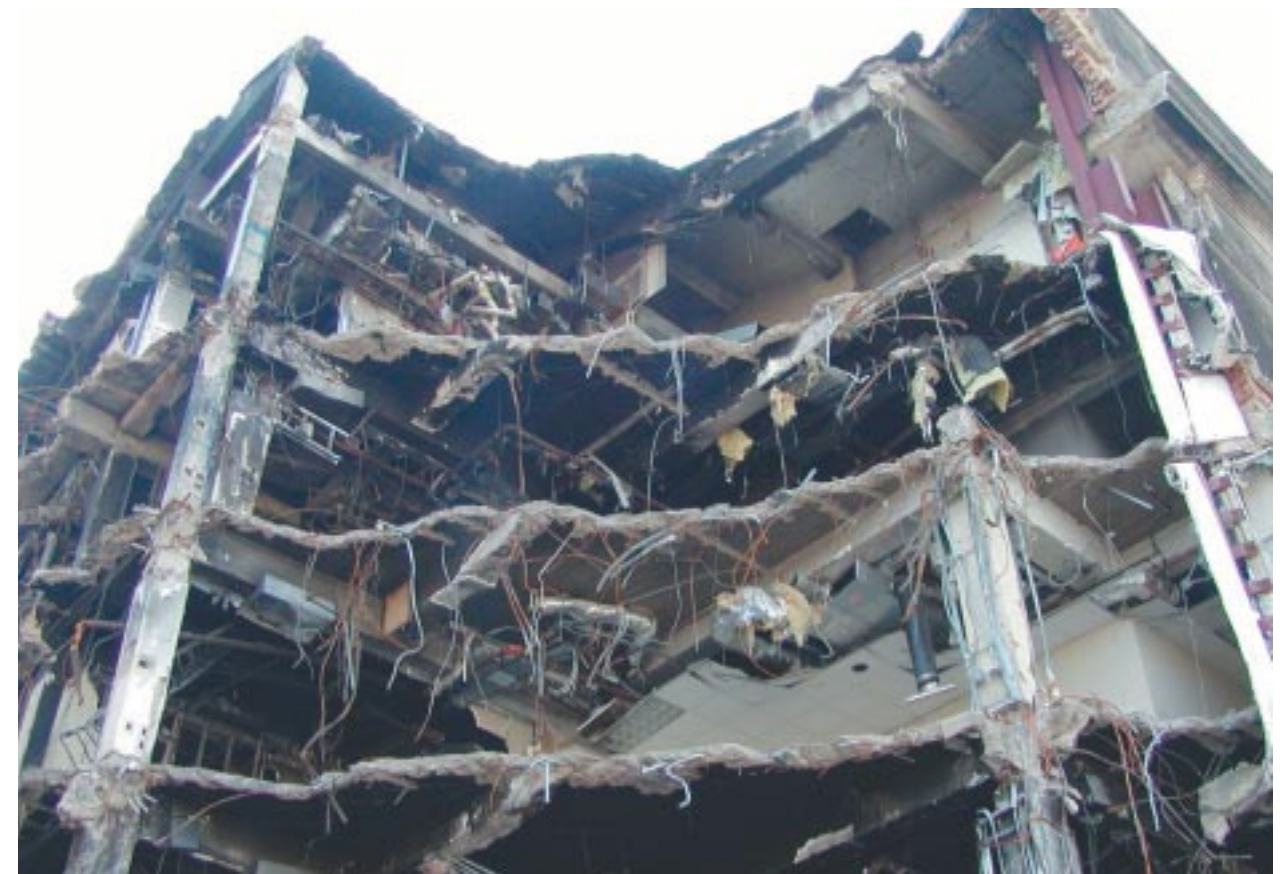
Figure 5.4 Remaining structure at southern extreme of collapse area

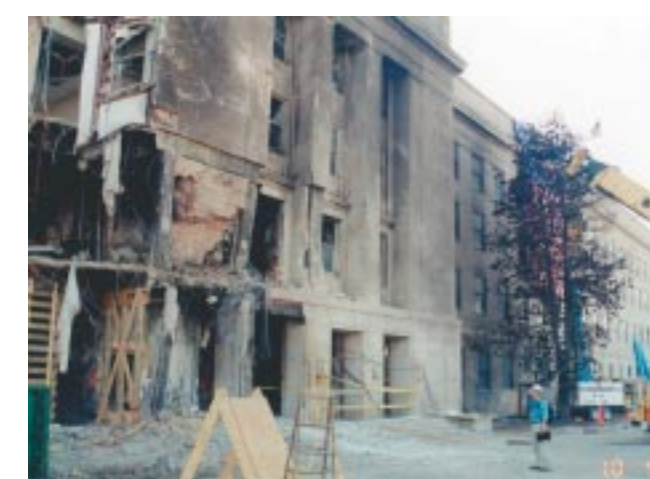
Figure 5.10 Exterior evidence of fire to the south of the impact area

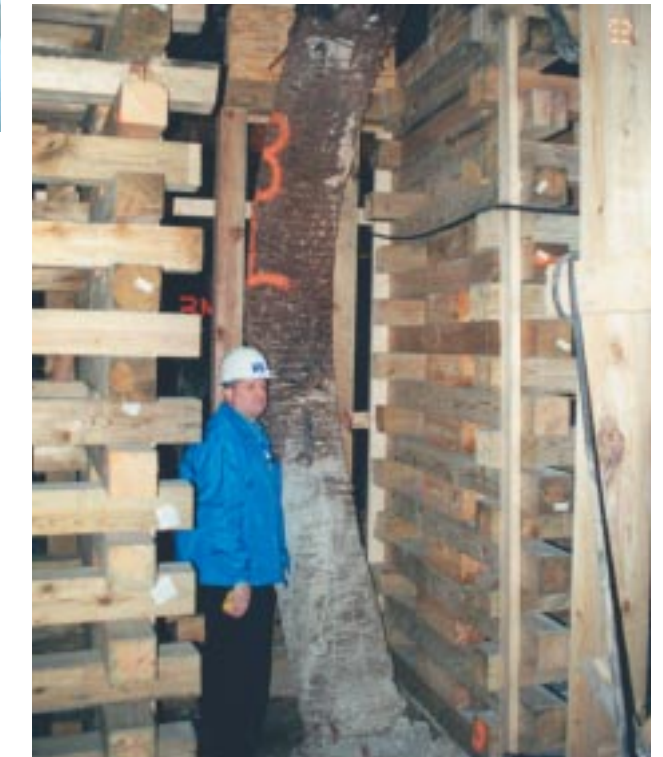
Figure 5.20 Column 3L with large deformation and discrete hinges

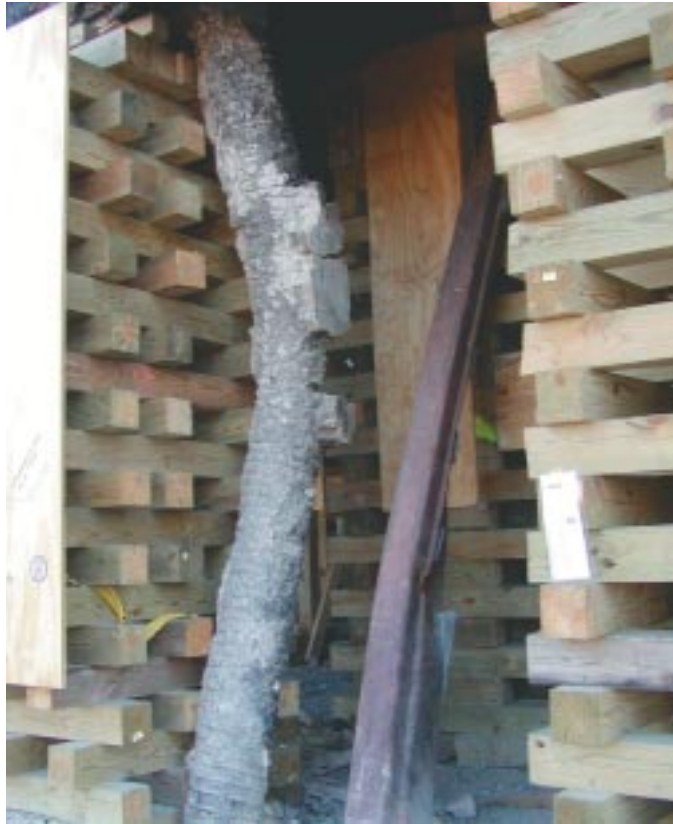
Figure 5.21 Column with triple curvature

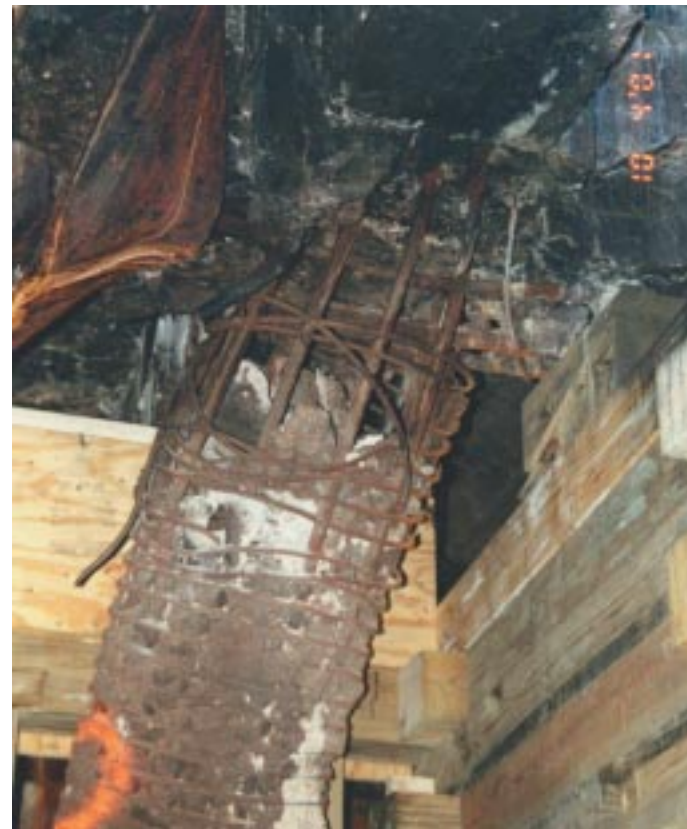
Figure 5.22 Top of column 3L, still attached to underside of second-floor framing

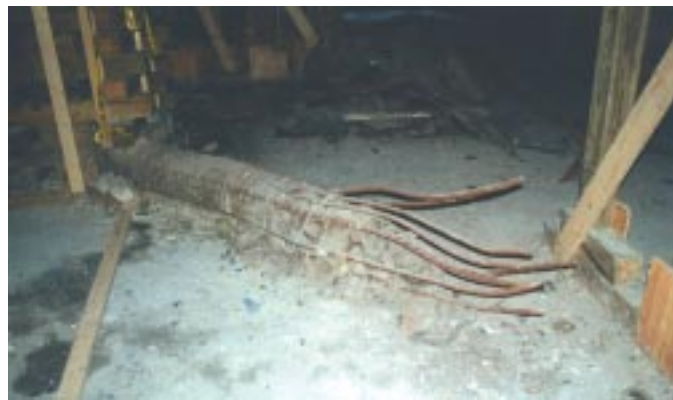
Figure 5.23 Severed column 5H

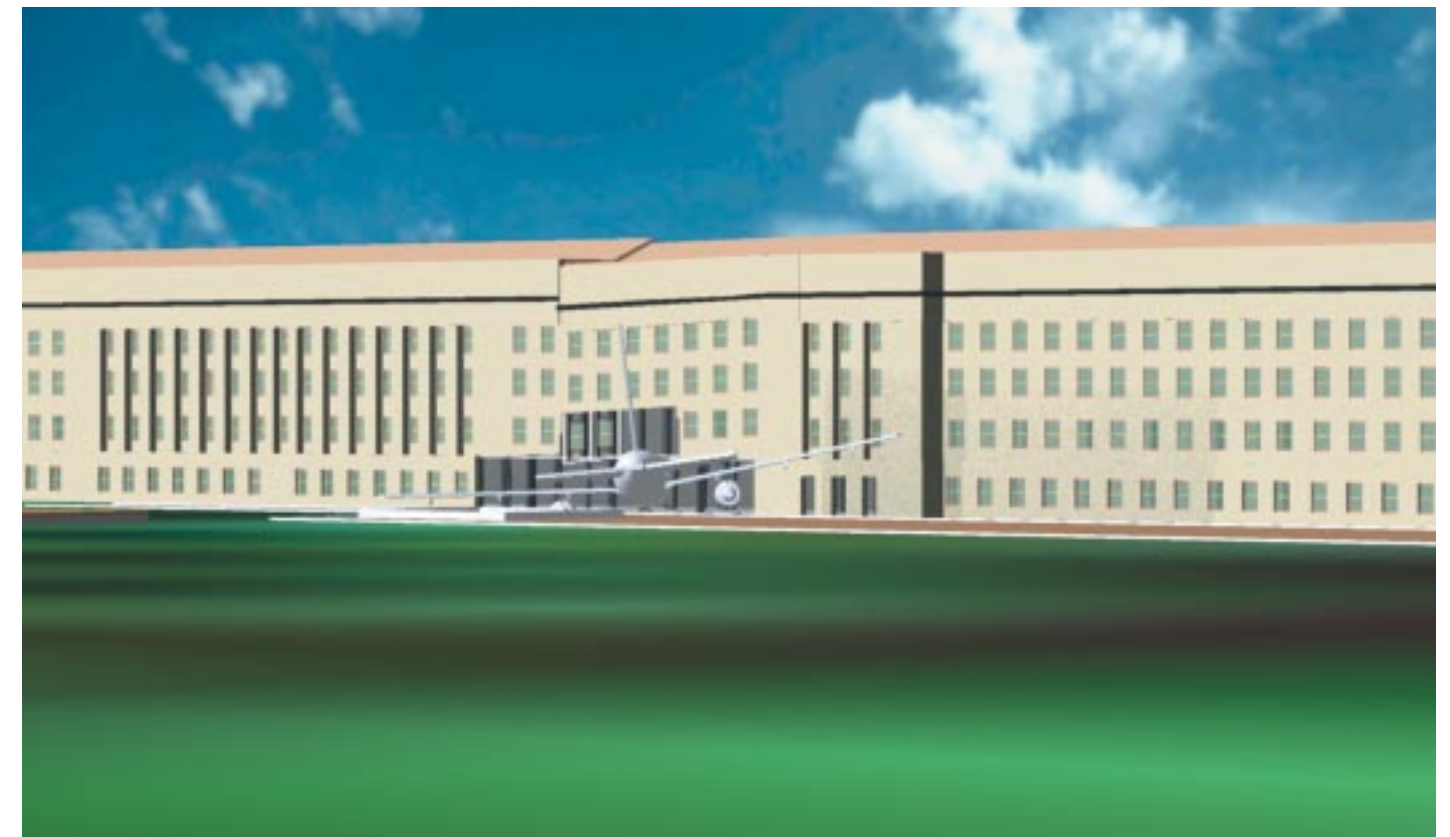
It is possible that less of the right wing than the left wing entered the building because the right wing struck the facade crossing the level of the second-floor slab. The strength of the second-floor slab in its own plane would have severed the right wing approximately at the location of the right engine. The left wing did not encounter a slab, so it penetrated more easily.

In any event, the evidence suggests that the tips of both wings did not make direct contact with the facade of the building and that portions of the wings might have been separated from the

Figure 6.1 Aircraft aligned with damage on west facade

fuselage before the aircraft struck the building. This is consistent with eyewitness statements that the right wing struck a large generator before the aircraft struck the building and that the left engine struck a ground-level, external vent structure. It is possible that these impacts, which occurred not more than 100 ft before the nose of the aircraft struck the building, may have damaged the wings and caused debris to strike the Pentagon facade and the heliport control building.

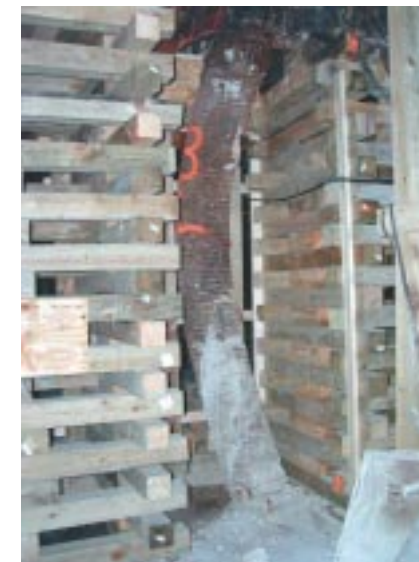
Impacted column

Several numerical simulations of a fluid mass (in this case modeled as aviation fuel) impacting a reinforced-concrete column fixed top and bottom were made by S.A. Kilic in support of the BPS study of the Pentagon. These simulations indicated that the maximum response velocity of the column was comparable to the velocity of the impacting fluid. The conclusion for the facade columns is self-evident. Their maximum response velocities could not have been less than 600 ft/s (vis-à-vis the impact velocity of approximately 780 ft/s). These columns engulfed by the fluid would have been destroyed immediately, however much energy might have been deflected by the facade walls and slabs. The question of interest is whether there was any system to the distribution of the severely damaged columns in the first story.

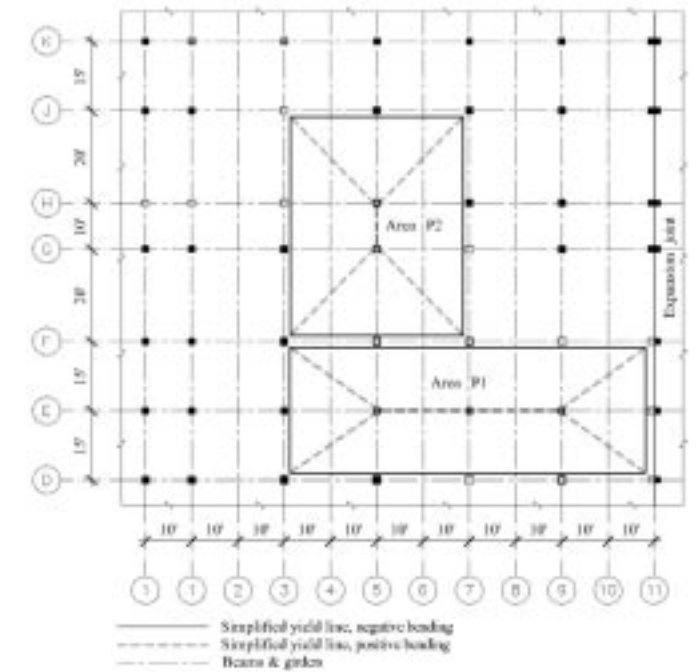
Figure 7.6a Yield line analysis of area with missing columns

column lines, why the structure could tolerate losses of columns. Simplified yield line analyses were also performed for areas within segment P that were missing several columns. Figure 7.6a shows two such areas, P1 and P2. The two areas are shown divided because the light well wall above (see figure 2.10, section 2) provides a stiff and strong support, and the second-story columns were able to act as hangers because the column vertical reinforcement was sufficiently well developed (having the lap enclosed within a spiral may have been a factor). The calculated capacities of the floor systems within P1 and P2 were both over 350 psf, more than twice the dead load. The light well wall was also analyzed for the loads that the area P1 and P2 mechanisms would deliver to it, and this analysis showed that some support from the two significantly impaired columns at 9 and 11 F would have been required to prevent a failure. The spiral reinforcement in those two columns must have been a key factor in preventing a widespread collapse.

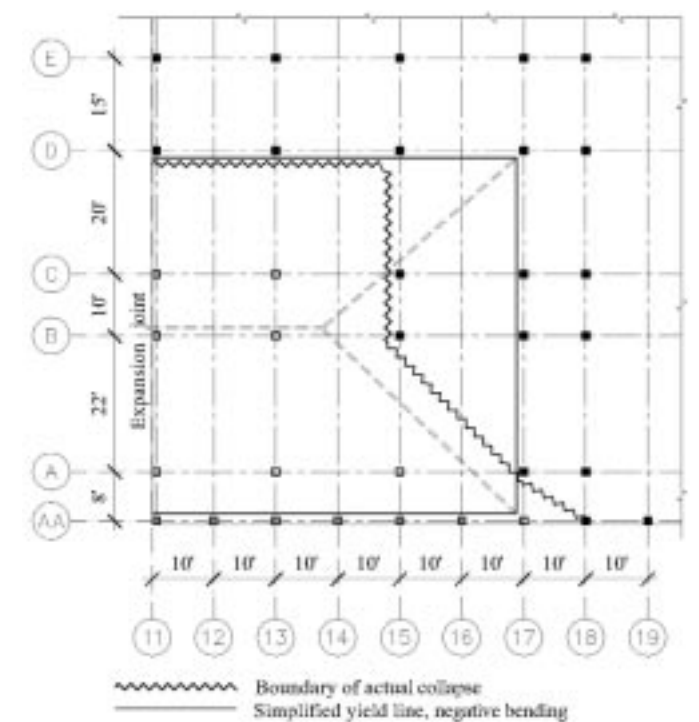
Figure 7.6b Yield line analysis of collapse area, segment Q

Figure 7.6b depicts the segment of the building between column lines 11 and 17 and AA and D. To obtain another perspective of the intrinsic strength of the floor system, its capacity to resist load at room temperature was estimated by assuming that all columns at the intersections of column lines 12 through 16 and AA, A, B, and C were lost. The assumed locations of the negative- and positive-moment yield lines are shown in the figure. The floor-system edge along line 11—the location of the expansion joint—was assumed to be unsupported. The support along line AA was considered to be provided by the facade wall that had not been destroyed by the impact. (An example of a similar phenomenon at a different building is shown in figure 7.7.)

The calculated capacity for the failure condition shown ideally in figure 7.6b was approximately 160 psf (with the dimension x set at 35 ft, corresponding to the minimum calculated yield load). For the assumed boundary, material, and support conditions, the floor system at level two would have been able to support itself over the assumed unsupported area. It is plausible to assume that the columns at the intersections of line AA with lines 11 through 16 were not functional at the time the photograph that constitutes figure 3.8 (section 3) was taken. Photographs taken immediately after the impact (figures 3.8 and 3.9, section 3) indicate that segment Q might have derived some support from segment P before collapsing. The partial support might have provided a collateral

mechanism for resisting the overall gravity loads on segment Q considered as a building block, but the floor system would still have had to be able to carry itself. The eventual collapse of this section is attributed to the effects of heat from the fire or high-strain creep, possibly exacerbated by the water pumped into the structure to quell the fire.

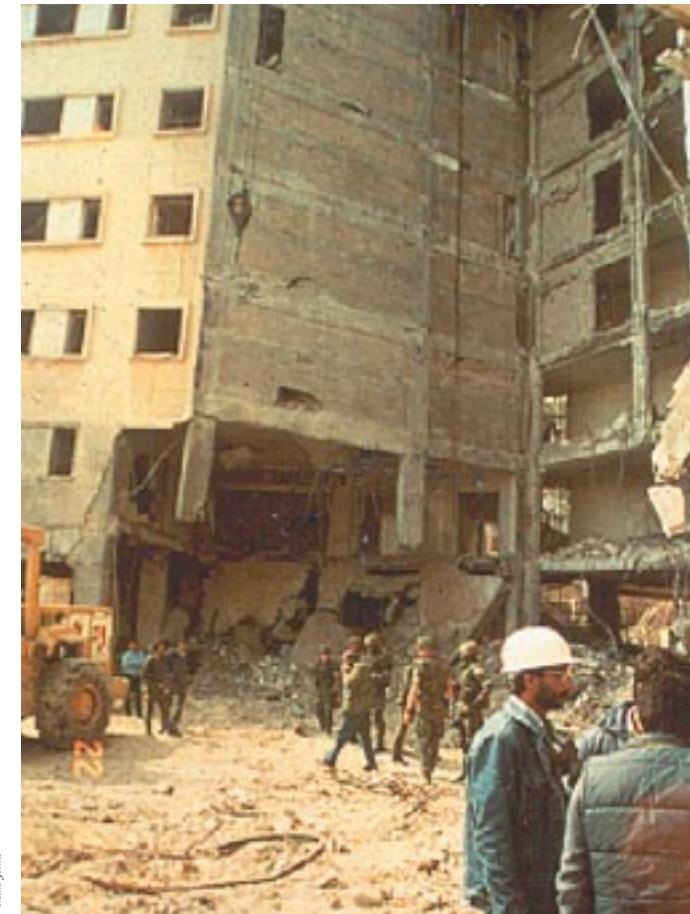
Figure 7.7 Reinforced-concrete frame with masonry filler walls acting as a vertical diaphragm to compensate for column loss

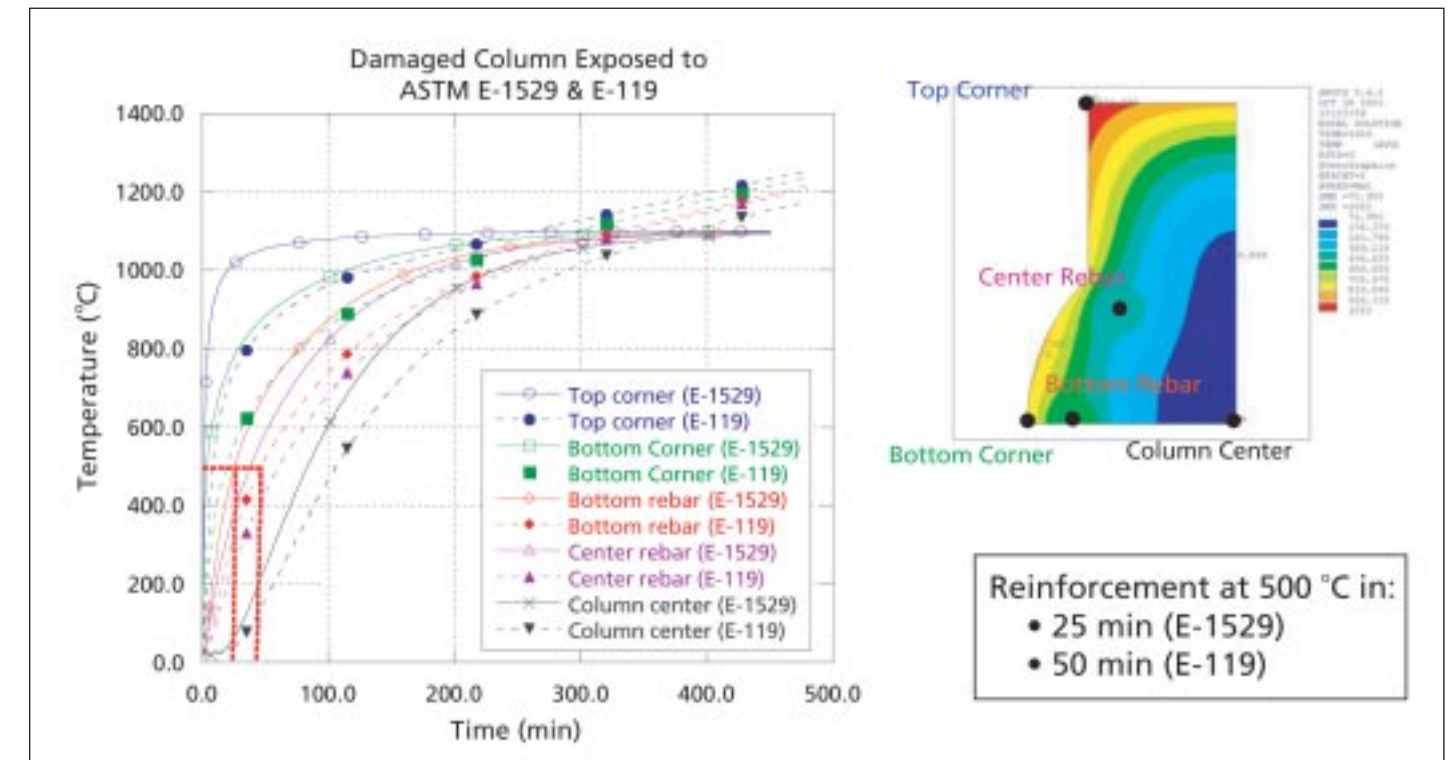
Figure 7.12 Temperature development in damaged column

and 120 minutes under the ISO 834 fire exposure. This represents the lower bound in fire endurance of the undamaged column and girder. However, once portions of the concrete cover for the reinforcement have been stripped off, the structural capacities of the damaged columns and girders can quickly be compromised, as reflected in the shortened fire endurance times obtained from the thermal analysis shown in figures 7.11 through 7.14 and listed in table 7.2. The fire endurance times for the column and beam are determined as the times for the main reinforcing steel to reach critical temperature (932°F [500°C], impending yielding temperature of steel reinforcement as defined in the Eurocode). For the column, the fire endurance time when damaged ranges from 25 minutes (based on the upper-bound fire ASTM E-1529) to 50 minutes (based on the lower-bound fire ASTM E-119). For the girder, the fire endurance time when damaged ranges from 12 minutes (ASTM E-1529) to 20 minutes (ASTM E-119). These endurance times compare well with the observed time to collapse after the initiation of the fire.

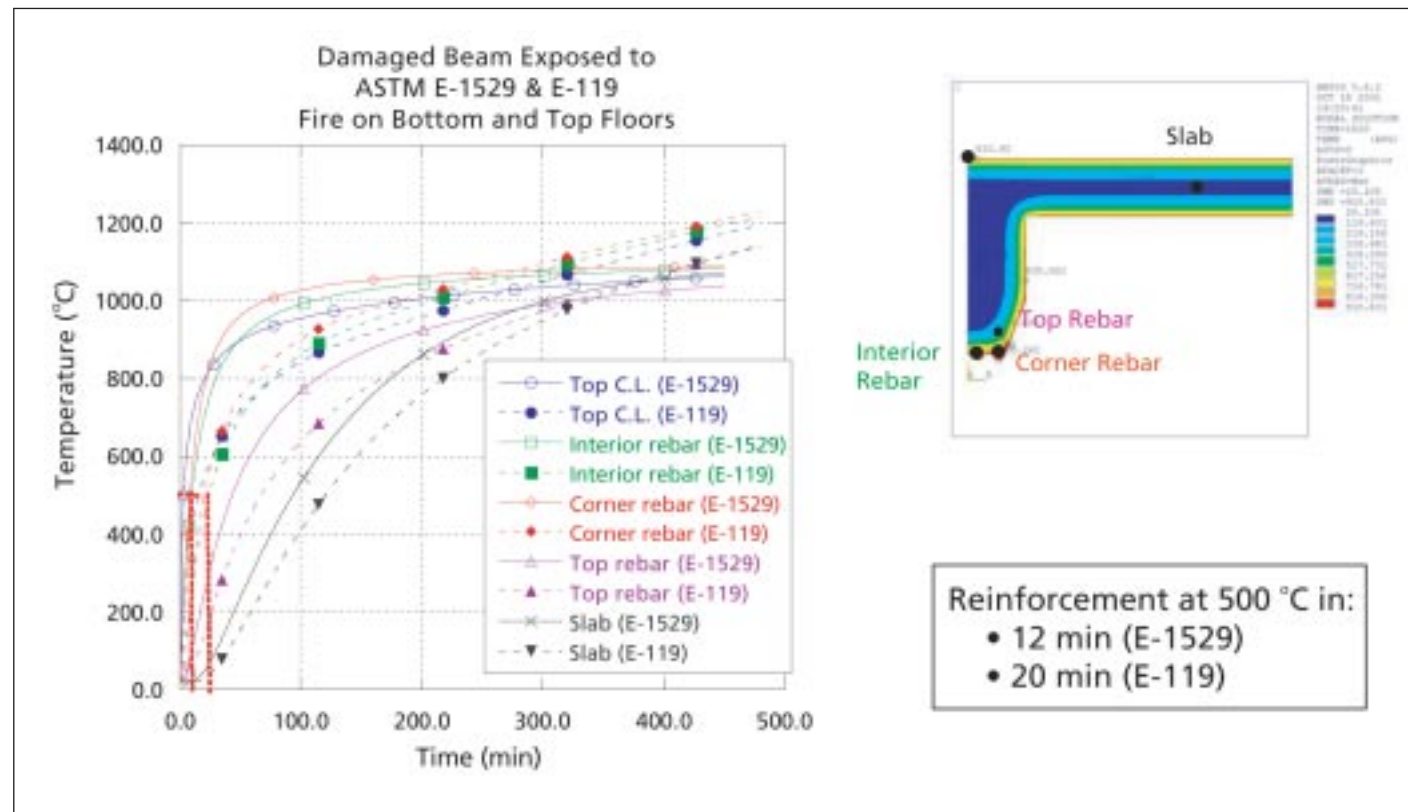
Figure 7.14 Temperature development in damaged beam

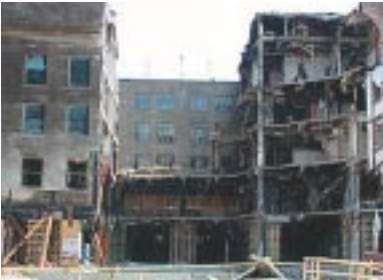
COLUMN LABEL	DESCRIPTION OF DAMAGE	PHOTO (IF AVAILABLE)
18AA	<ul style="list-style-type: none"> • Bowed • Concrete completely missing at top • Spalling present from midheight to top • Shored

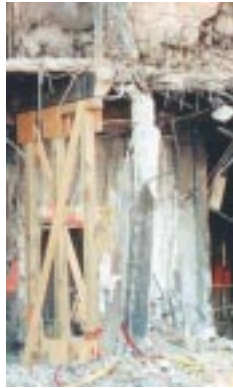
11A	<ul style="list-style-type: none"> • Missing • Shored

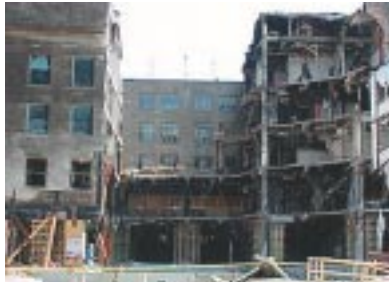
17A	<ul style="list-style-type: none"> • Stripped to spiral reinforcement at top of column • Shored

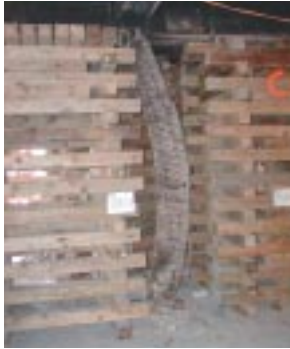
9C	<ul style="list-style-type: none"> • Severely bowed • Stripped to spiral reinforcement • Lost some concrete inside spiral reinforcement • Shored

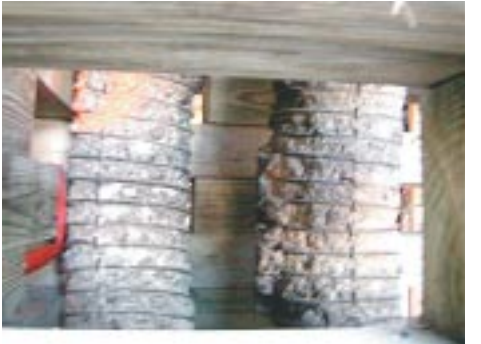
13D	<ul style="list-style-type: none"> • Stripped to spiral reinforcement • Bowed to Northeast • Shored

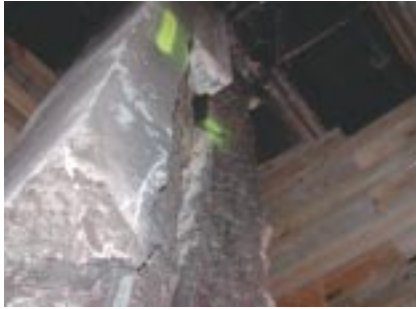
11F	<ul style="list-style-type: none"> • Impacted, bowed • Stripped to spiral reinforcement • Shored

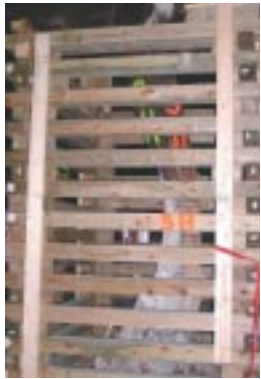
5H	<ul style="list-style-type: none"> • Downed • Stripped to spiral reinforcement • Shored

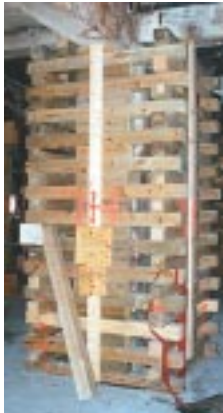
7H	<ul style="list-style-type: none"> • Moderate spalling • Spalling more at top • No steel appears visible • Shored

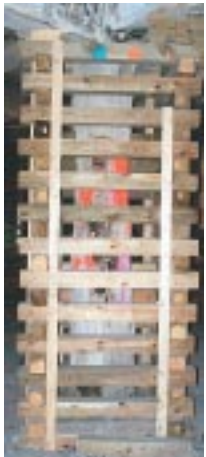
9H	<ul style="list-style-type: none"> • Moderate spalling • Some spiral reinforcement visible • Vertical cracks • Shored

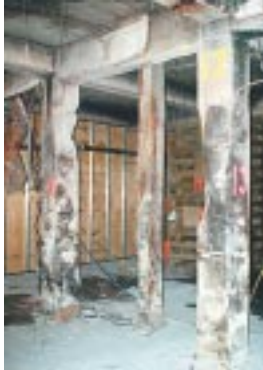
COLUMN LABEL	DESCRIPTION OF DAMAGE	PHOTO (IF AVAILABLE)
1J-North & 1J-South	<ul style="list-style-type: none"> • Intact • Blackened

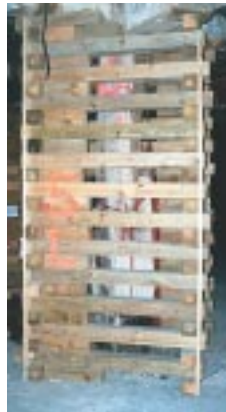
5L-South	<ul style="list-style-type: none"> • Split • Stripped to spiral reinforcement at 4 feet above floor • Shored
