THE PENTAGON BUILDING PERFORMANCE REPORT

January 2003

American Society of Civil Engineers

SEI
Structural Engineering Institute
of the American Society of Civil Engineers

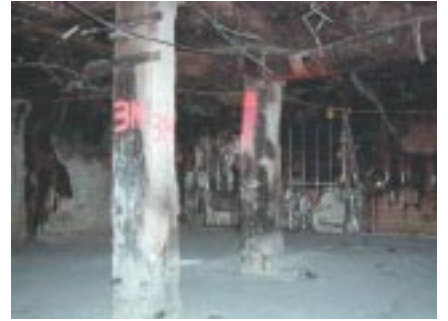
COLUMN LABEL	DESCRIPTION OF DAMAGE	PHOTO (IF AVAILABLE)
3M-North	<ul style="list-style-type: none"> • Damaged (per FBI)
